RESIDENTIAL PROPERTY REPORT

1234 Main St. Paraparaumu Wellington 5032

09/08/2021 9:00AM

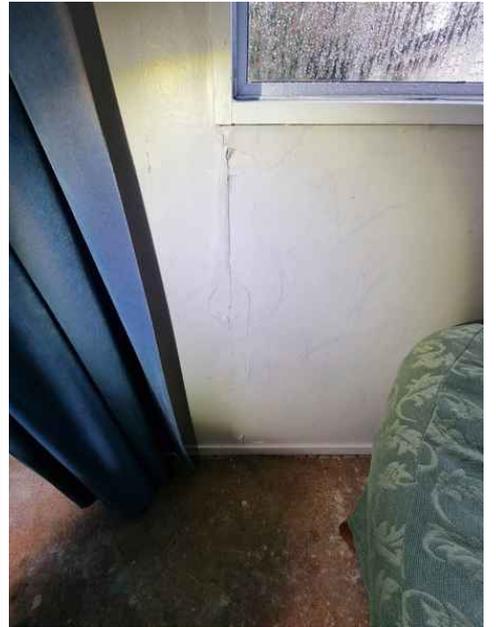
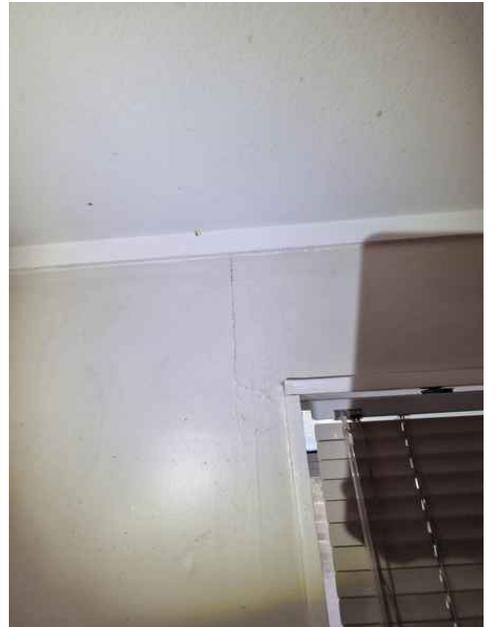
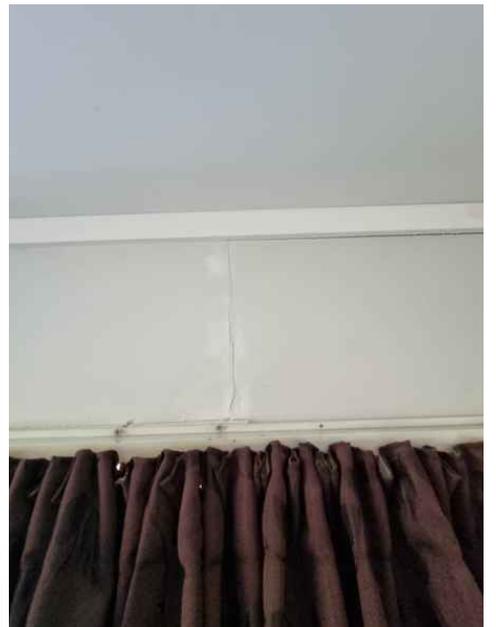
14.1.2 INTERIOR OBSERVATIONS

SETTLEMENT CRACKS

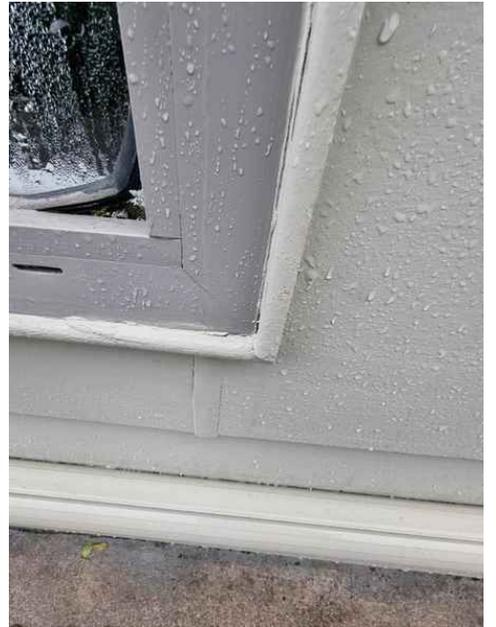
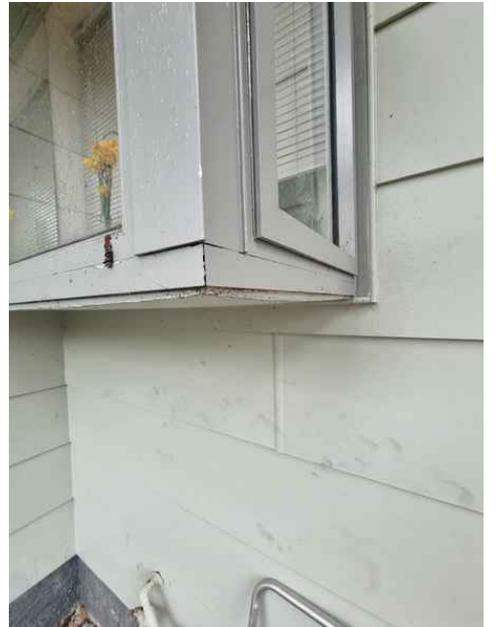
17.1.2 JOINERY OBSERVATIONS

DAMAGE AT OR IN JOINERY

CONDENSATION DAMAGE AT JOINERY

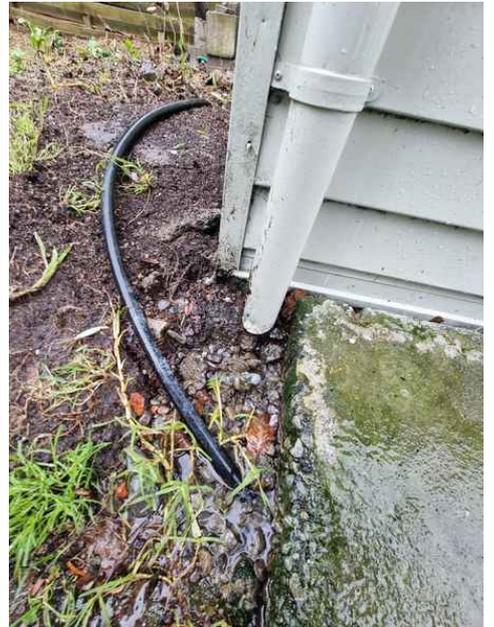
19.1.4 EXTERIOR ROOFING OBSERVATIONS

DEBRIS HAS ACCUMULATED IN THE DRAINAGE SYSTEM

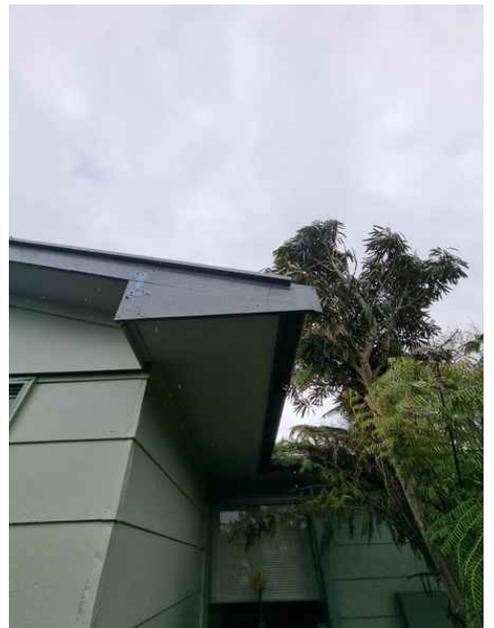
19.1.6 EXTERIOR ROOFING OBSERVATIONS

FASCIA BOARDS AND/OR SOFFITS SHOW MOISTURE DAMAGE AND/OR ROT IN MULTIPLE AREAS

- This is common observation for this age of fascia board edging.
- The moisture damage sighted in the soffits is also common.
- These issues should be addressed sooner rather than later.

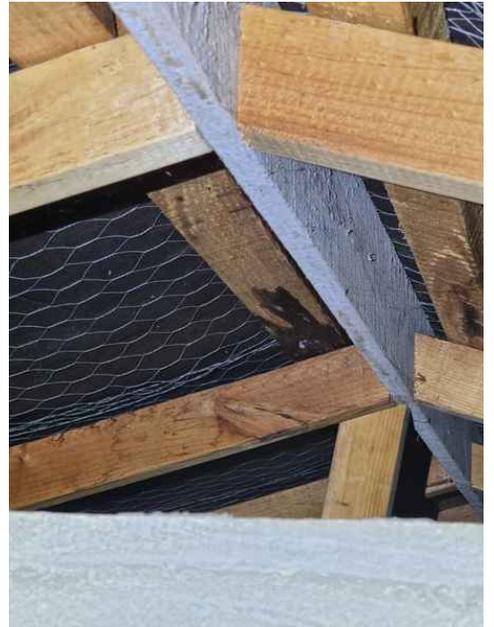
20.1.2 ROOF STRUCTURE OBSERVATIONS

- Moisture damage and/or staining noted in one or more areas of the ceiling cavity.

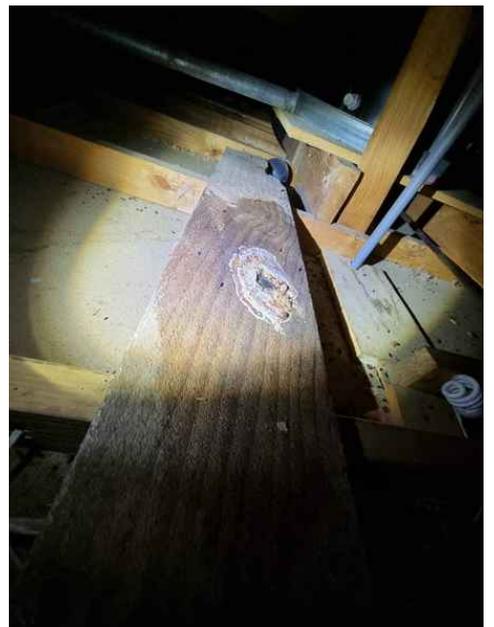
20.1.3 ROOF STRUCTURE OBSERVATIONS SIGNS OF TIMBER ROT

ROT NOTED

- The roof structure shows rot in some areas.
- This is relatively common and somewhat expected in older homes, however it should be removed where possible and the rot treated in any areas not able to be removed.

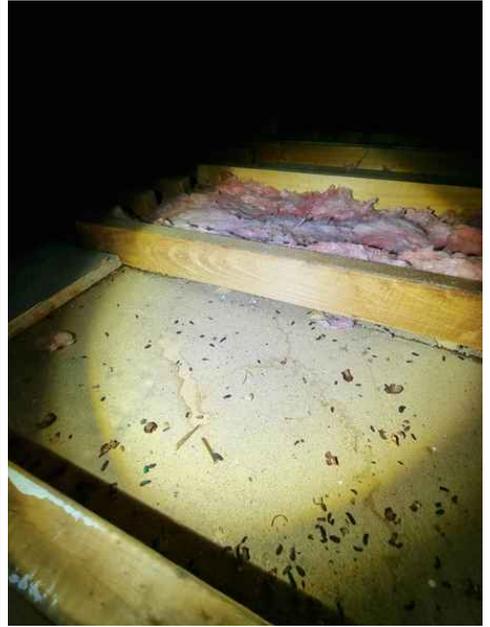
20.1.4 ROOF STRUCTURE OBSERVATIONS

PEST ISSUES NOTED

Maintenance Item

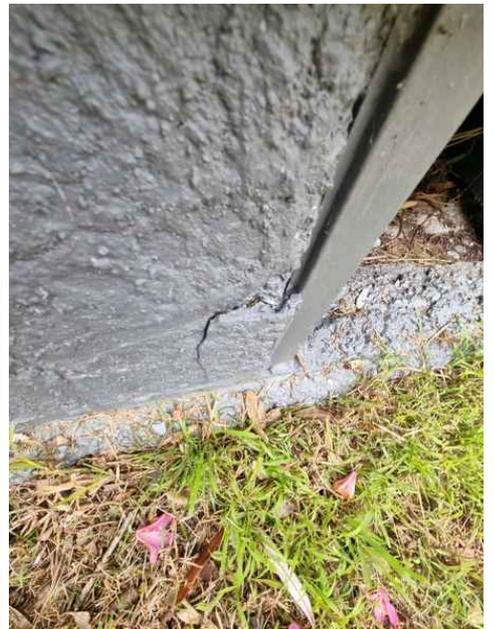
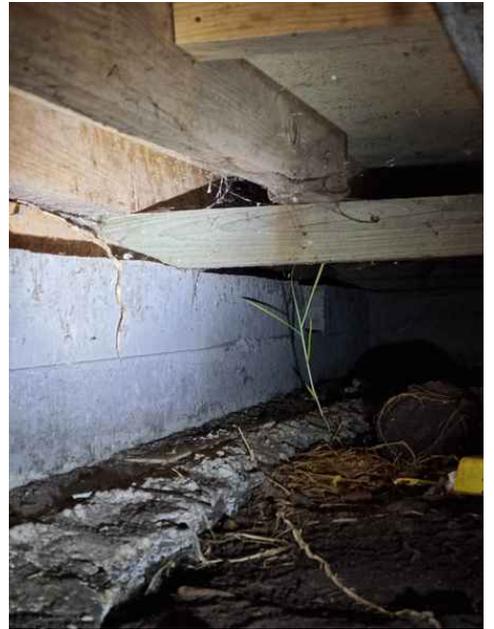
20.2.1 FOUNDATION OBSERVATIONS

SETTLEMENT AND/OR SETTLEMENT DEFECTS

- If they continue to get wider, obtain a chartered engineer's advice on repair options.

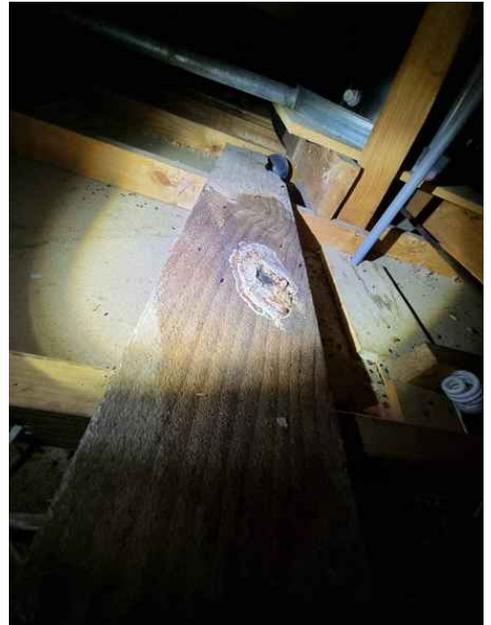
The hallway light is flickering because a roof leak has created a puddle and is arcing across the terminals. This has the potential to cause serious injury, death and/or fire.
