# COMPREHENSIVE PROPERTY REPORTS

## RESIDENTIAL PROPERTY REPORT COPY

1234 Main St. Paraparaumu Wellington 5032

09/08/2021 9:00AM

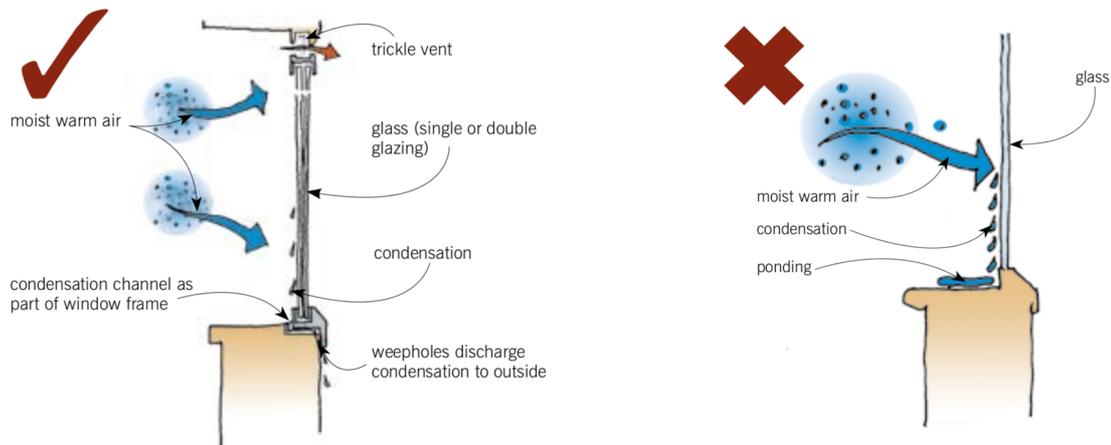
**Water damage:** around windows can be caused by condensation or leaks. Try to reduce the amount of condensation in your home.

### CONDENSATION DAMAGE AT JOINERY

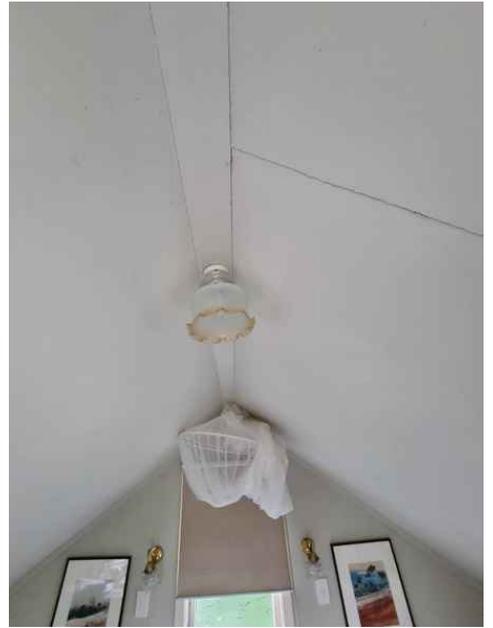
**NOTABLE TEMPERATURE DIFFERENTIALS  
AND/OR  
INDICATIONS OF ELEVATED MOISTURE LEVELS**

Images/areas documented in this observation may be showing moderate to high temperature differentials with the FLIR MR277 Thermal Imaging camera and/or elevated moisture levels with the FLIR MR60 Moisture meter. These areas may not be at the through-wall stage yet, they may be considered areas with a "developing" issue that, if remedied sooner rather than later should not develop into a major concern. Regardless of what stage they are currently at, they must still be monitored closely even after repair work has been done.

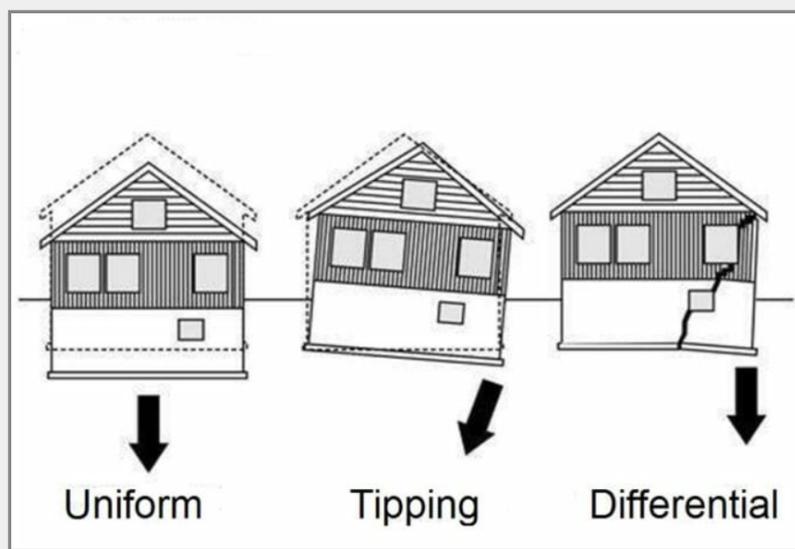
### SETTLEMENT CRACKS & THE 3 TYPES OF SETTLEMENT

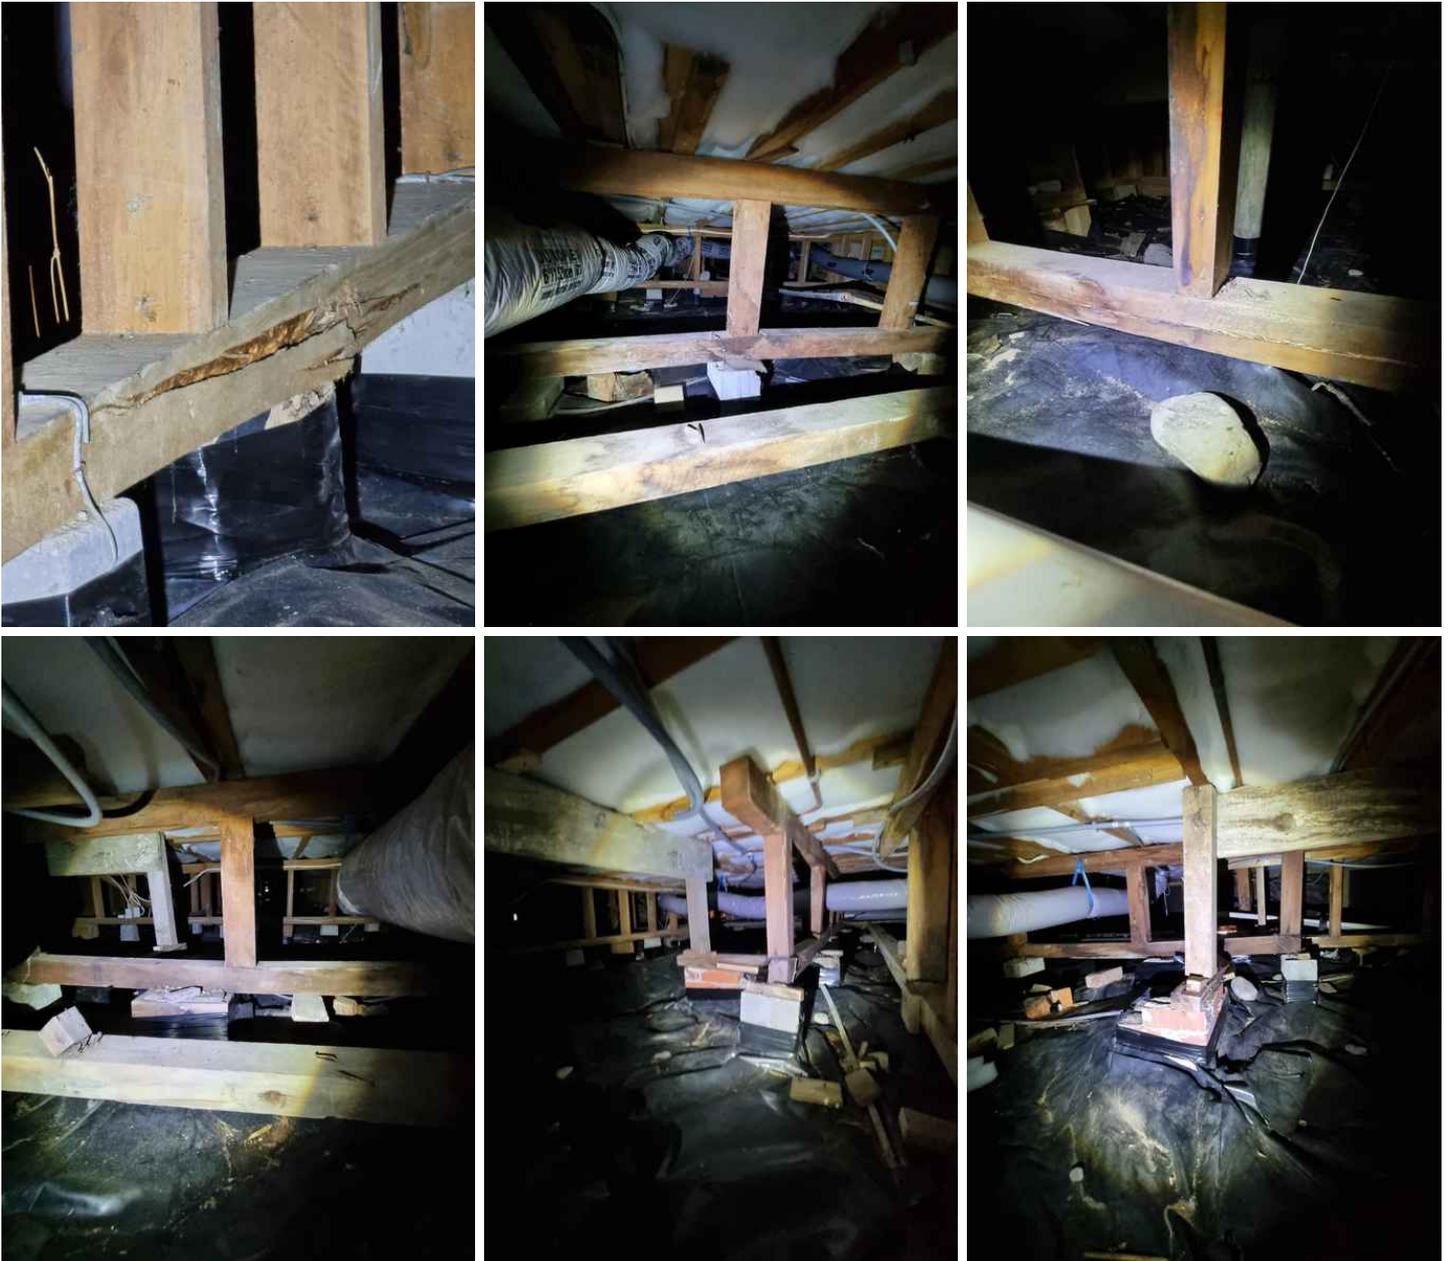
### ROTTEN TIMBER

- check that the source of the moisture has been identified and remedied
- remove all visible rot
- remove at least one meter of timber past the last visible sign of rot damage as the root system of the rot may be present in apparently sound timber – in some cases, it may prove easier to replace the entire piece of affected timber rather than trying to replace and strengthen a portion
- treat cut timber with a proprietary paint-on preservative.

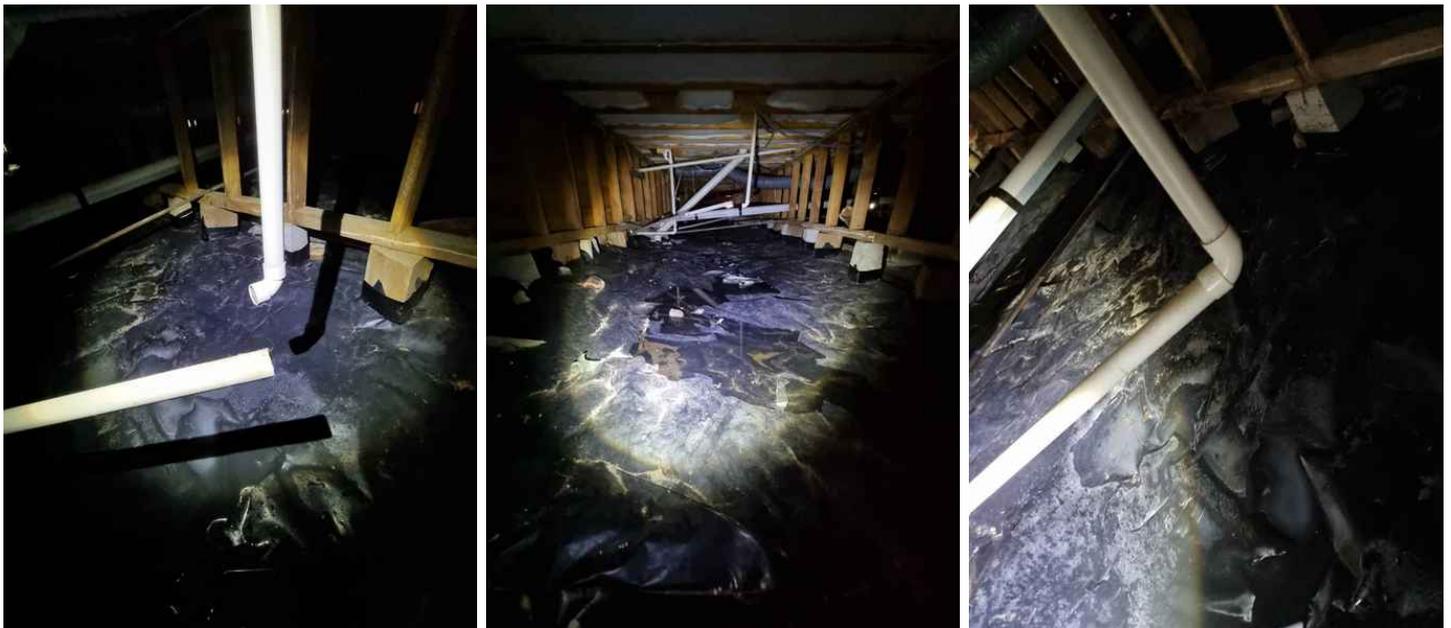
**UNSATISFACTORY PLUMBING ITEM**

The item/s in this section require repair/replacement.
