COMPREHENSIVE PROPERTY REPORTS

RESIDENTIAL PROPERTY REPORT COPY

1234 Main St. Paraparaumu Wellington 5032

29/09/2021 9:00AM

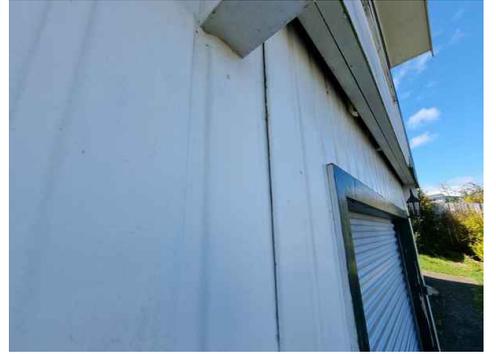
DAMAGED SHADOWLINE

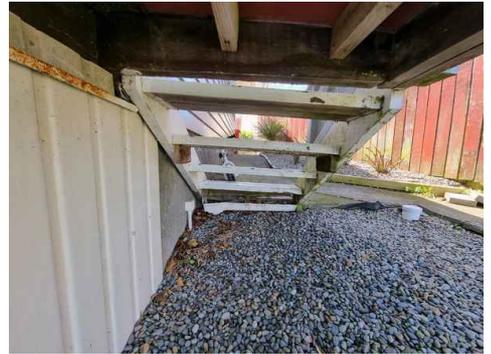
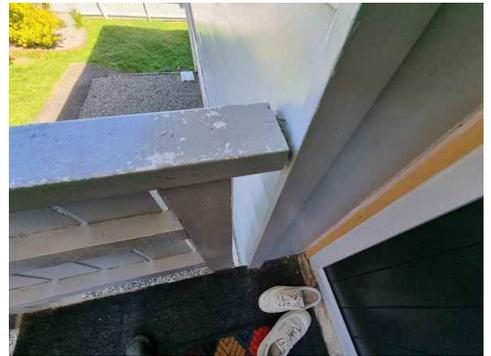
PORCH | VERANDA NEEDS REMOVING AND REBUILDING

- Material deterioration, under foot movement/sag noted.
- Recommend a qualified builder assess and quote for repair and/or replace.

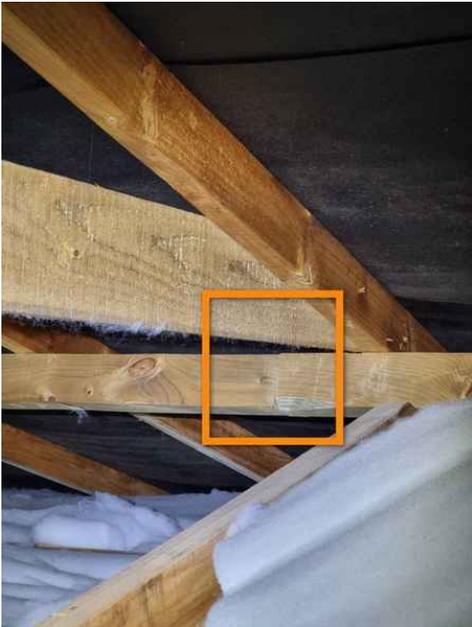
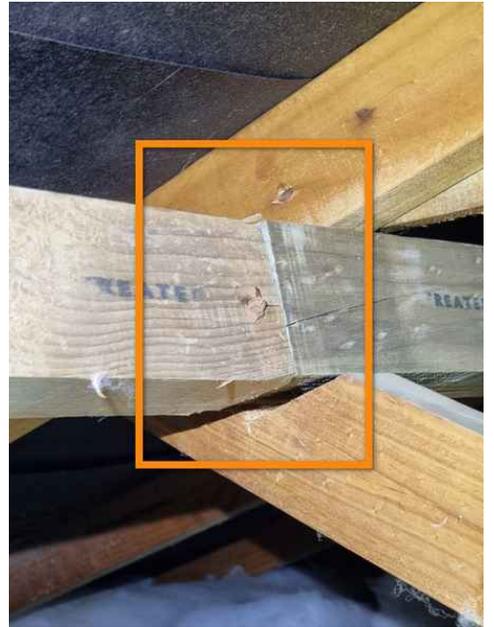
SUB-STANDARD CONSTRUCTION PRACTICES NOTED

- This is a common observation for this era of construction, however common it is a poor construction practice.

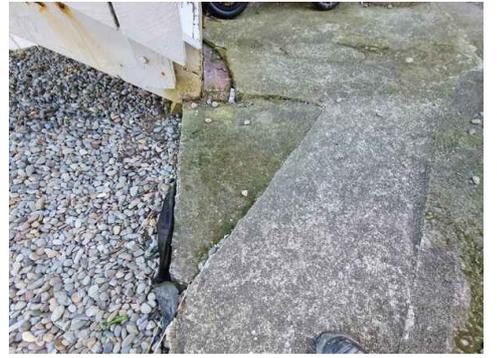
GROUND SETTLEMENT AND/OR FLAT CONCRETE CRACKS

Minor to moderate cracking observed in driveway and/or pathway concrete and/or masonry areas. These are a common observation and generally expected at most properties.

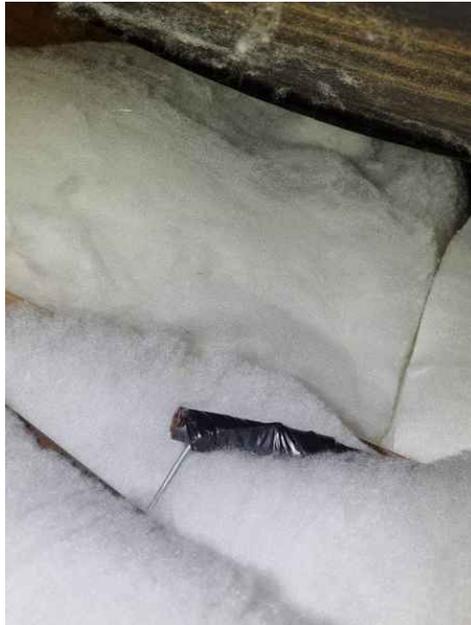
UNSATISFACTORY ELECTRICAL ITEM

The item/s in this section require repair/replacement.
