REPAIR REQUEST LIST

1234 Main St.
16/10/2021 4:24 am

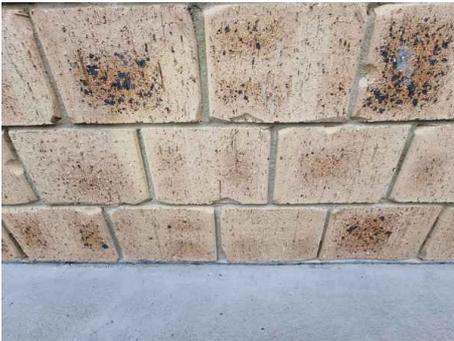
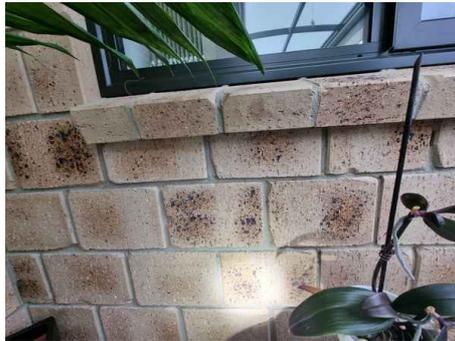
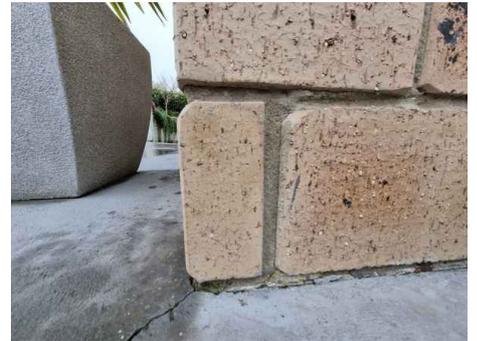
OBSERVATION | MASONRY CLADDING

Only 3X Cracks in masonry and/or mortar cracks noted. **This is very impressive for this style of brick and the location of the property**

NZ\$750 credit requested

Estimate from Inspector.

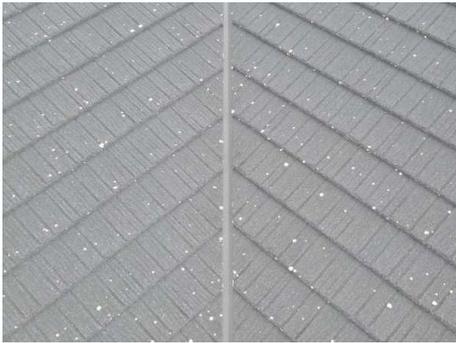
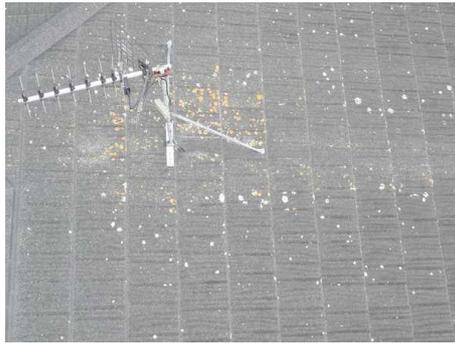
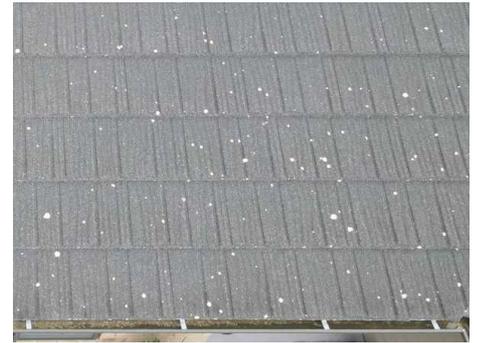
LICHEN, ALGAE AND/OR MOSS SIGHTED

Lichen, Algae and/or moss sighted in one or more areas.

Lichen causes damage and is extremely difficult to remove with pressure cleaning or scrubbing alone. The lichen will begin to regrow immediately after pressure cleaning from the residue left behind.

SOLUTION: LICHEN REMOVAL

Bio-Shield is a very good product for stopping the regrowth of lichen.

The key to successfully cleaning and removing lichen is to apply the Bio-Shield solution to saturate the lichen through to the base of the growths, and ensuring it does not dry out too quickly. Aim to allow drying over 10 to 15 minutes to ensure the Bio-Shield gives a good kill. Application on a cloudy day or early morning will assist. You will notice a slight colour change in most lichens once Bio-Shield is applied as it penetrates and kills the lichen. A surface treated with Bio-Shield

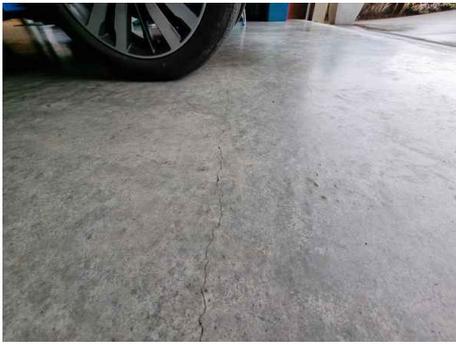
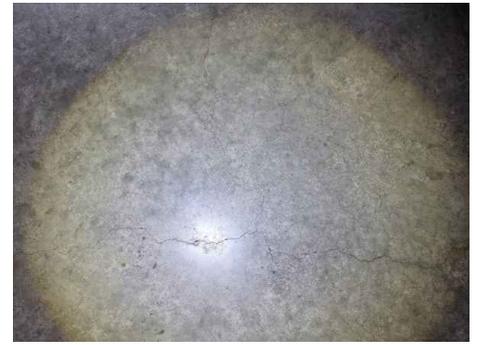
CRACKS NOTED IN CONCRETE WORK

Cracking due to ground shift/settlement or displacement was noted in the foundation work, masonry walls and/or connecting concrete areas. Surface cracking and/or edges cracking of slab corners is relatively normal in concrete construction of this type. Cracking in concrete plaster rendering is also a common observation.

Monitor the width of cracks for a period of time (approximately every six months):
If they do not change, seal with a flexible exterior grade sealant. *(You must still monitor these areas after sealing them)*

If they continue to get wider, obtain a chartered engineer's advice on repair options.

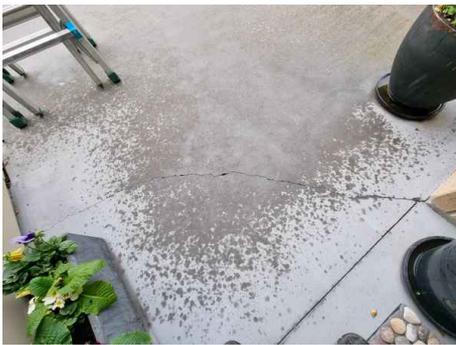
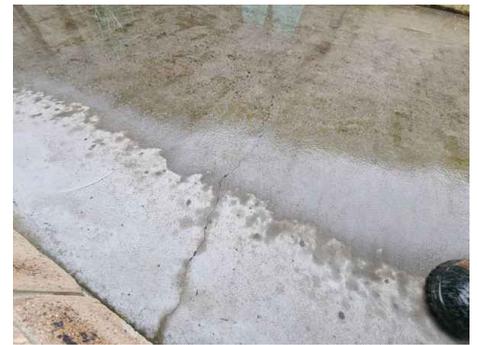
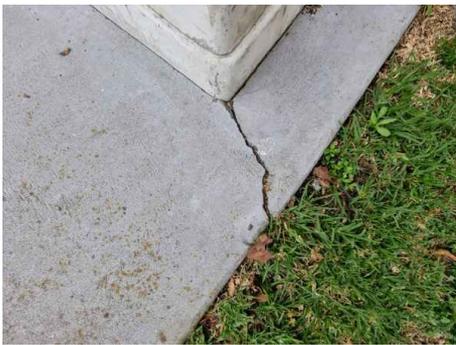
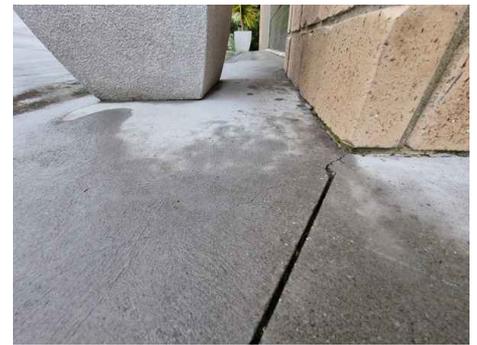
GROUND SETTLEMENT AND/OR FLAT CONCRETE CRACKS

Minor cracking observed in driveway and/or pathway concrete and/or masonry areas. These are a common observation and generally expected at most properties.

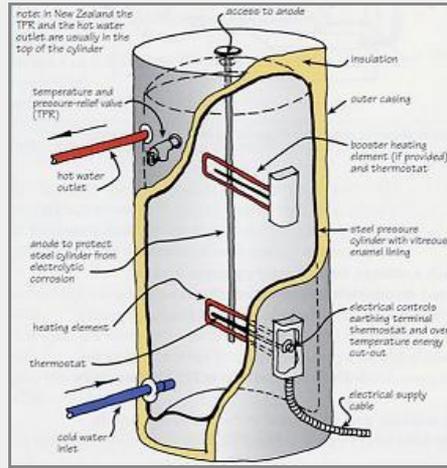
HOT WATER CYLINDER

Hot water cylinder should be off the ground. This is a common observation, However the mounting of the HWS on a platform is quite important for a few reasons. The main reason cylinders are placed on platforms is to ventilate the underside of the cylinder. Water can condense underneath it due to the inside temp being hotter than the outside of the cylinder. This can cause the cylinder and floor to rot a lot quicker underneath if you do not allow for ventilation. Drip pan may not be present. Plumbing may be leaking. Corrosion may have been sighted on a section of the hot water system and/or the systems plumbing. Water heater may be improperly installed and/or in a dangerous location. Cylinder may not be properly restrained

REPAIR: Ensure the base is blocked to stop it from sliding in an earthquake, then install restraining straps to stop the cylinder tipping over. Stainless steel straps 25 x 1mm around the top and bottom of the cylinder must be securely fixed to framing. Cylinders over 200 litres require a third strap in the centre. Restraint kits including straps, screws and tensioning devices are available from hardware stores. (Ensure you buy a kit with stainless steel straps and not the galvanised steel straps that are for indoor use.)
