WEATHERTIGHTNESS REPORT COPY

1234 Main St. Paraparaumu Wellington 5032

13/02/2022 9:00AM

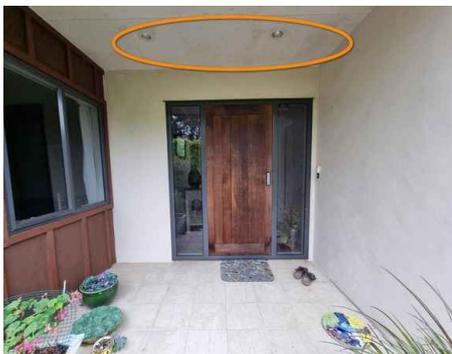
EITHER GRIME BUILD UP AND/OR MOULD NOTED ON SOFFIT

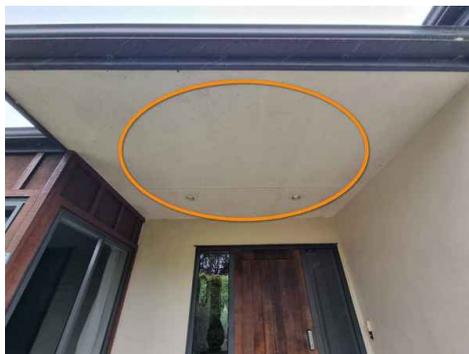
ELEVATED MOISTURE NOTED IN THE CEILING INSIDE THE FRONT DOOR

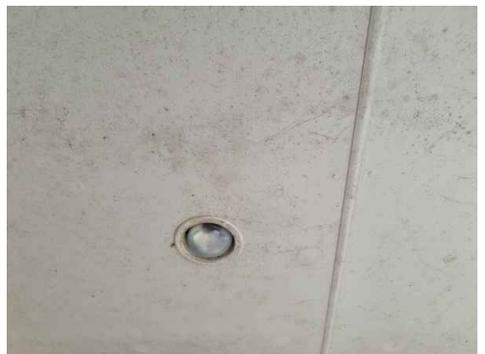
APPEARS TO BE MOULD ON SOFFITS

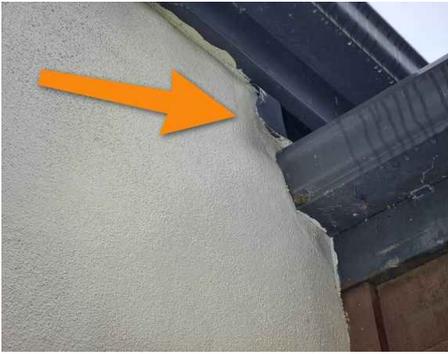
DEFECT IS ELEVATED FROM THE HALLWAY CEILING AND FRONT DOOR SOFFIT OBSERVATIONS. POSSIBLE CAUSE

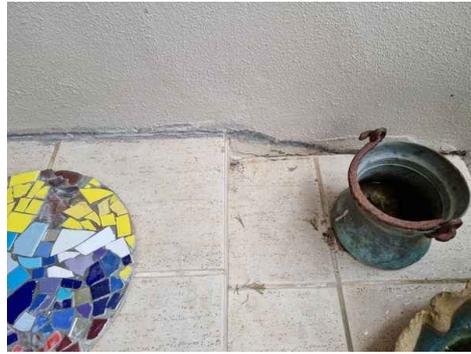
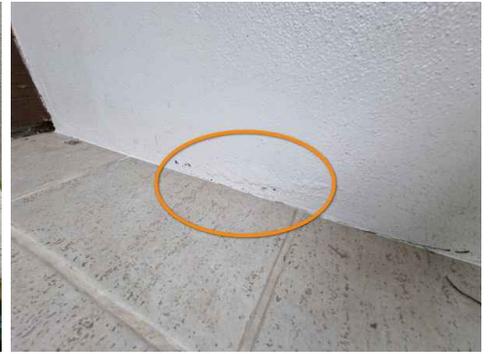
EFFLORESCENCE NOTED

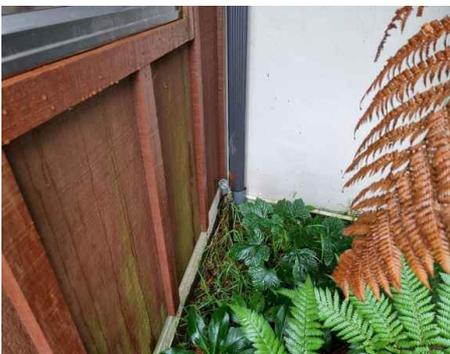
LICHEN, ALGAE AND/OR MOSS ON CLADDING

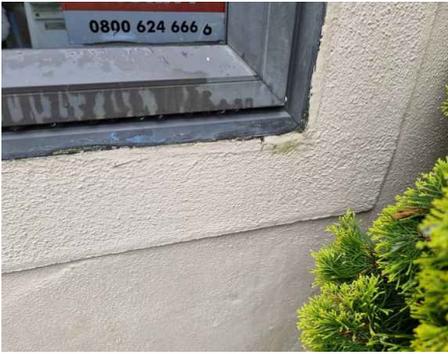
FAILING WEATHER SEAL AT JOINERY TO CLADDING JUNCTION

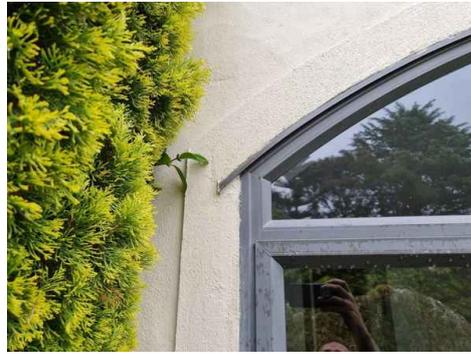
FAILING WEATHER SEAL AT JOINERY TO CLADDING JUNCTION

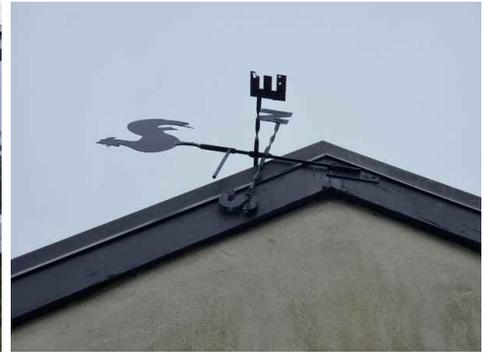
WEATHER SEAL DEFECT - ROOFING

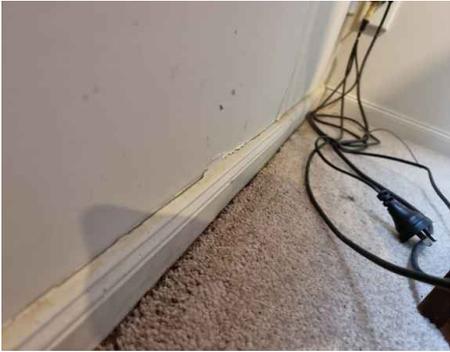
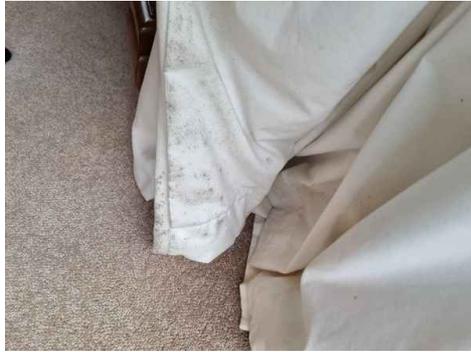
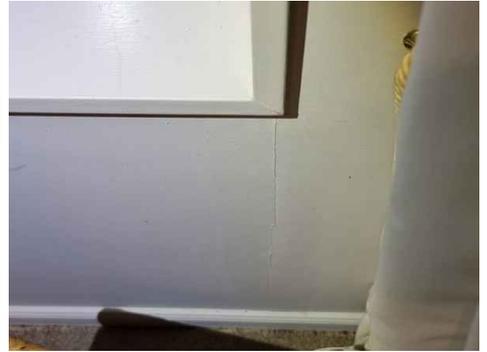
MOULD SIGHTED

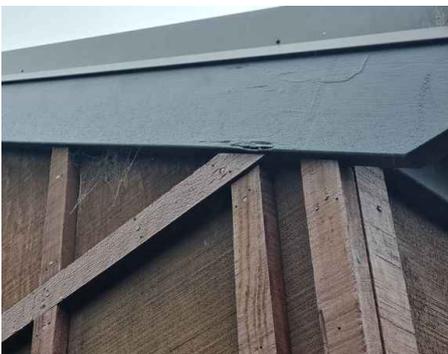
WEATHER SEAL DEFECT - ROOFING

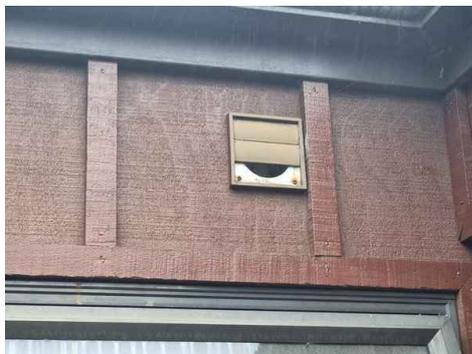
DAMAGED VENT

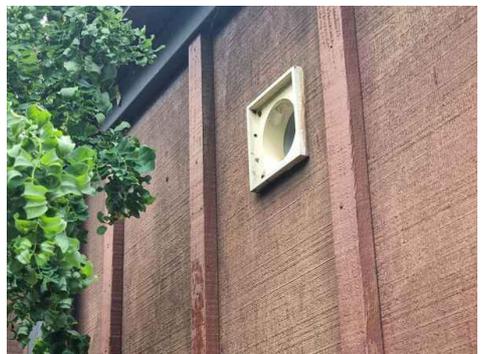
DAMAGED VENT

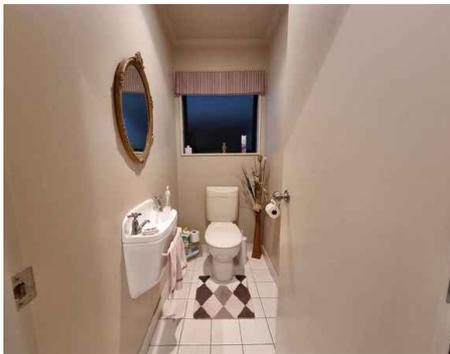
SEPARATE TOILET - NO MAJOR DEFECTS TO NOTE

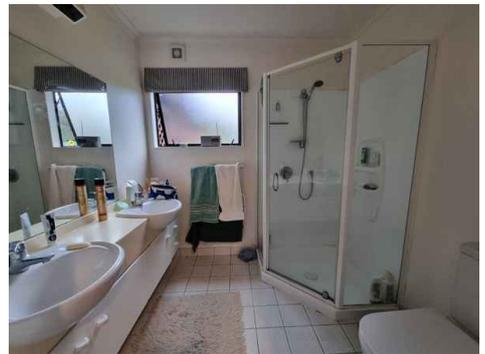
ENSUITE - NO MAJOR DEFECTS TO NOTE

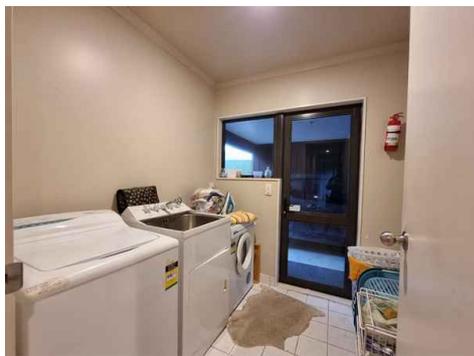
LAUNDRY - NO MAJOR DEFECTS TO NOTE

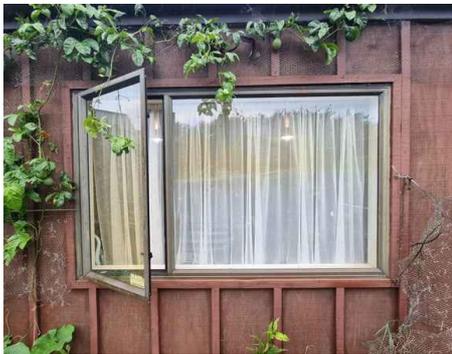
PLANTS IN CONTACT WITH CLADDING

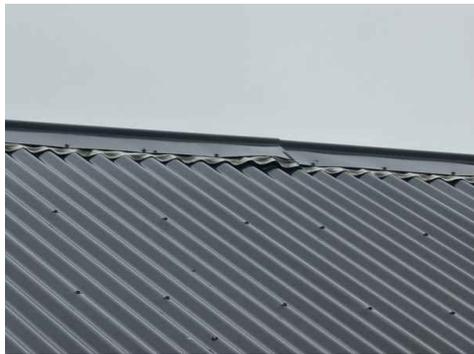
WEATHER SEAL DEFECT - ROOFING

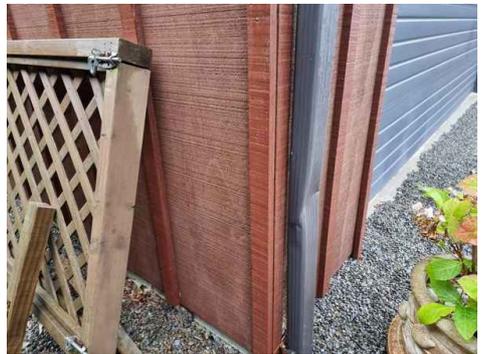
DAMAGED DOWNPIPE

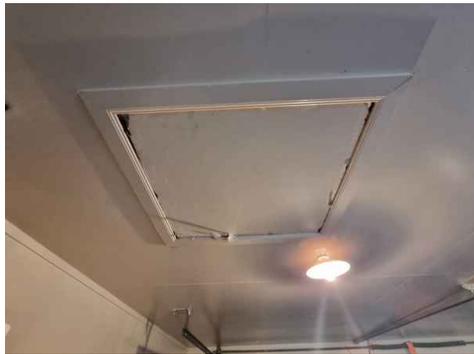
SWOLLEN BUILDING MATERIALS

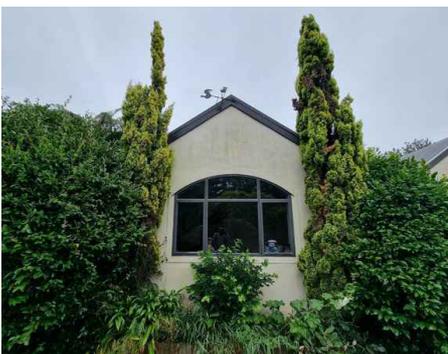
- Board & batten cladding is in a generally good overall condition.
- Texture coat cladding is in an average to poor overall condition.
- The B&B cladding showed the expected amount of weathering.
- **The Texture coat cladding showed an excess amount of weathering**
- Weathering and/or cracking of the cladding materials.
- Weather seal breakdown.
- Areas of cladding are high risk for moisture ingress.

TOO MANY OBSERVATIONS TO LIST
