RESIDENTIAL PROPERTY REPORT

1234 Main St. Paraparaumu Wellington 5032

09/08/2021 9:00AM

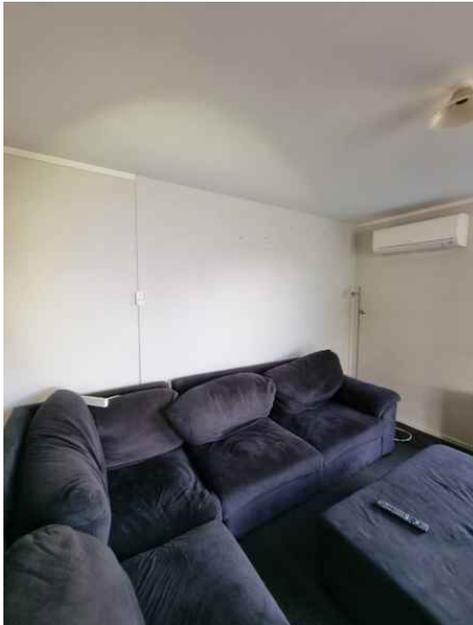
POOR FINISHING | POOR TRADE WORK

HALF DONE DIY WALL

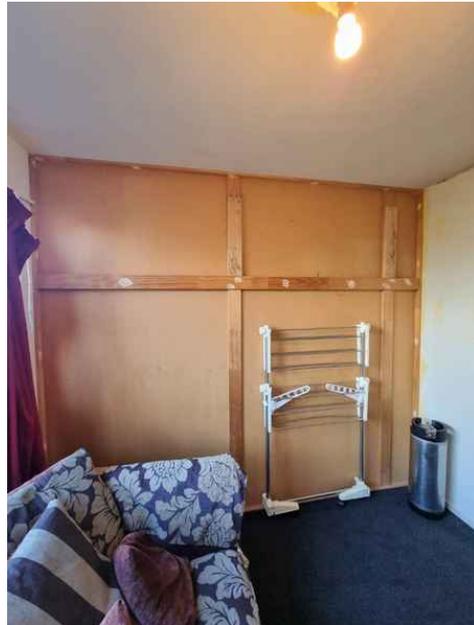
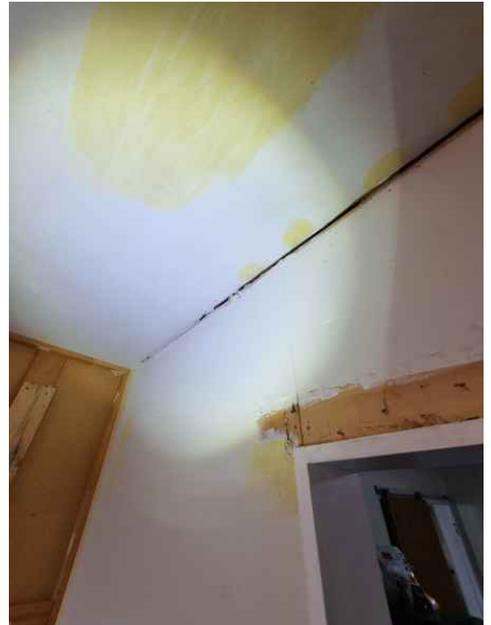
HALF DONE DIY WALL

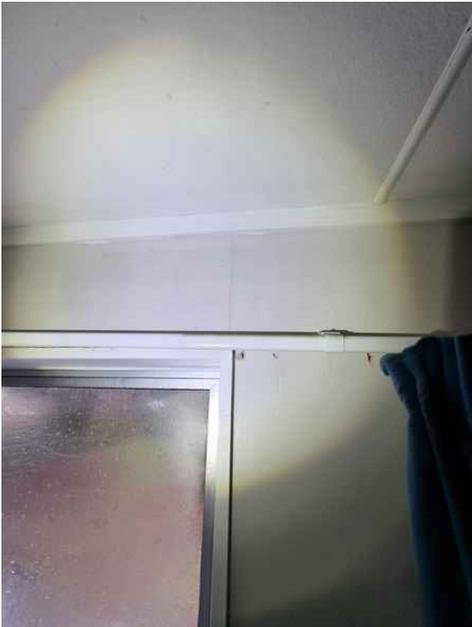
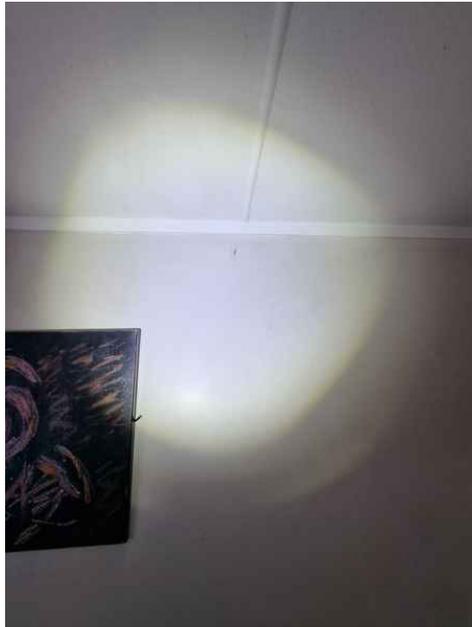
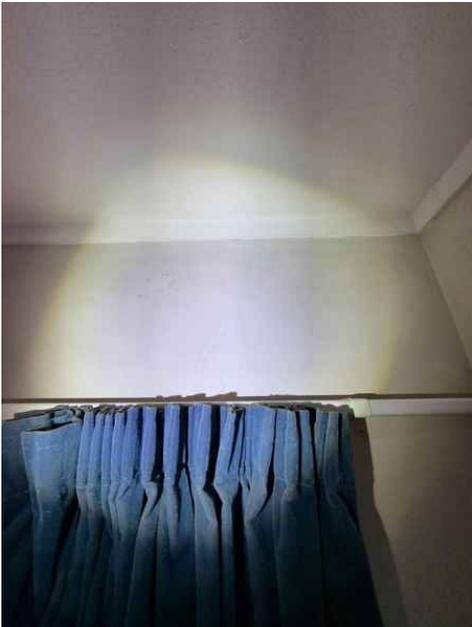
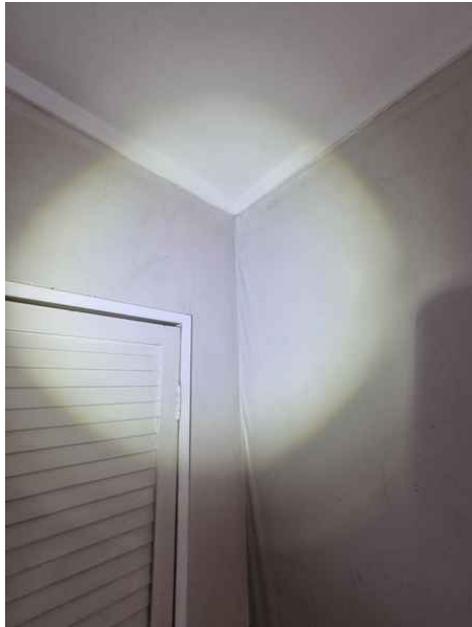
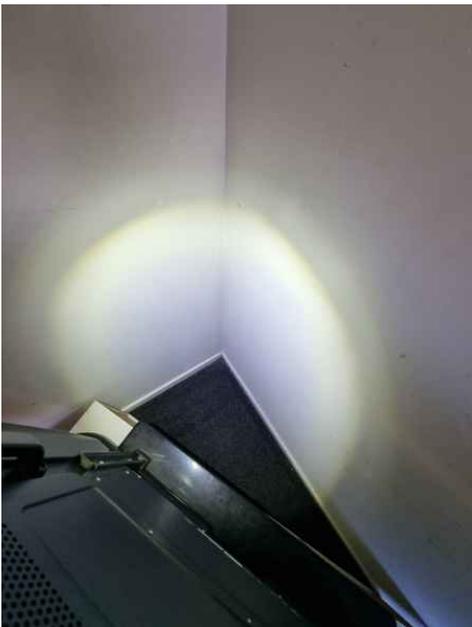
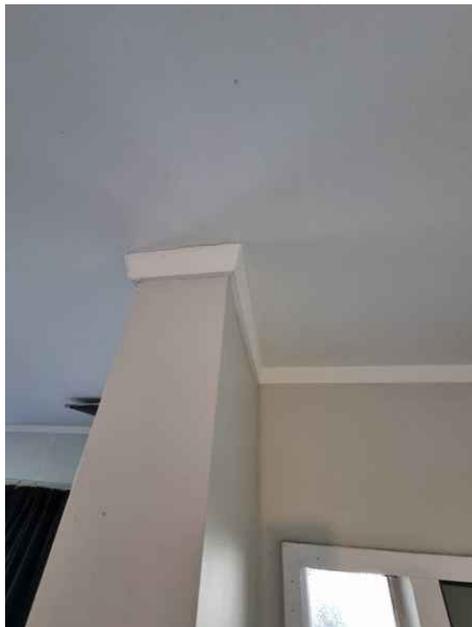
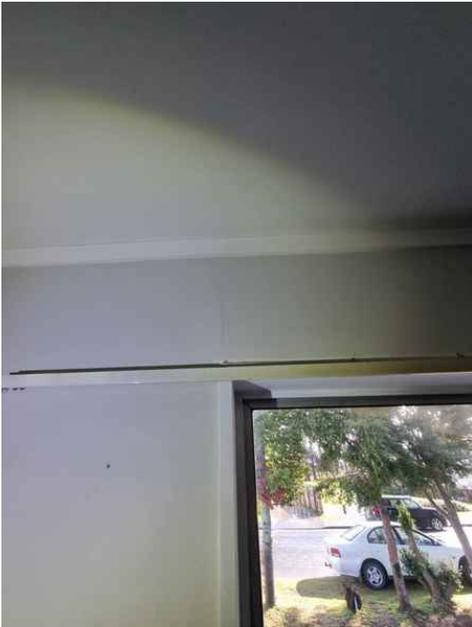
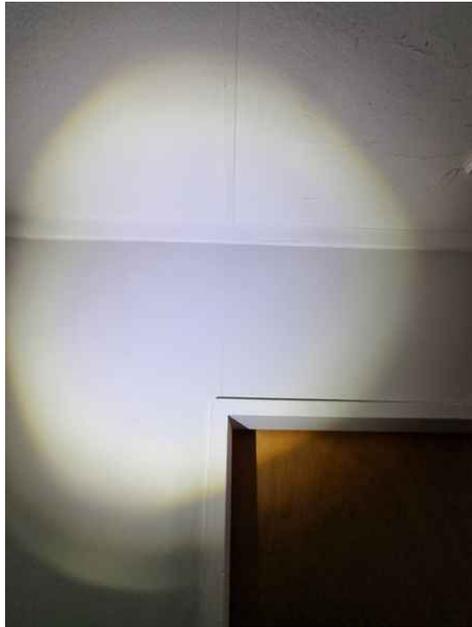
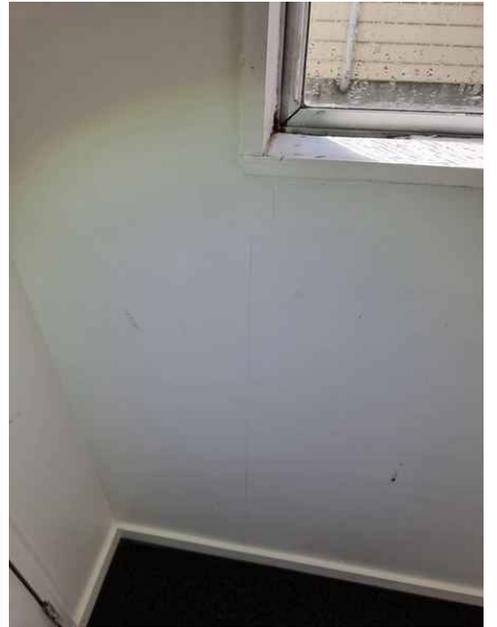
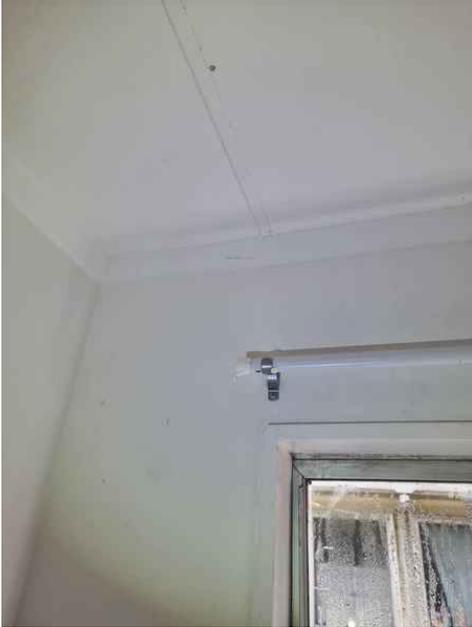
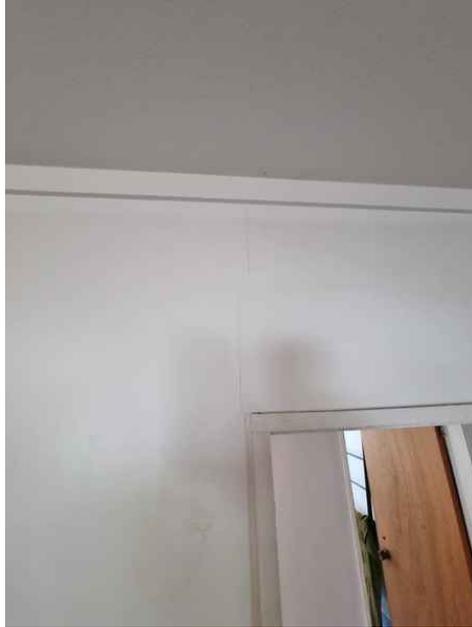
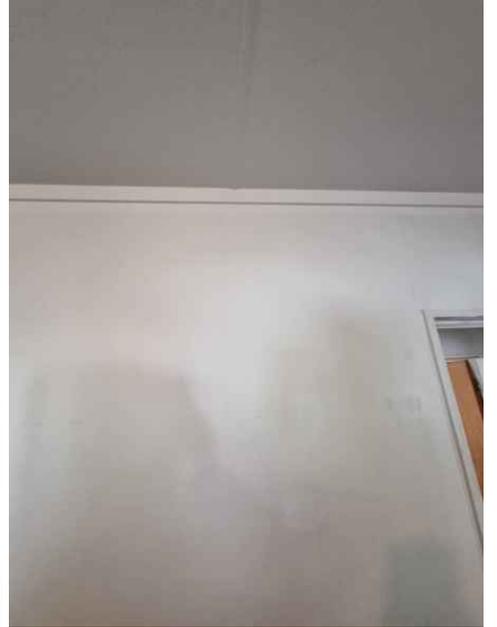
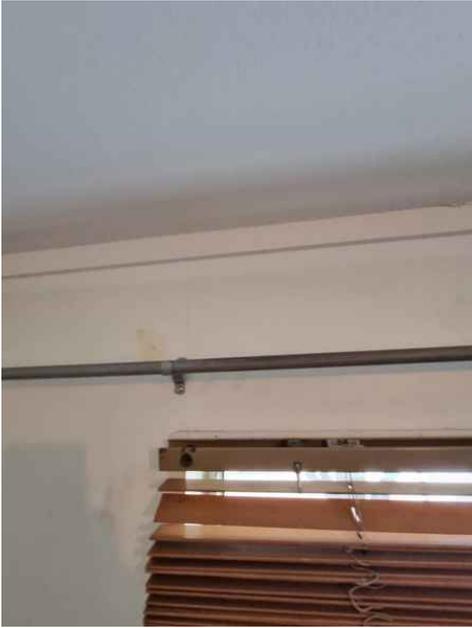
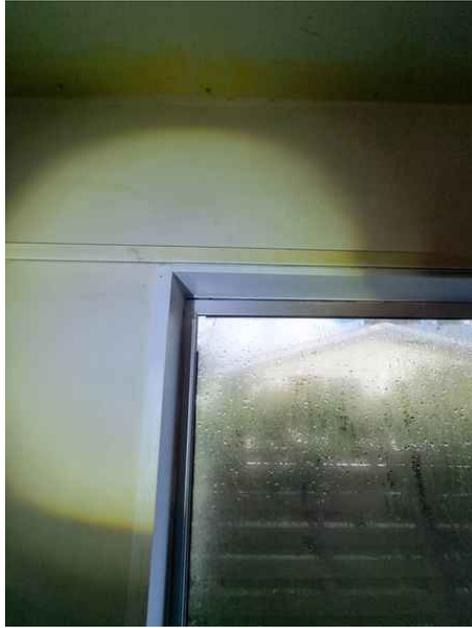
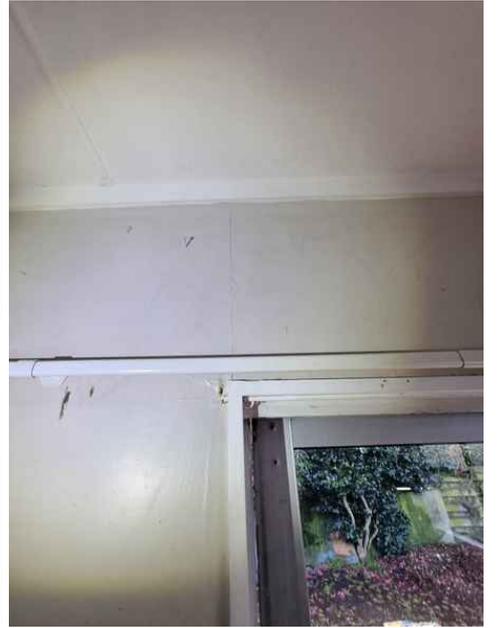
14.1.2 INTERIOR OBSERVATIONS

SETTLEMENT CRACKS

- Settlement cracking in interior walls is also very common in older buildings due to the wall lining techniques used then. The new technique of wall lining is to finish the taper end Gib joints in the centre of joinery cut-outs not at either end. This has gone a long way to reducing the amount of interior wall lining cracks in each dwelling as it ages.
- Exterior cracks and or open joints in non-monolithic cladding systems are usually quite easily be addressed with a cosmetic touch up of the cracked and/or open area using a Builders bog and paintable filler type product and then sealed with a coat of weather sealant paint. However cracks in any monolithic cladding systems must be repaired by a qualified monolithic contractor.

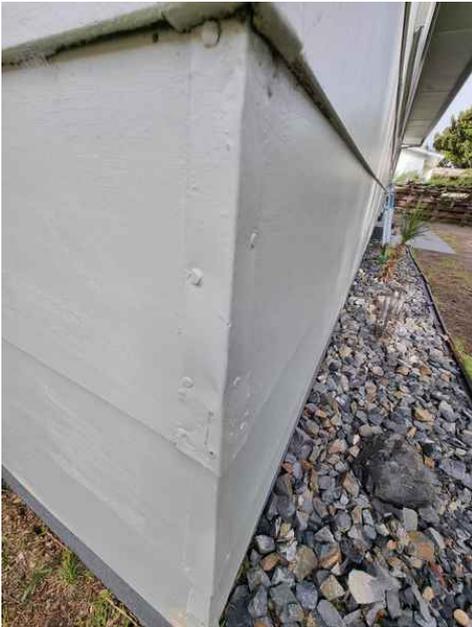
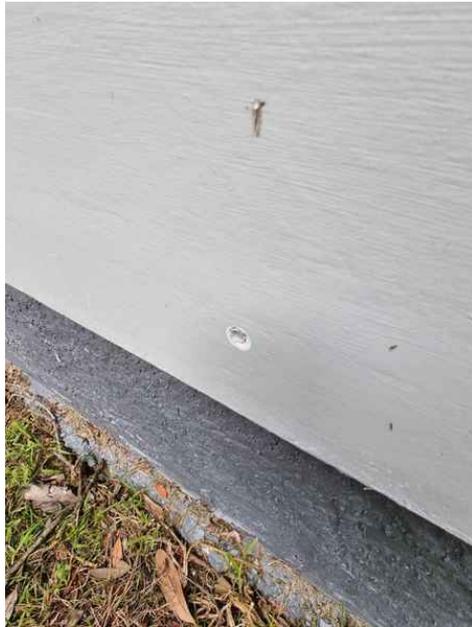
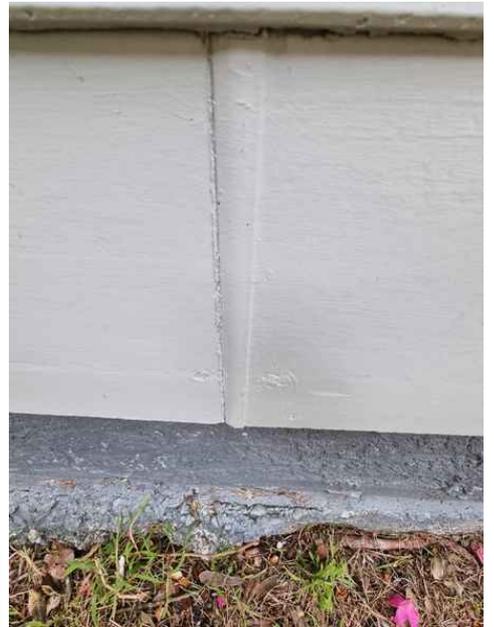
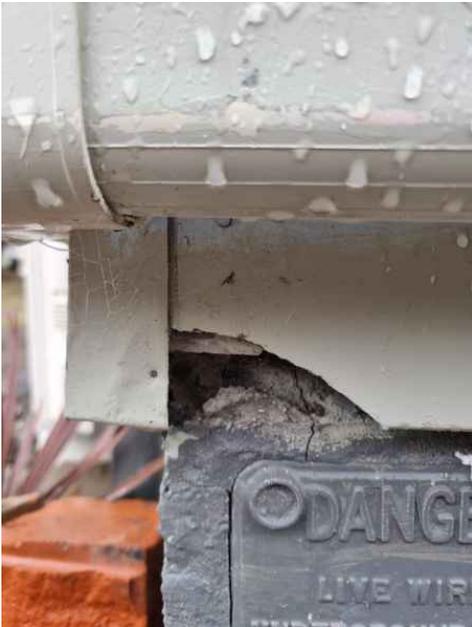
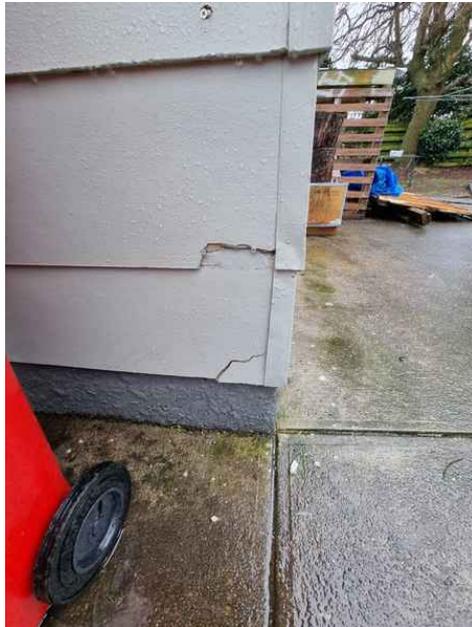
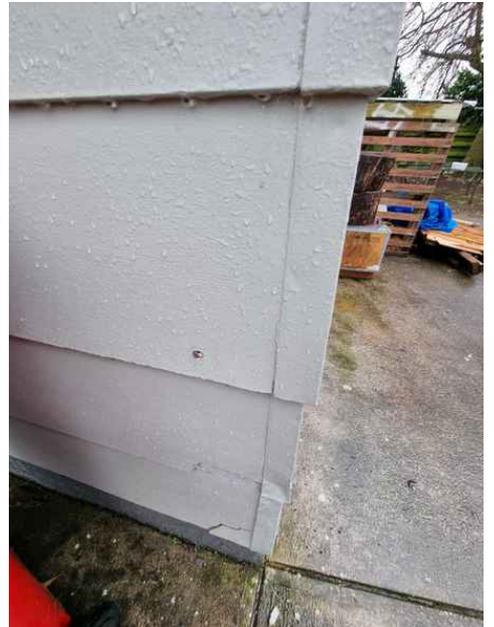
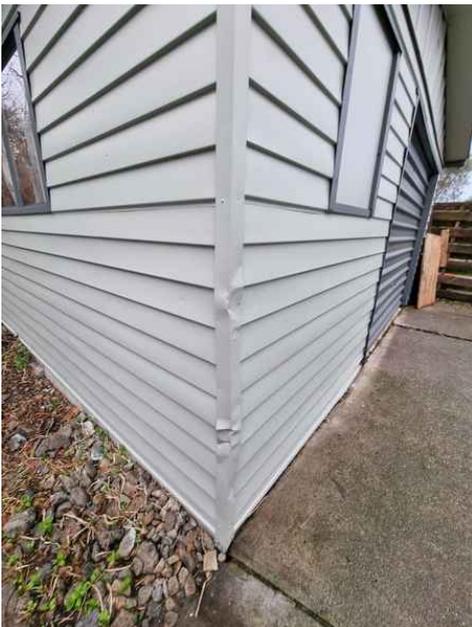
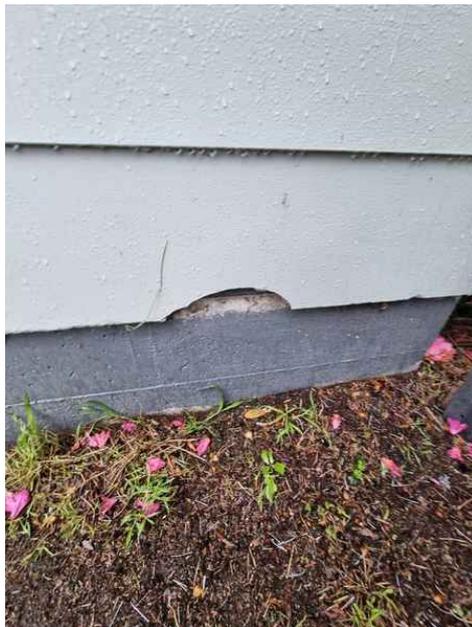
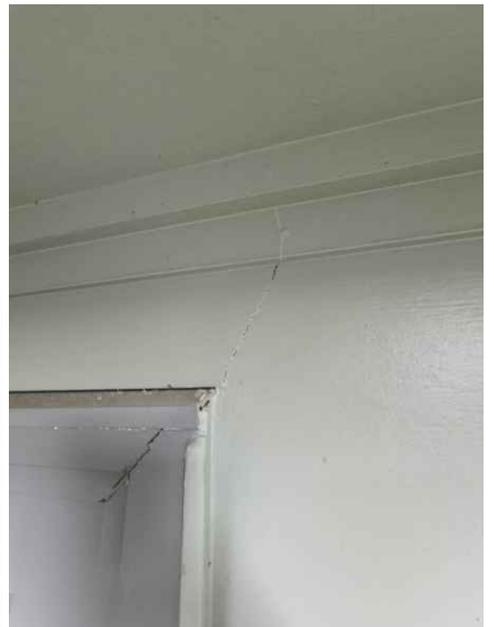
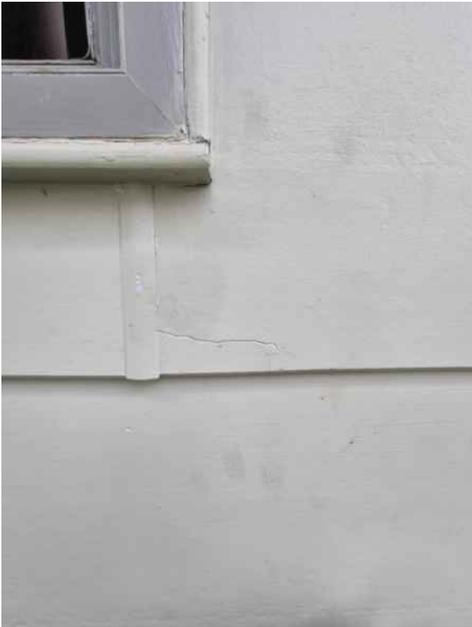
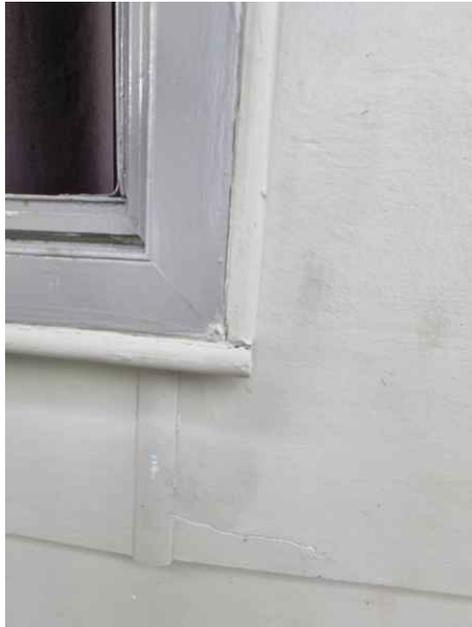
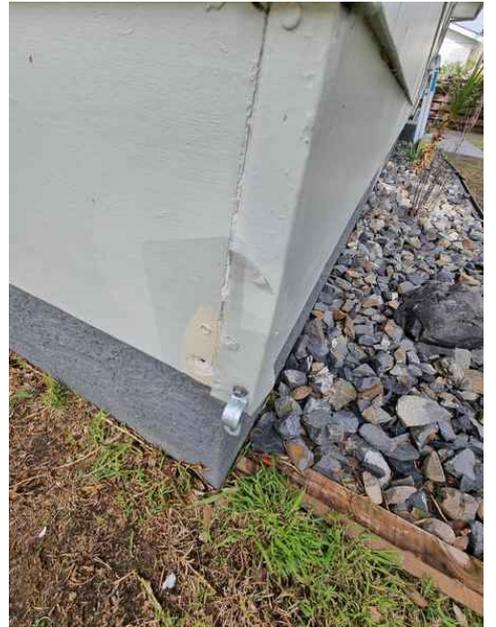
IN	NI	NP	O
15.1	CLADDING OBSERVATIONS	X			X

- Siding too close to and/or in contact with the ground.
- Cracks and/or splits in cladding.
- Failed weatherproofing.
- Rotten and/or waterlogged cladding.
- Timber battens are coming away from the siding and require reattaching and resealing.

- This cladding material may contain asbestos.
- We did **not** perform any definitive testing for asbestos.
- **We do not recommend you carry out any repair work yourself without having the cladding materials tested.**

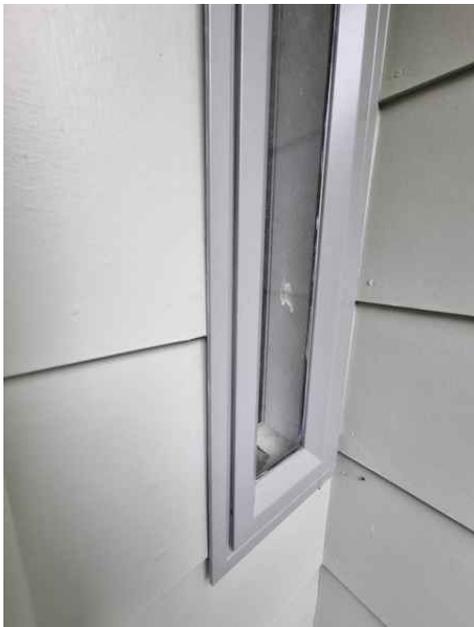
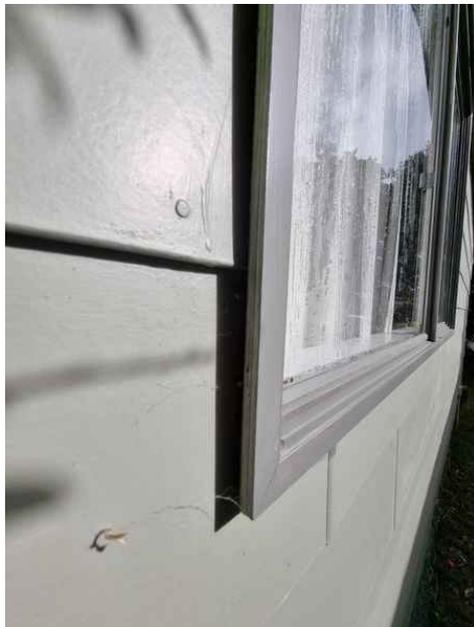
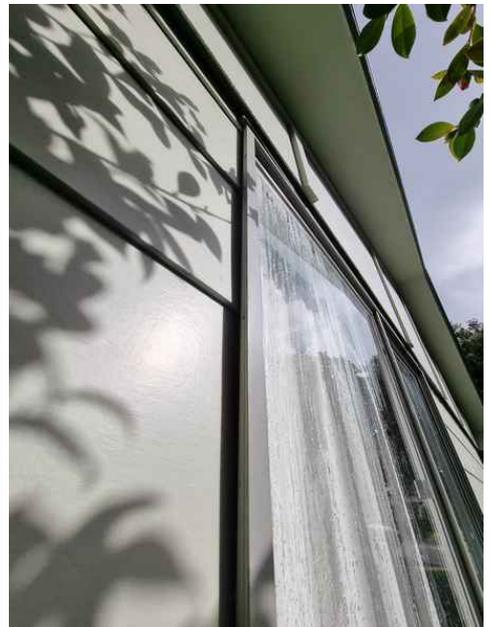
- Substandard weatherproof paint seal at joinery.
- Gaps at joinery to cladding junctions .
- Cracks and/or splits in joinery timber.
- Moisture damage.
- Rot in timber joinery and/or surrounding timber material.
- Missing head flashings.

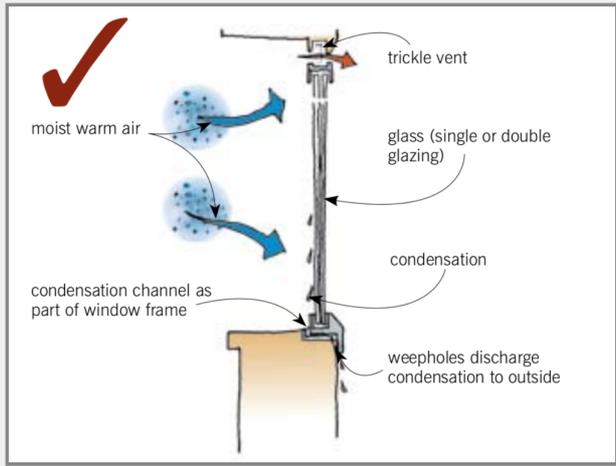
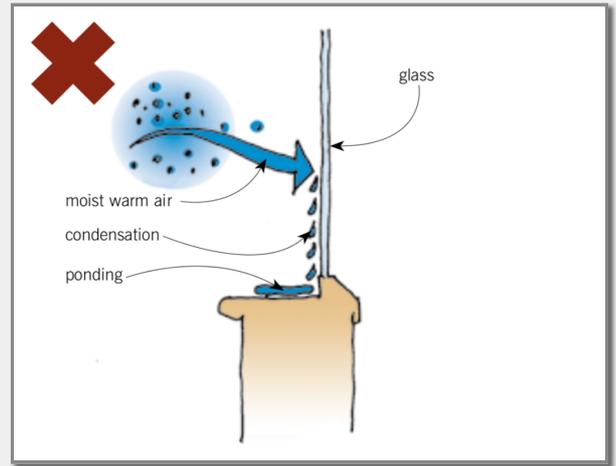
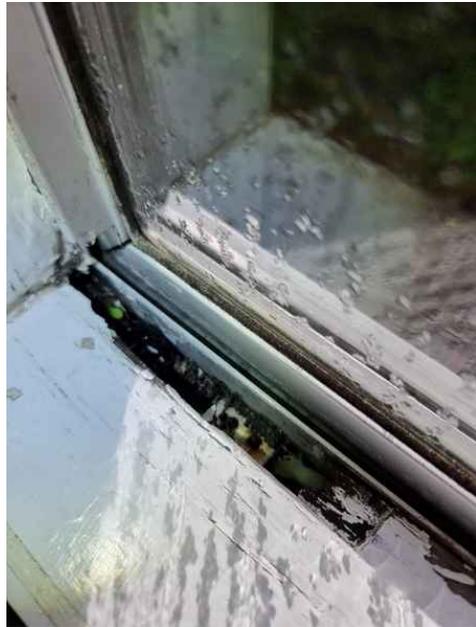
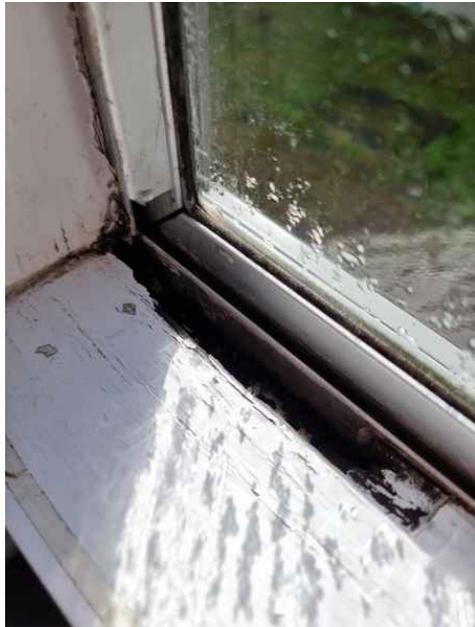
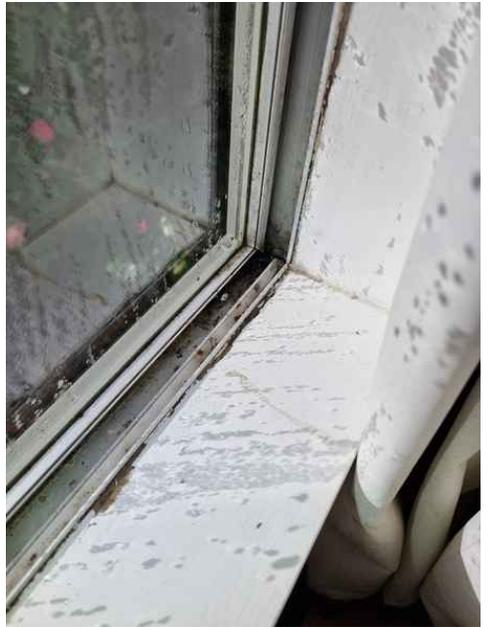
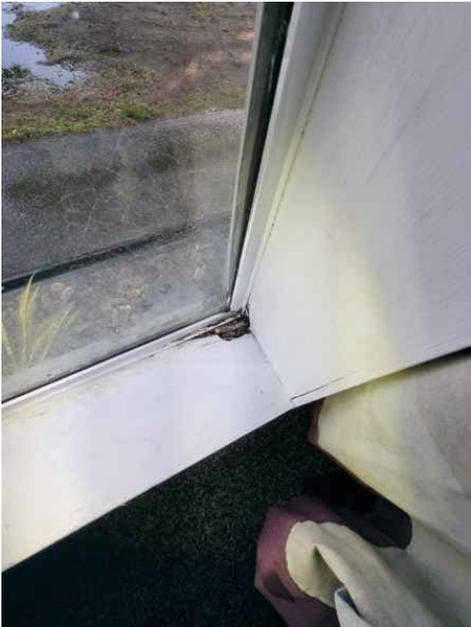
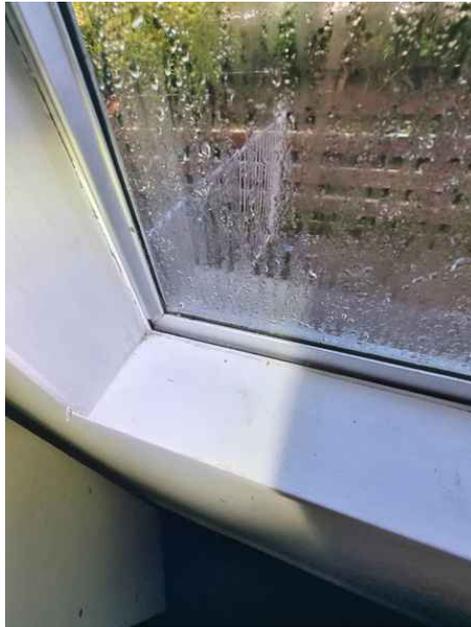
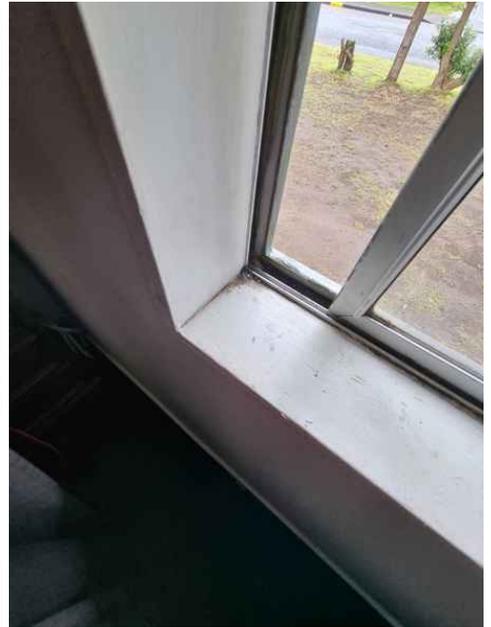
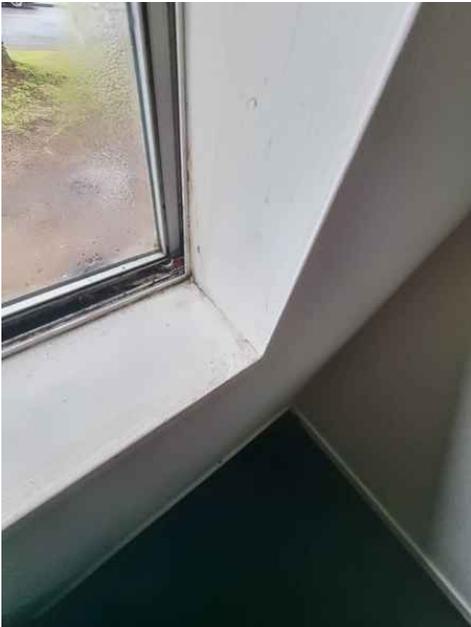
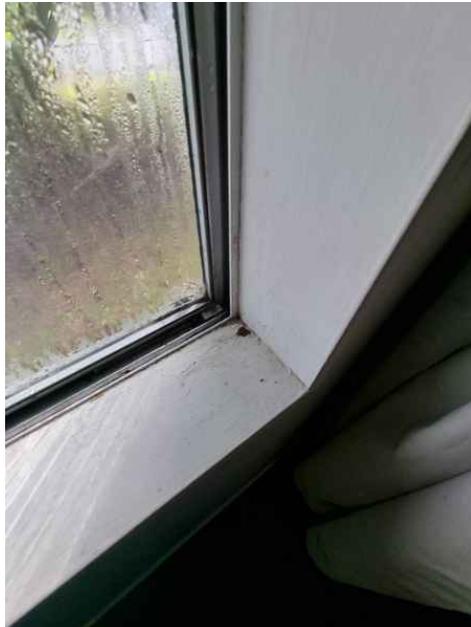
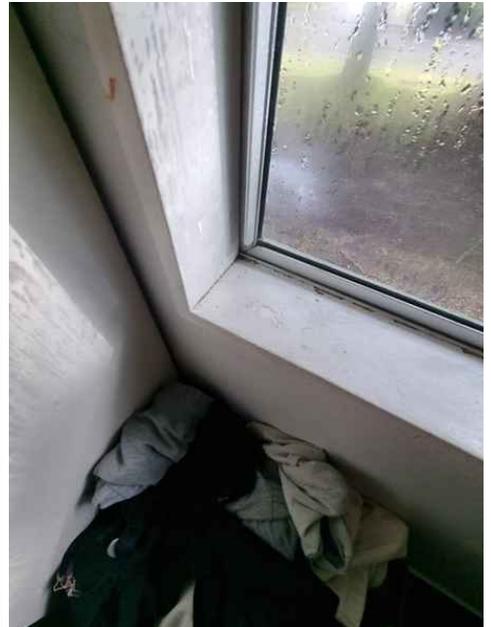
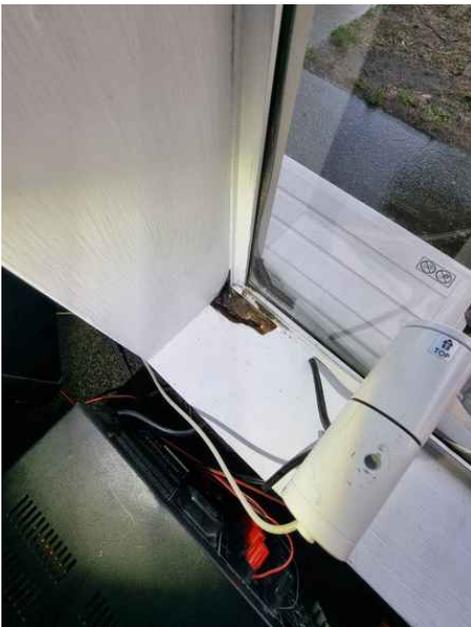
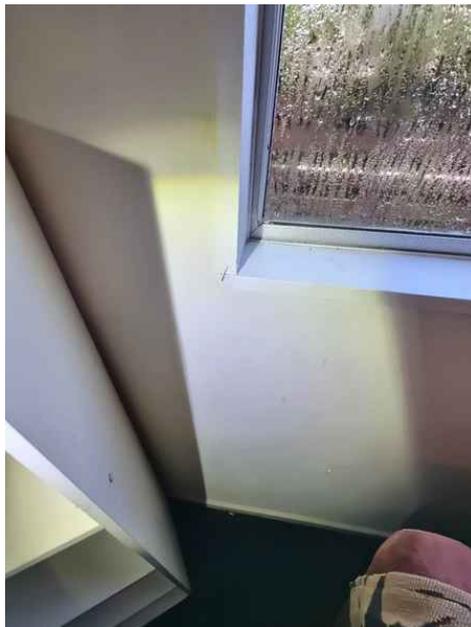
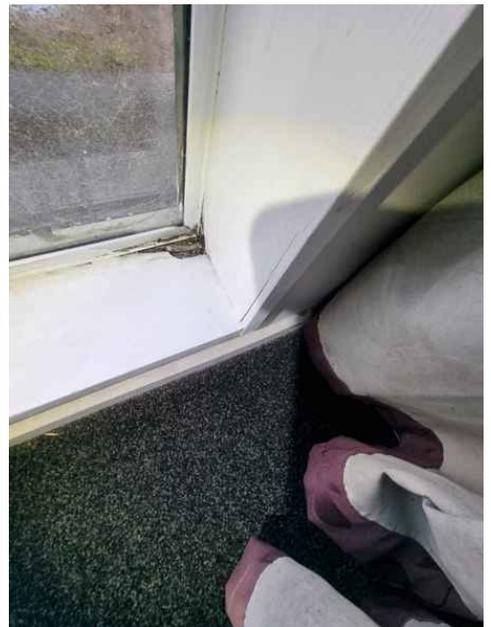
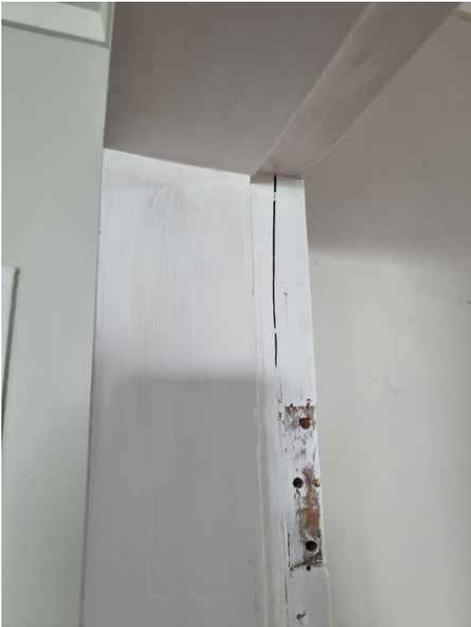
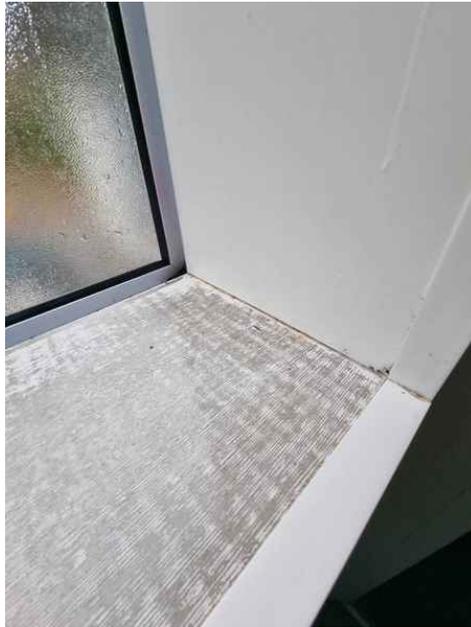
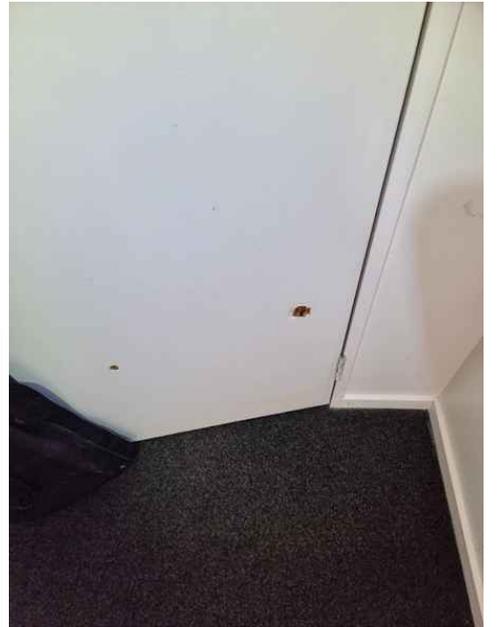
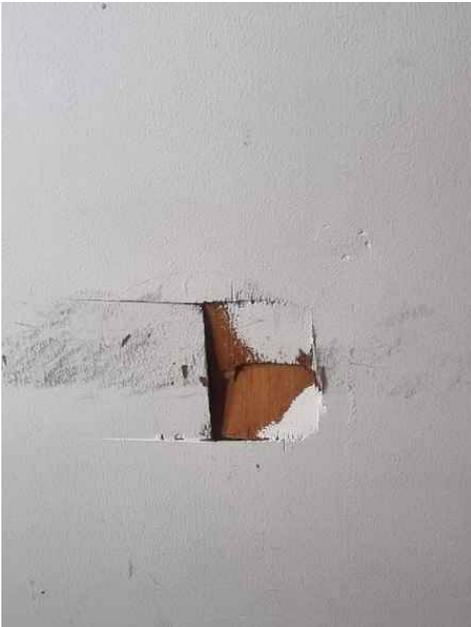
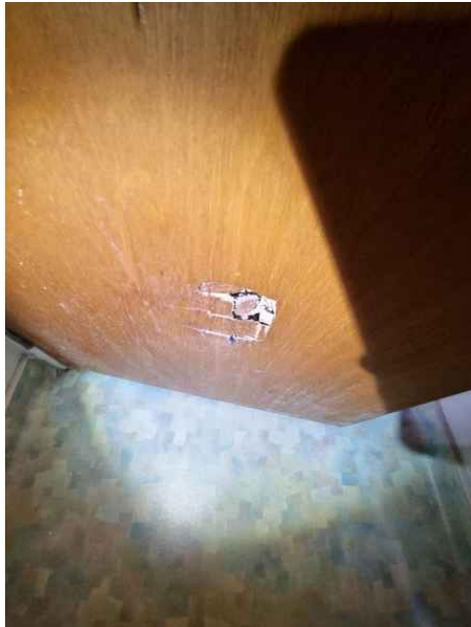
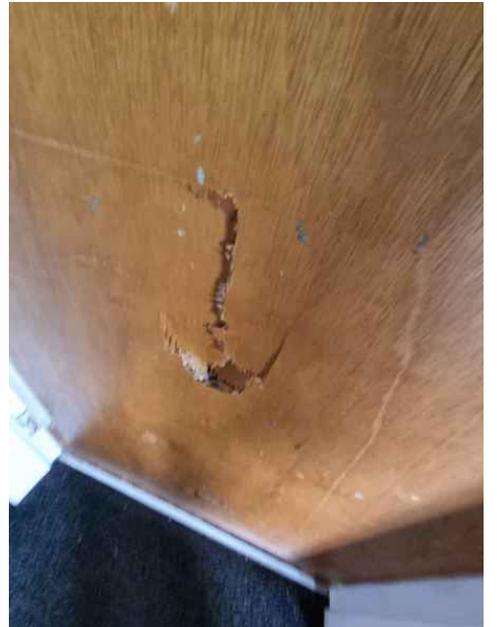
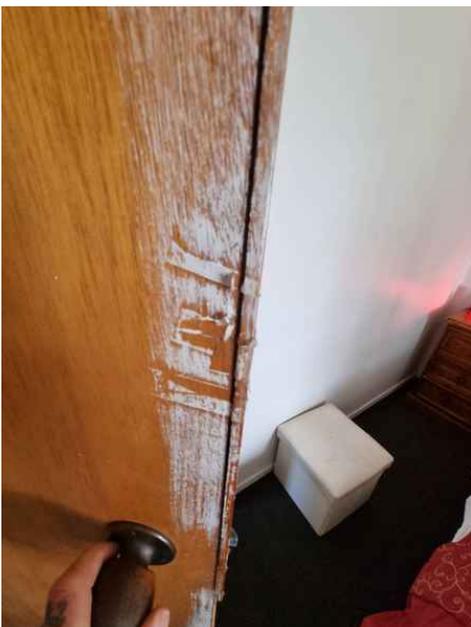
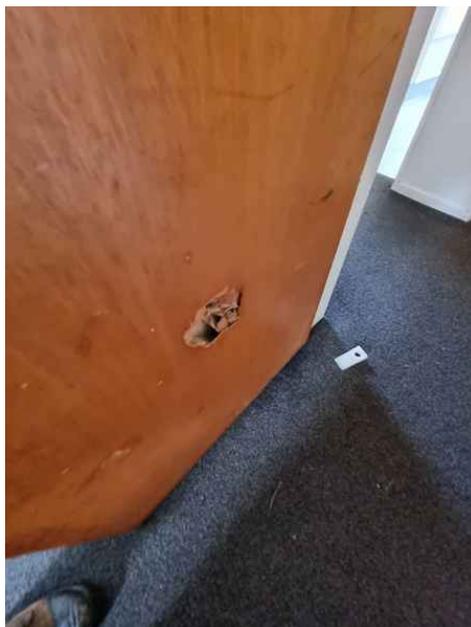
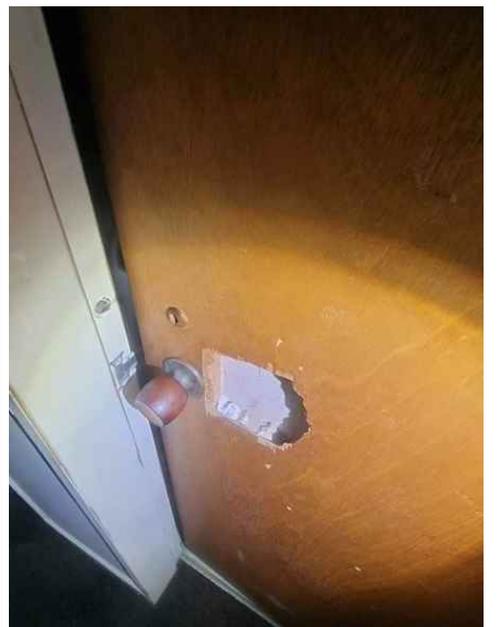
17.1.2 JOINERY OBSERVATIONS

DAMAGE AT OR IN JOINERY

Hardware operation, joinery damage and/or draught seal observations noted.

Water damage: around windows can be caused by condensation or leaks. Try to reduce the amount of condensation in your home.

CONDENSATION DAMAGE AT JOINERY

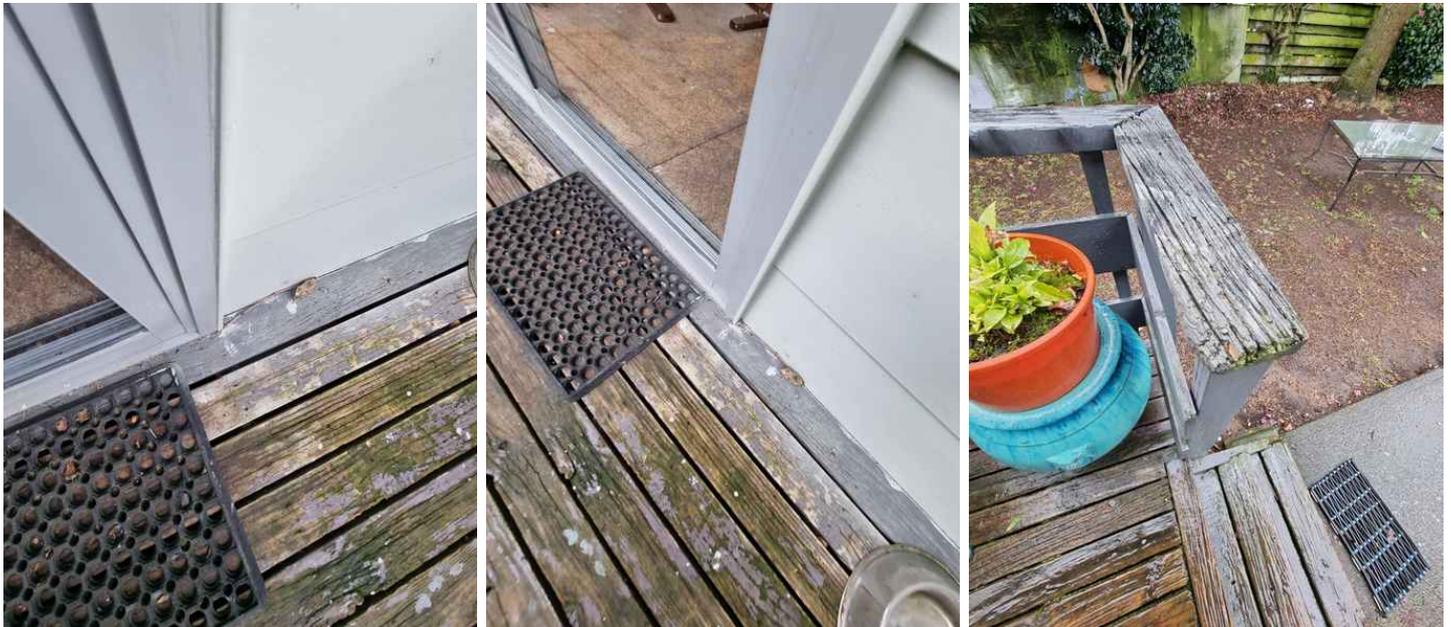
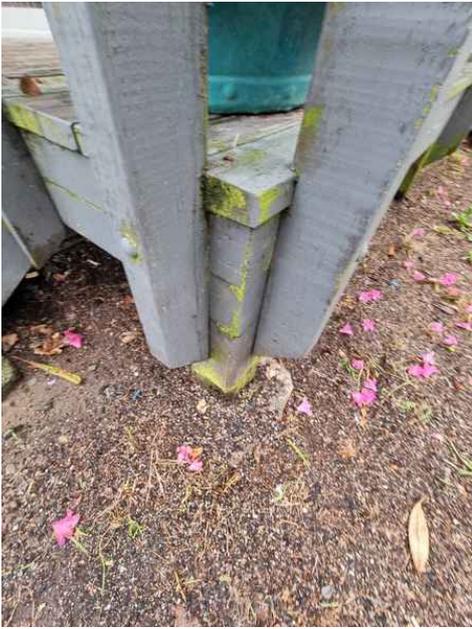
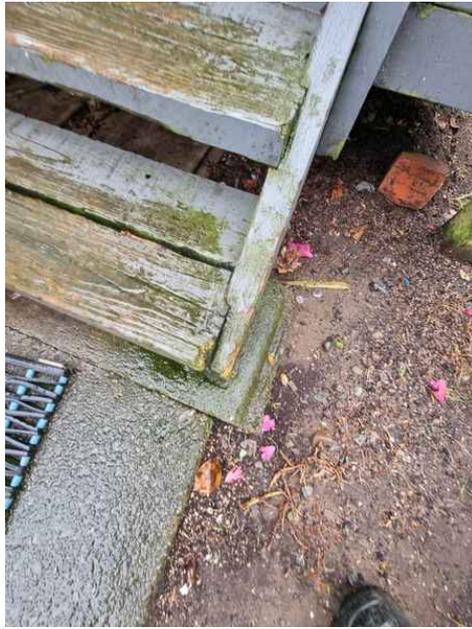
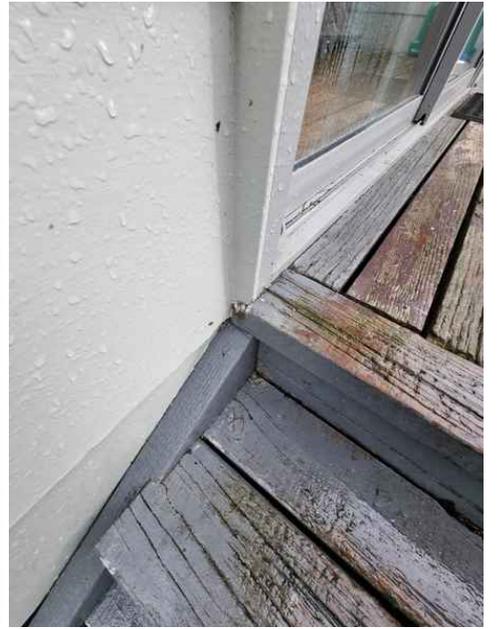
DETERIORATION OF TIMBER ELEMENTS

- Decking and/or stairs shows deterioration of the timber elements.

- Remove any rotten timber.
- Recommend replacing with treated timber.

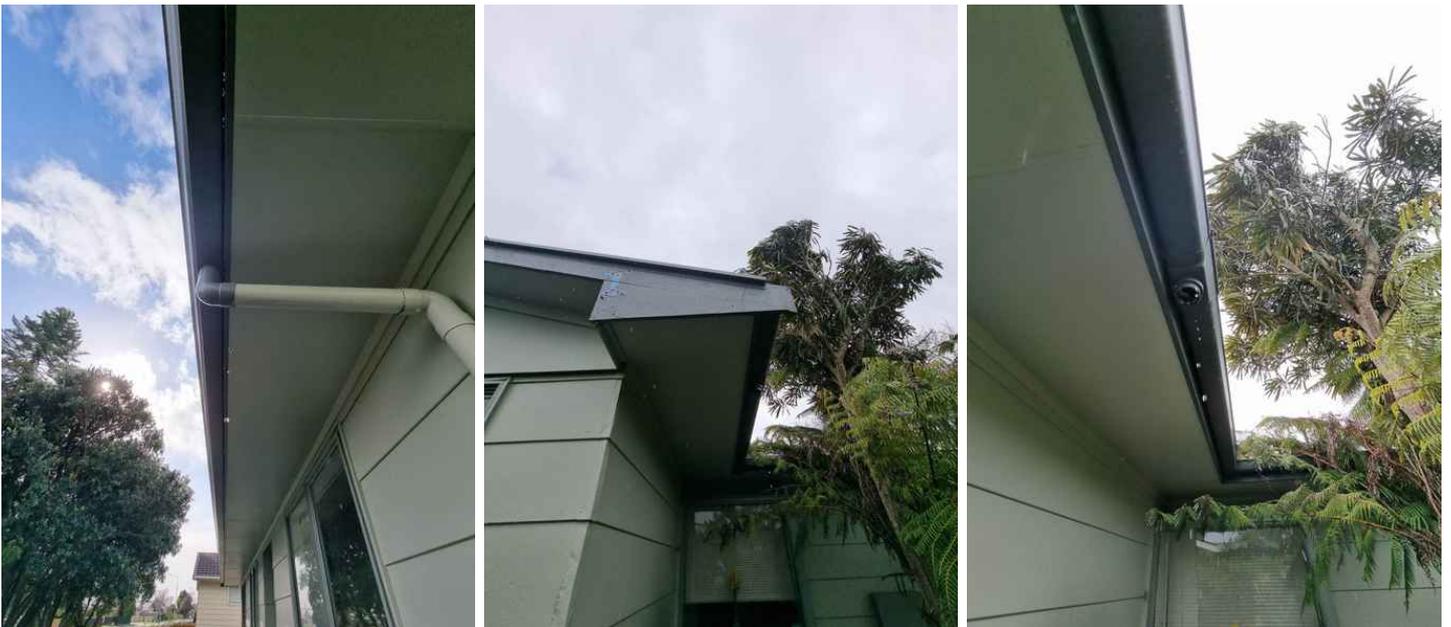
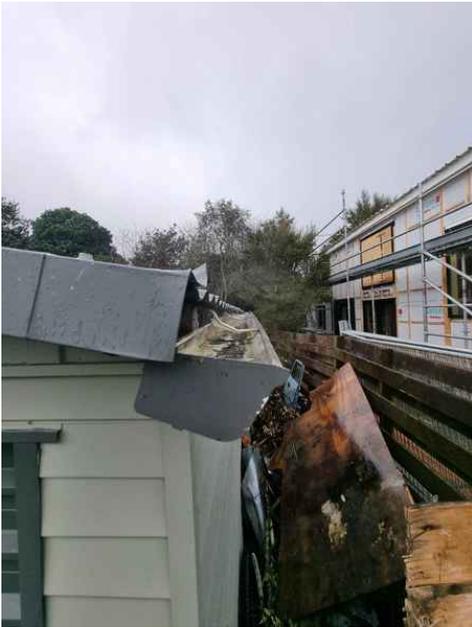
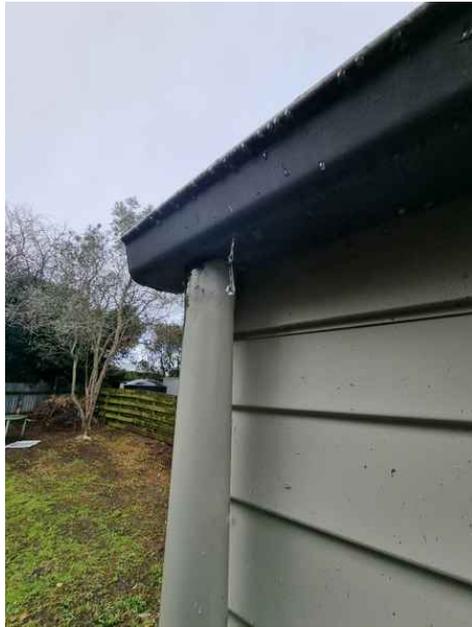
DAMAGED AREAS OF GUTTERING AND/OR DOWNPIPES

- One or more downpipe attachments require re-attaching or replacement.
- Roofing drainage system showed damage in one or more areas.
- Recommend a qualified professional evaluate and repair.

DOWNPIPE DISCHARGING TOO CLOSE TO FOUNDATION AND/OR FLASHING**One of the following may apply:**

- Downpipes need to be extended away from the flashing and/or plumbed into guttering to prevent deterioration of the roof coverings, building materials and moisture damage. There could damage to the building materials beneath the area.
- Downpipes need to be either plumbed into the storm water system correctly or extended away from the home by a minimum of four feet, with six feet being preferred.

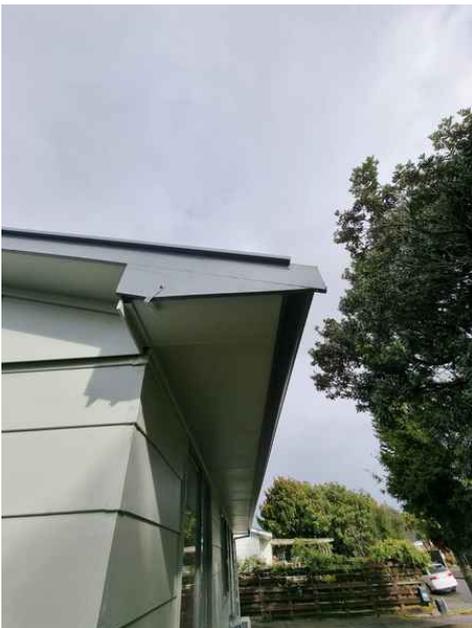
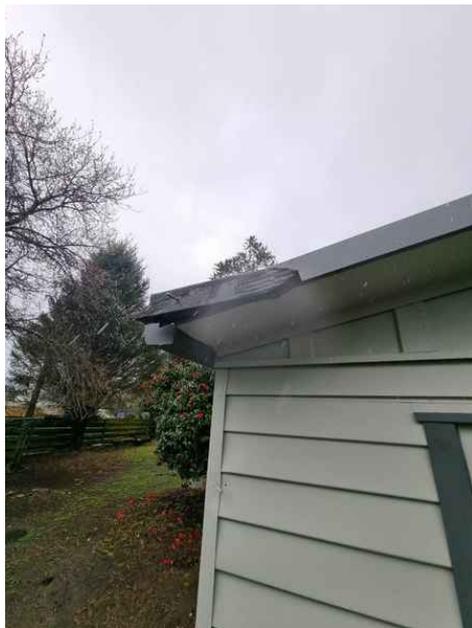
19.1.6 EXTERIOR ROOFING OBSERVATIONS

FASCIA BOARDS AND/OR SOFFITS SHOW MOISTURE DAMAGE AND/OR ROT IN MULTIPLE AREAS

- This is common observation for this age of fascia board edging.
- The moisture damage sighted in the soffits is also common.
- These issues should be addressed sooner rather than later.

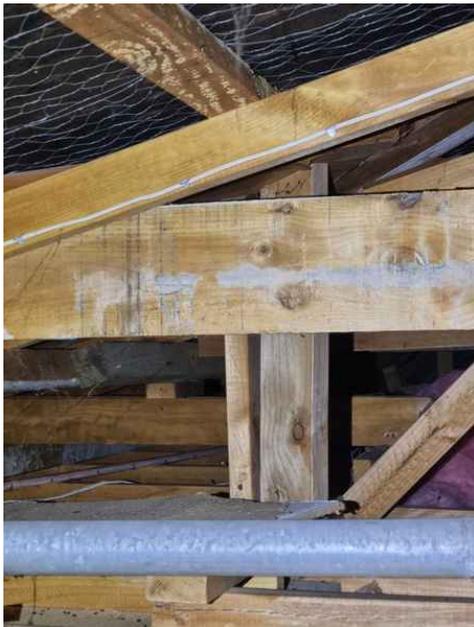
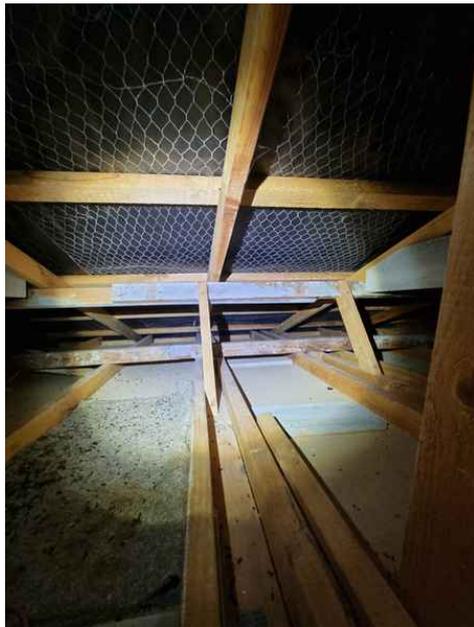
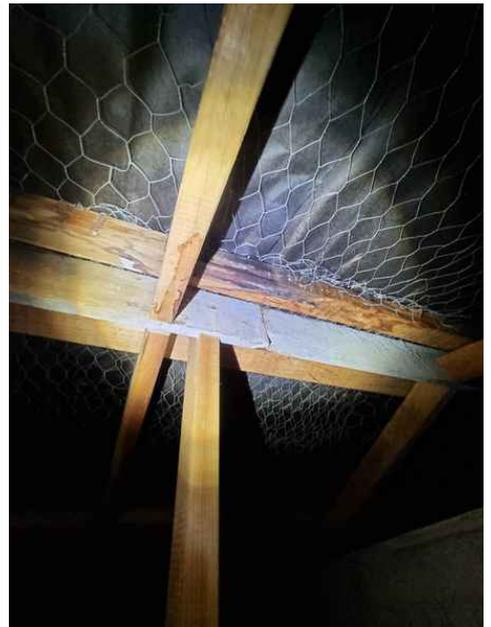
SUB-STANDARD CONSTRUCTION PRACTICES NOTED

- This is a common observation for this era of construction, however common it is a poor construction practice.

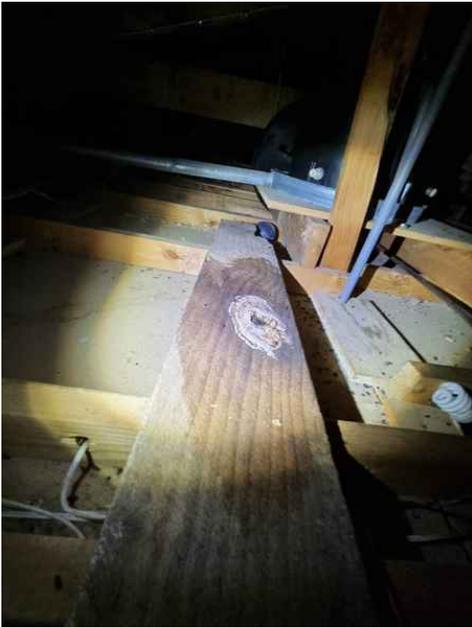
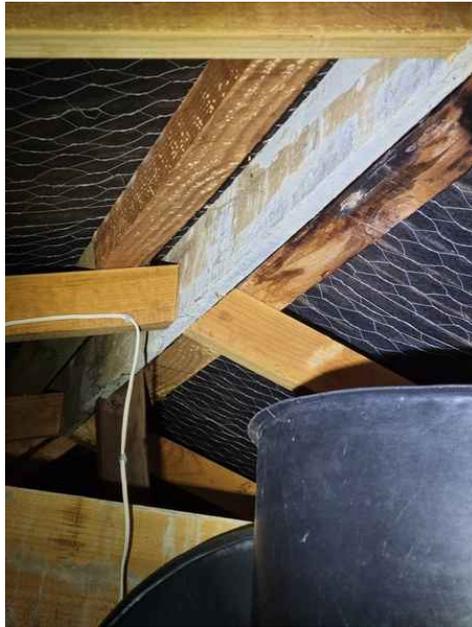
20.1.2 ROOF STRUCTURE OBSERVATIONS

MOISTURE DAMAGE | STAINING ON TIMBER

- Moisture damage and/or staining noted in one or more areas of the ceiling cavity.
