RESIDENTIAL PROPERTY REPORT

1234 Main St. Paraparaumu Wellington 5032

09/08/2021 9:00AM

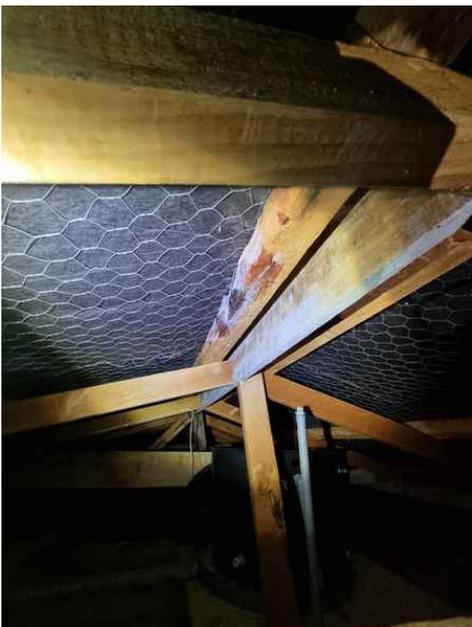
20.1.3 ROOF STRUCTURE OBSERVATIONS SIGNS OF TIMBER ROT

ROT NOTED

- The roof structure shows rot in some areas.
- This is relatively common and somewhat expected in older homes, however it should be removed where possible and the rot treated in any areas not able to be removed.

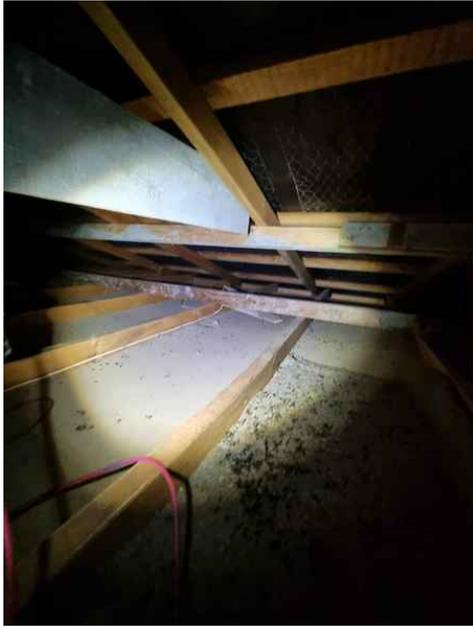
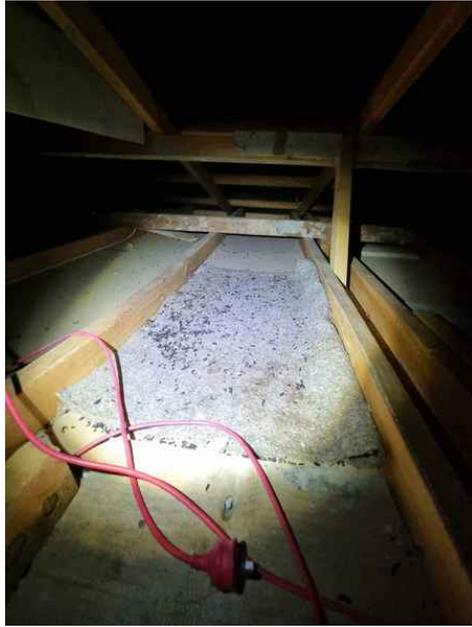
20.1.4 ROOF STRUCTURE OBSERVATIONS

PEST ISSUES NOTED

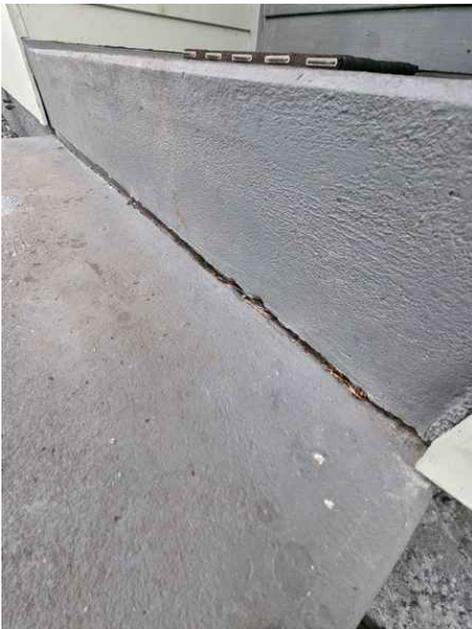
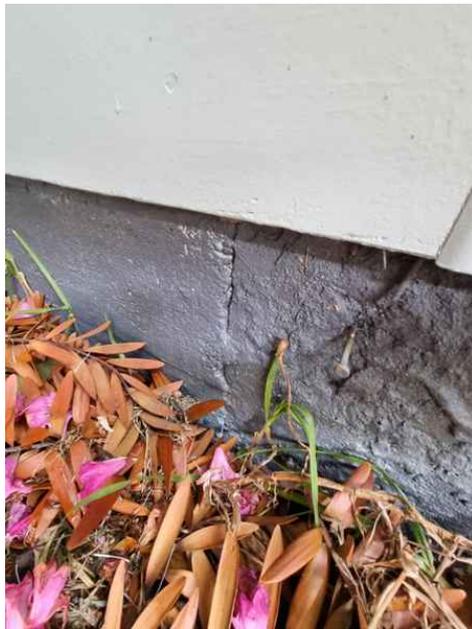
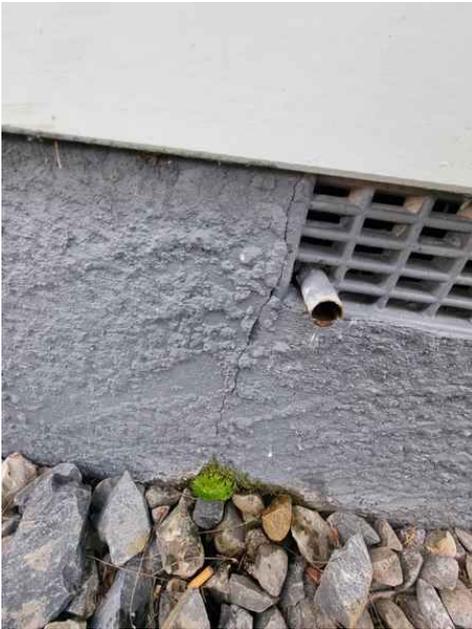
20.2.1 FOUNDATION OBSERVATIONS

DEFECTS NOTED IN STRUCTURAL AND/OR NON-STRUCTURAL ELEMENTS

Cracking, settlement and/or defects sighted in one or more of the concrete foundational elements. This is a relatively common observation, however any defects in any foundational elements should be monitored for further deterioration every 6 weeks or so.

- Cracking due to ground shift/settlement or displacement was noted in the foundation work, masonry walls and/or connecting concrete areas.
- Surface cracking and/or edges cracking of slab corners is relatively normal in concrete construction of this type.
- Cracking in concrete plaster rendering is also a common observation.

These areas require monitoring. (Refer to images provided) If the settlement cracking worsens we recommend you seek the advise of a qualified builder and/or structural engineer that can provide a quote to remedy the observation.

- Monitor the width of cracks for a period of time (approximately every six months):
- If they do not change, seal with a flexible exterior grade sealant. (*You must still monitor these areas after sealing them*)

- If they continue to get wider, obtain a chartered engineer's advice on repair options.

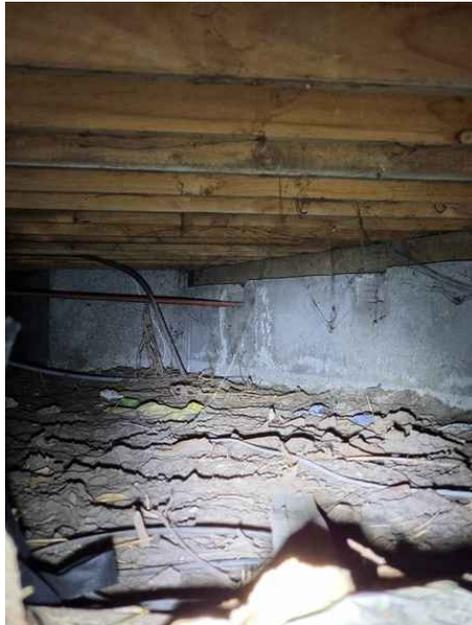
20.2.2 FOUNDATION OBSERVATIONS
EFFLORESCENCE NOTED

Efflorescence is usually caused by a combination of the following factors:

- One or more of the constituents of concrete may contain salts
- A high water-cement ratio resulting in a more porous concrete that allows movement of water and salt solutions
- Inadequate curing which may leave un-hydrated products near the surface of the concrete
- Exposure to rain or other water sources (moisture allows salts to be transported to the surface where they accumulate as the water evaporates)
- Slow rate of evaporation of water allowing time for salts to permeate to the surface (this is why efflorescence tends to be more of a problem during the winter months; in summer, high temperatures may cause evaporation and hence depositing of salts within the concrete rather than on the surface)
- Variability of concrete (e.g. from compaction or curing) can result in localised problems where water can permeate more easily through the concrete.

This solution is how the drainage should have been done. It may or may not be possible in this case but the general principle remains the same.

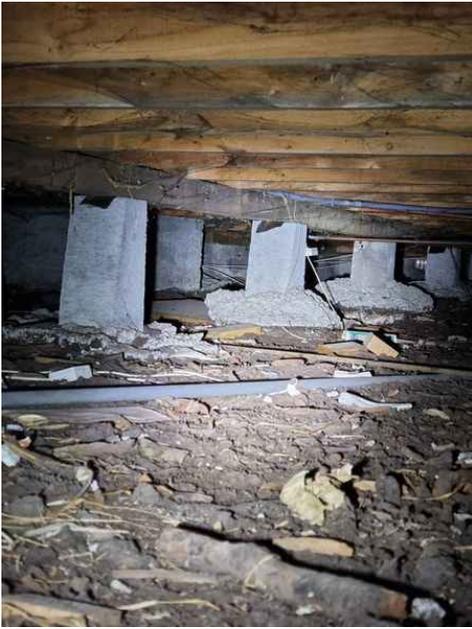
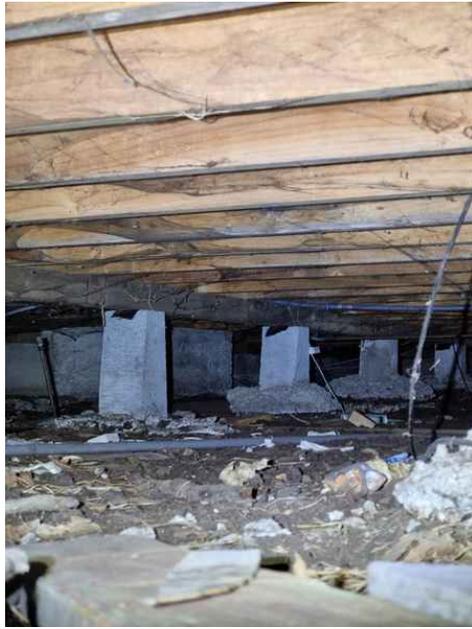
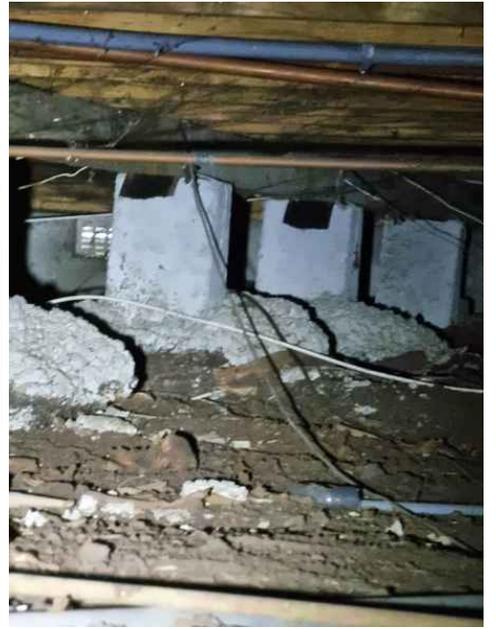
20.2.3 FOUNDATION OBSERVATIONS

UNDERMINING NOTED BENEATH THE STRUCTURE

- Undermined piles/foundations
- Piles close to the edge of an unsupported bank
- The pile footings may have been exposed

Shovelling soil back around the footings or base of the piles is not a solution. It will not provide the strength needed in the foundations

In some cases, repiling or the installation of new members to support the floor may be required. This falls into the category of 'restricted building work'. When done by a contractor, it must be carried out or supervised by a licensed building practitioner with a Foundations license

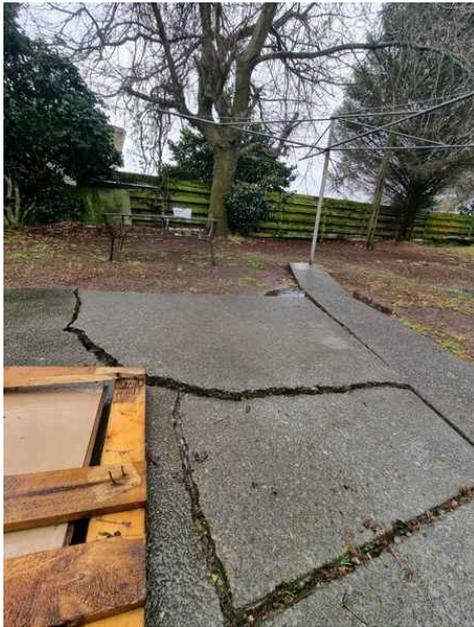
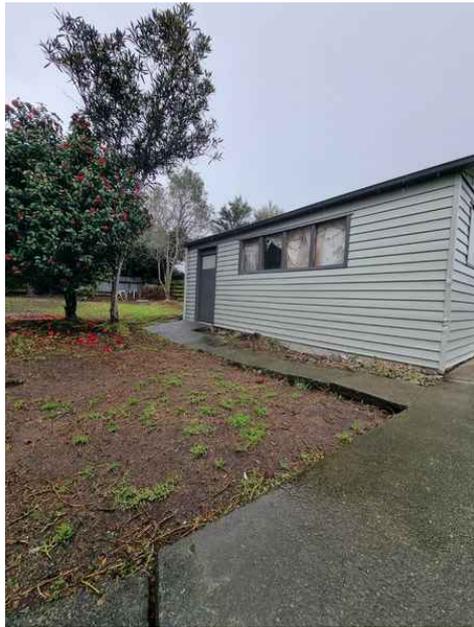
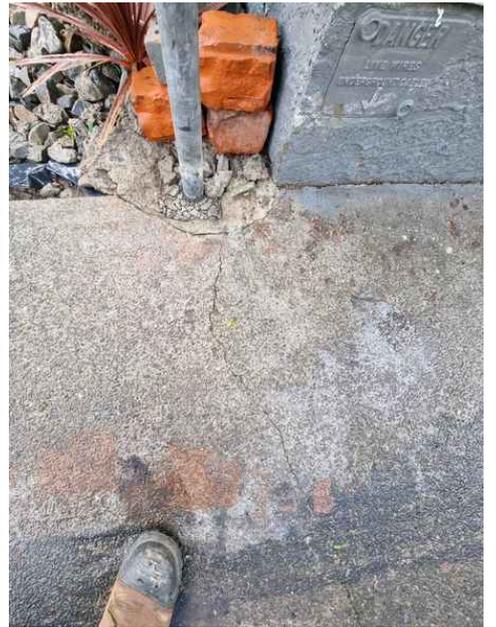
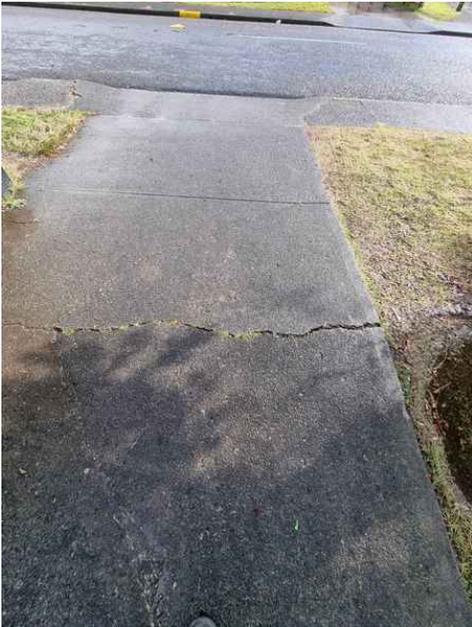
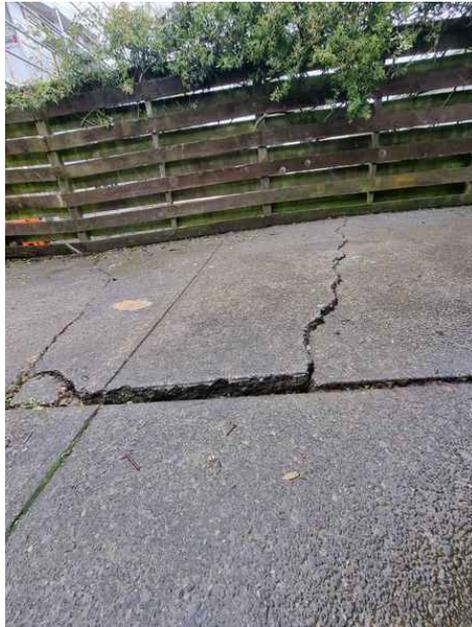
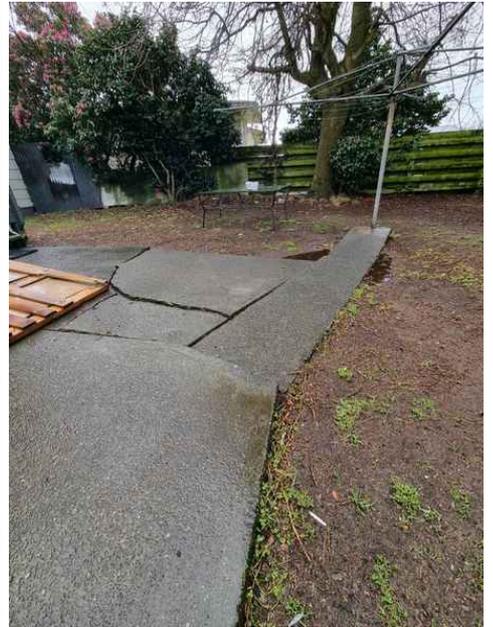
SETTLEMENT AND/OR FLAT CONCRETE CRACKS NOTED

Minor to moderate cracking observed in driveway and/or pathway concrete and/or masonry areas. These are a common observation and generally expected at most properties, However if we have documented multiple areas of settlement cracking and/or if this observation is indicated in orange, there may be a more serious issues that needs investigating.

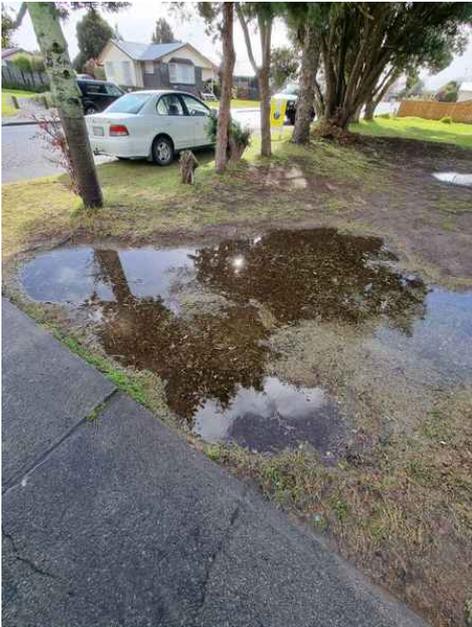
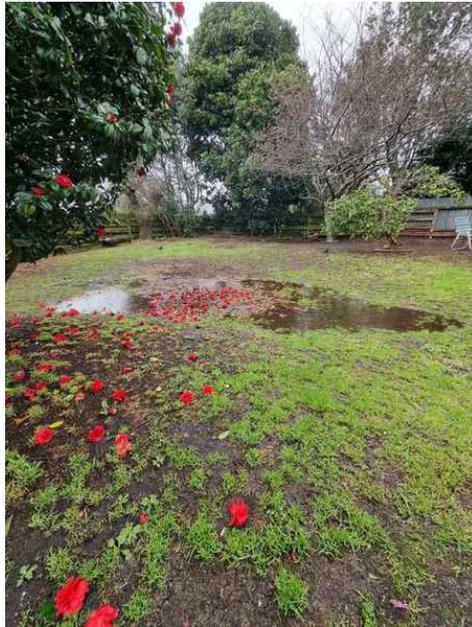
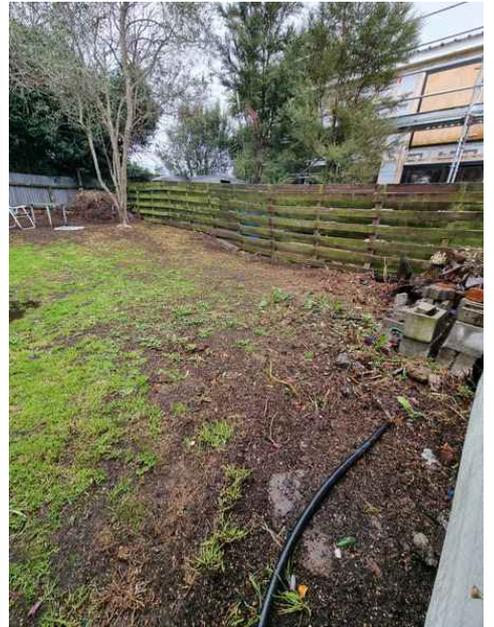
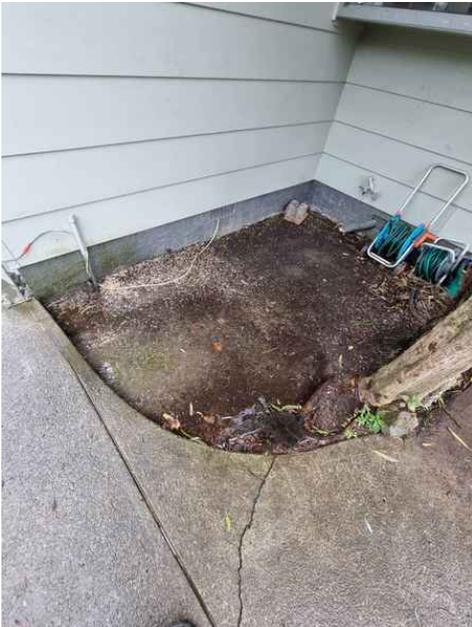
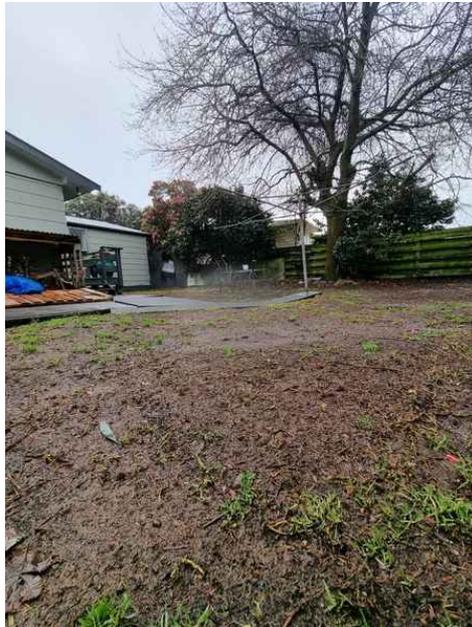
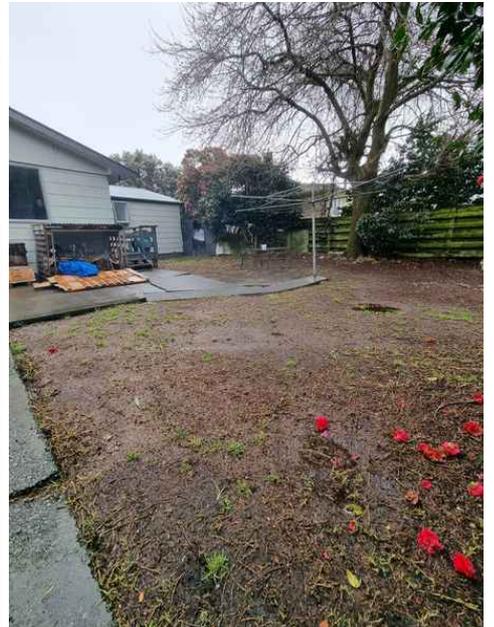
21.1.3 DRIVEWAY & YARD OBSERVATIONS
AREAS OF STANDING WATER

AREAS OF STANDING WATER

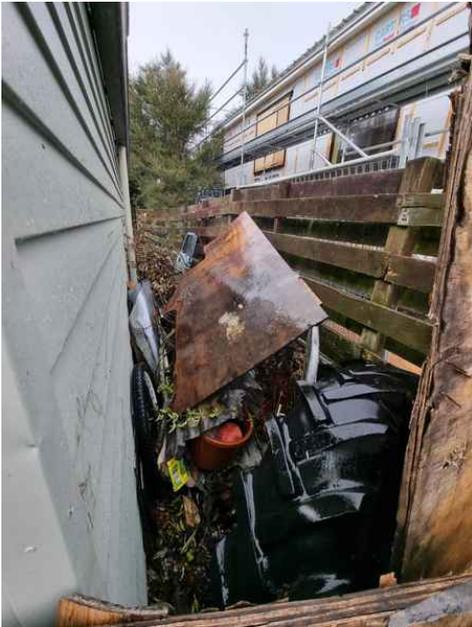
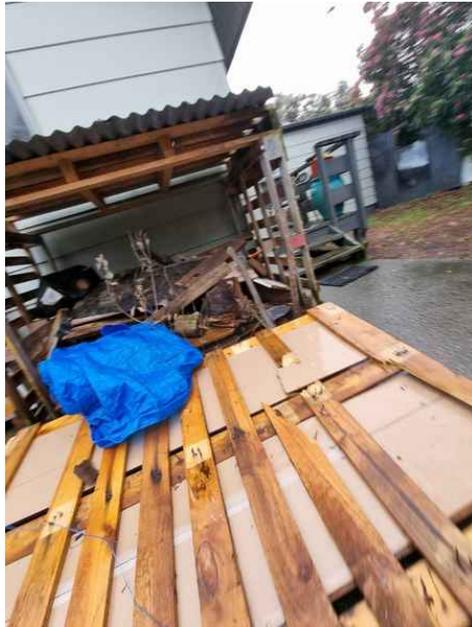
21.1.4 DRIVEWAY & YARD OBSERVATIONS

RUBBISH | WASTE BUILD UP

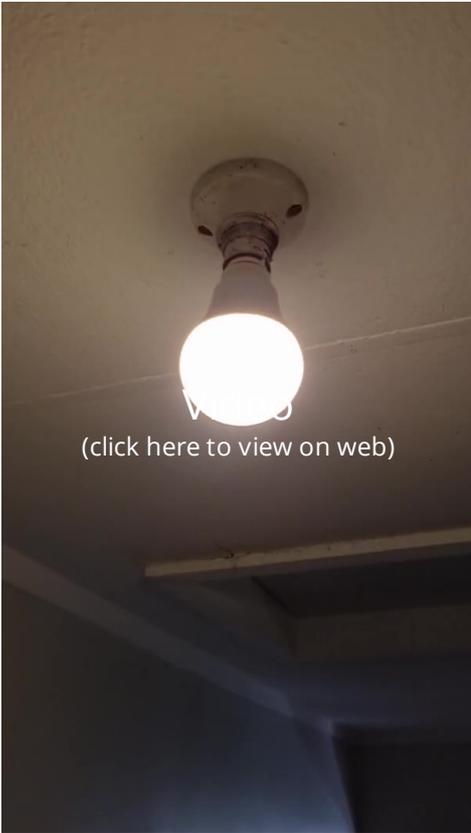
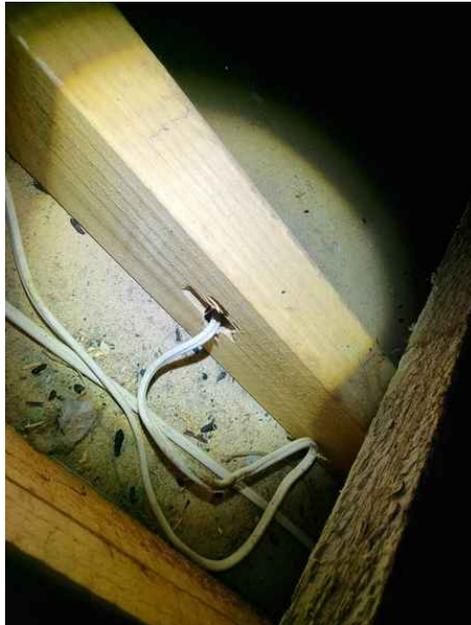
UNSATISFACTORY ELECTRICAL ITEM

The hallway light is flickering because a roof leak has created a puddle and is arcing across the terminals. This has the potential to cause serious injury, death and/or fire.

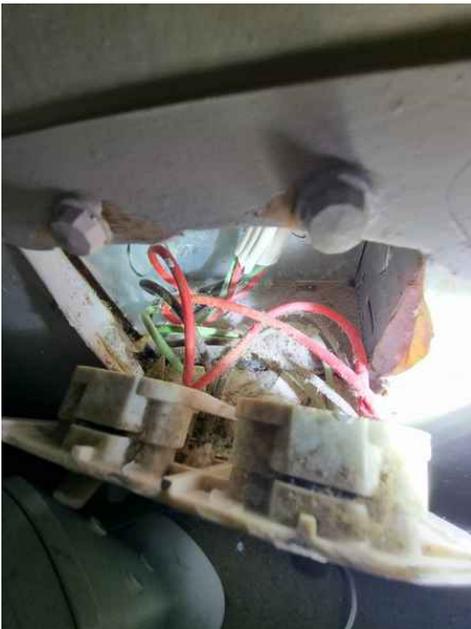
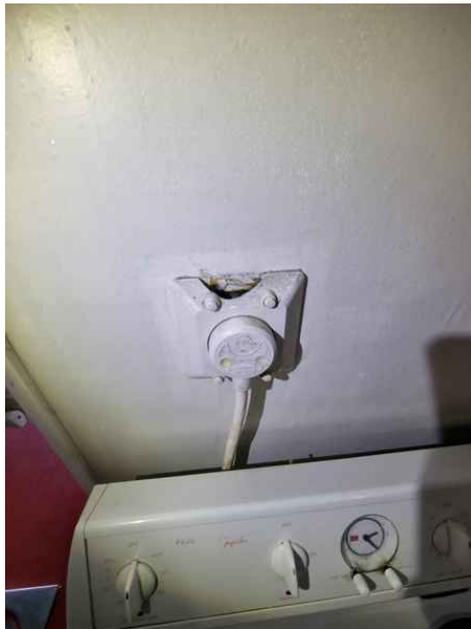
The hallway light is flickering because a roof leak has created a puddle and is arcing across the terminals. This has the potential to cause serious injury, death and/or fire.

exposed 6mm TC+E cable (High current/very dangerous)

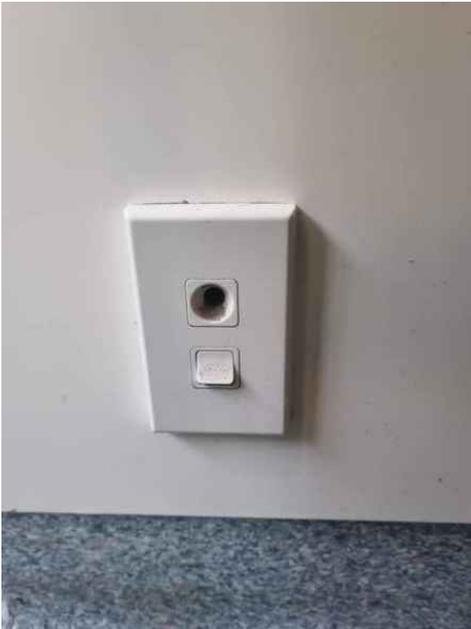
Bathroom RCD doesn't trip.

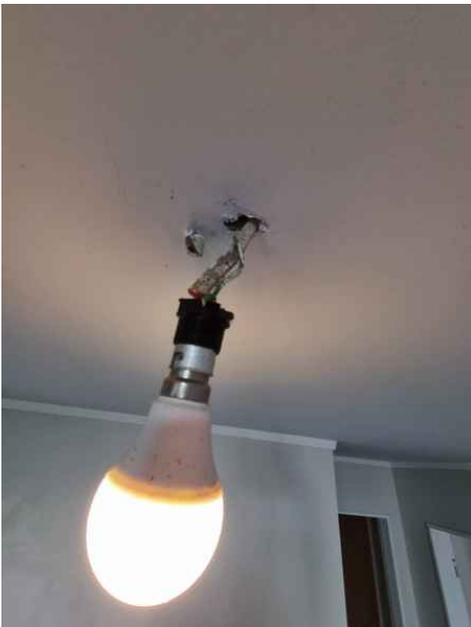
Multiple lights hanging from the ceiling with naked terminals exposed.

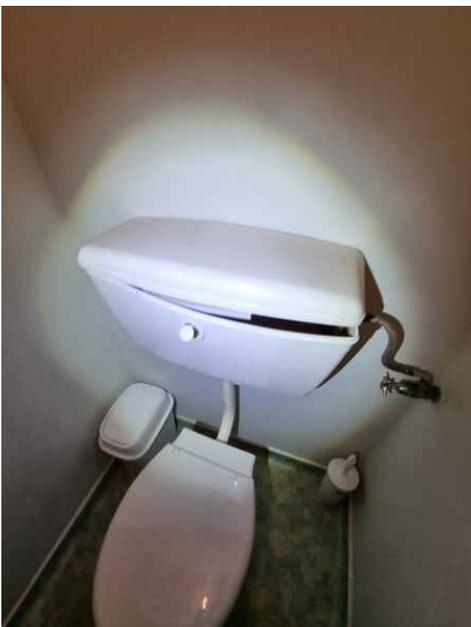
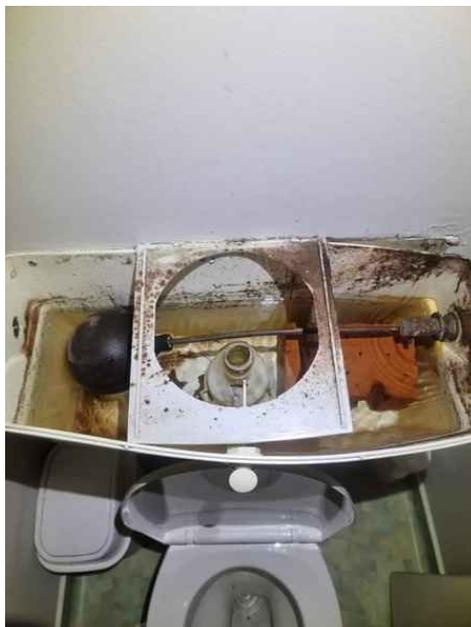
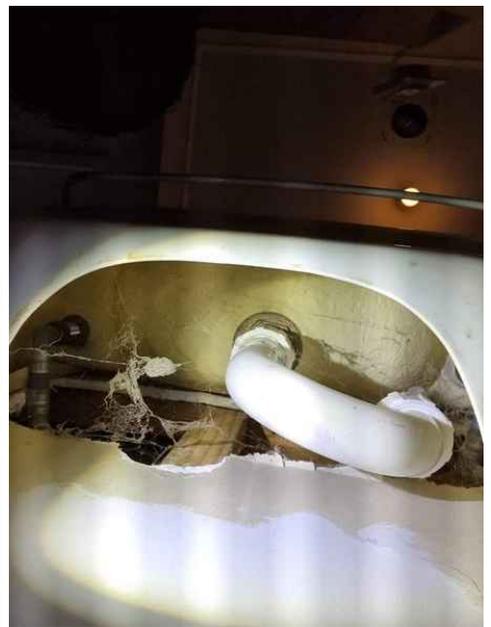
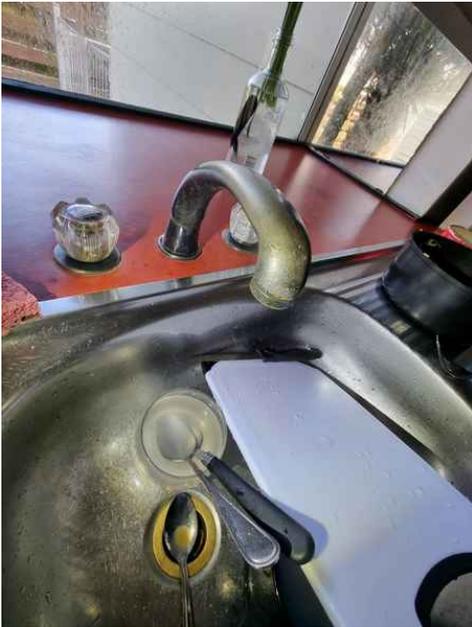
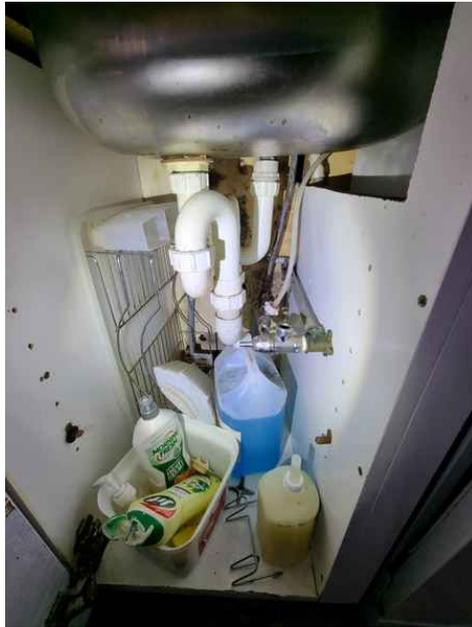
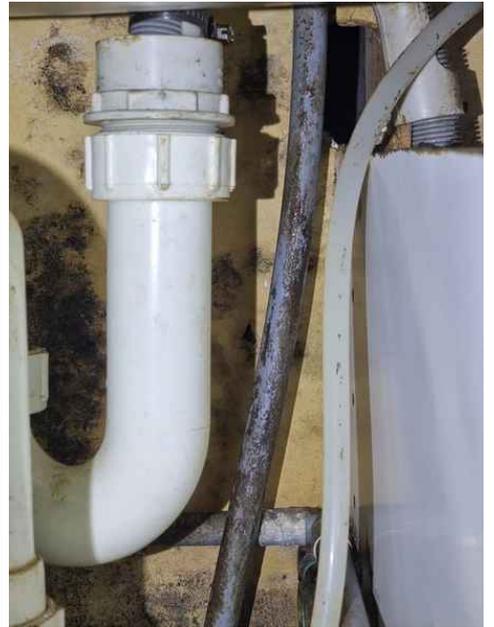
22.1.2 UTILITIES OBSERVATIONS

UNSATISFACTORY PLUMBING ITEM

The item/s in this section require repair/replacement.

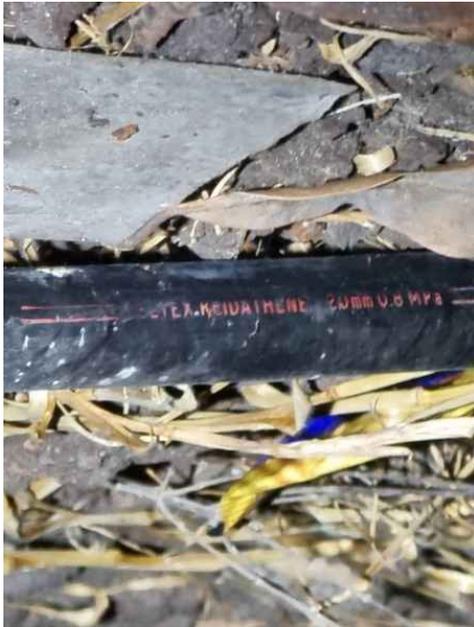
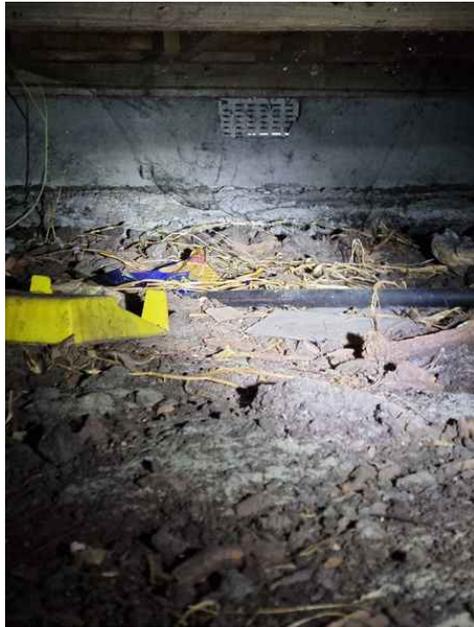
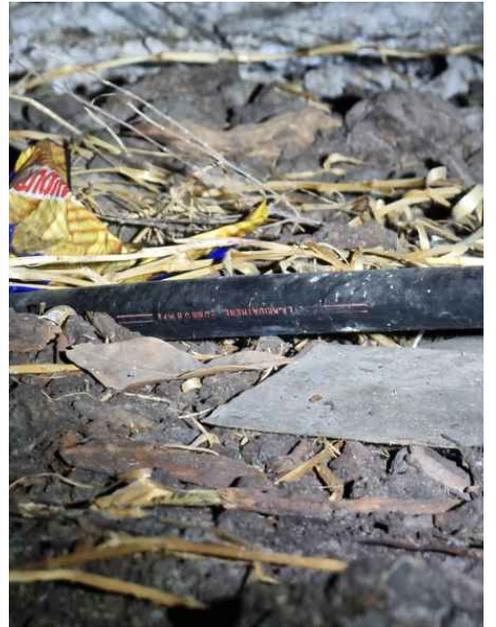
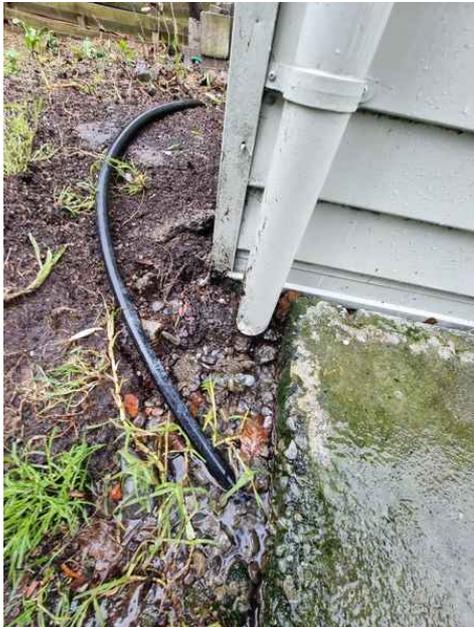
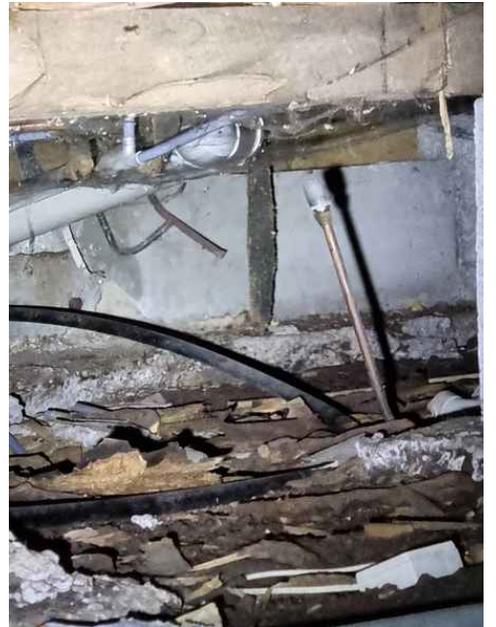
22.2.1 HOT WATER SYSTEM OBSERVATIONS

HWC SHOULD BE MOUNTED ON A SECURE PLATFORM

The main reason cylinders are placed on platforms is to ventilate the underside of the cylinder. Water can condense underneath it due to the inside temp being hotter than the outside of the cylinder. This can cause the cylinder and floor to rot a lot quicker underneath if you do not allow for ventilation.

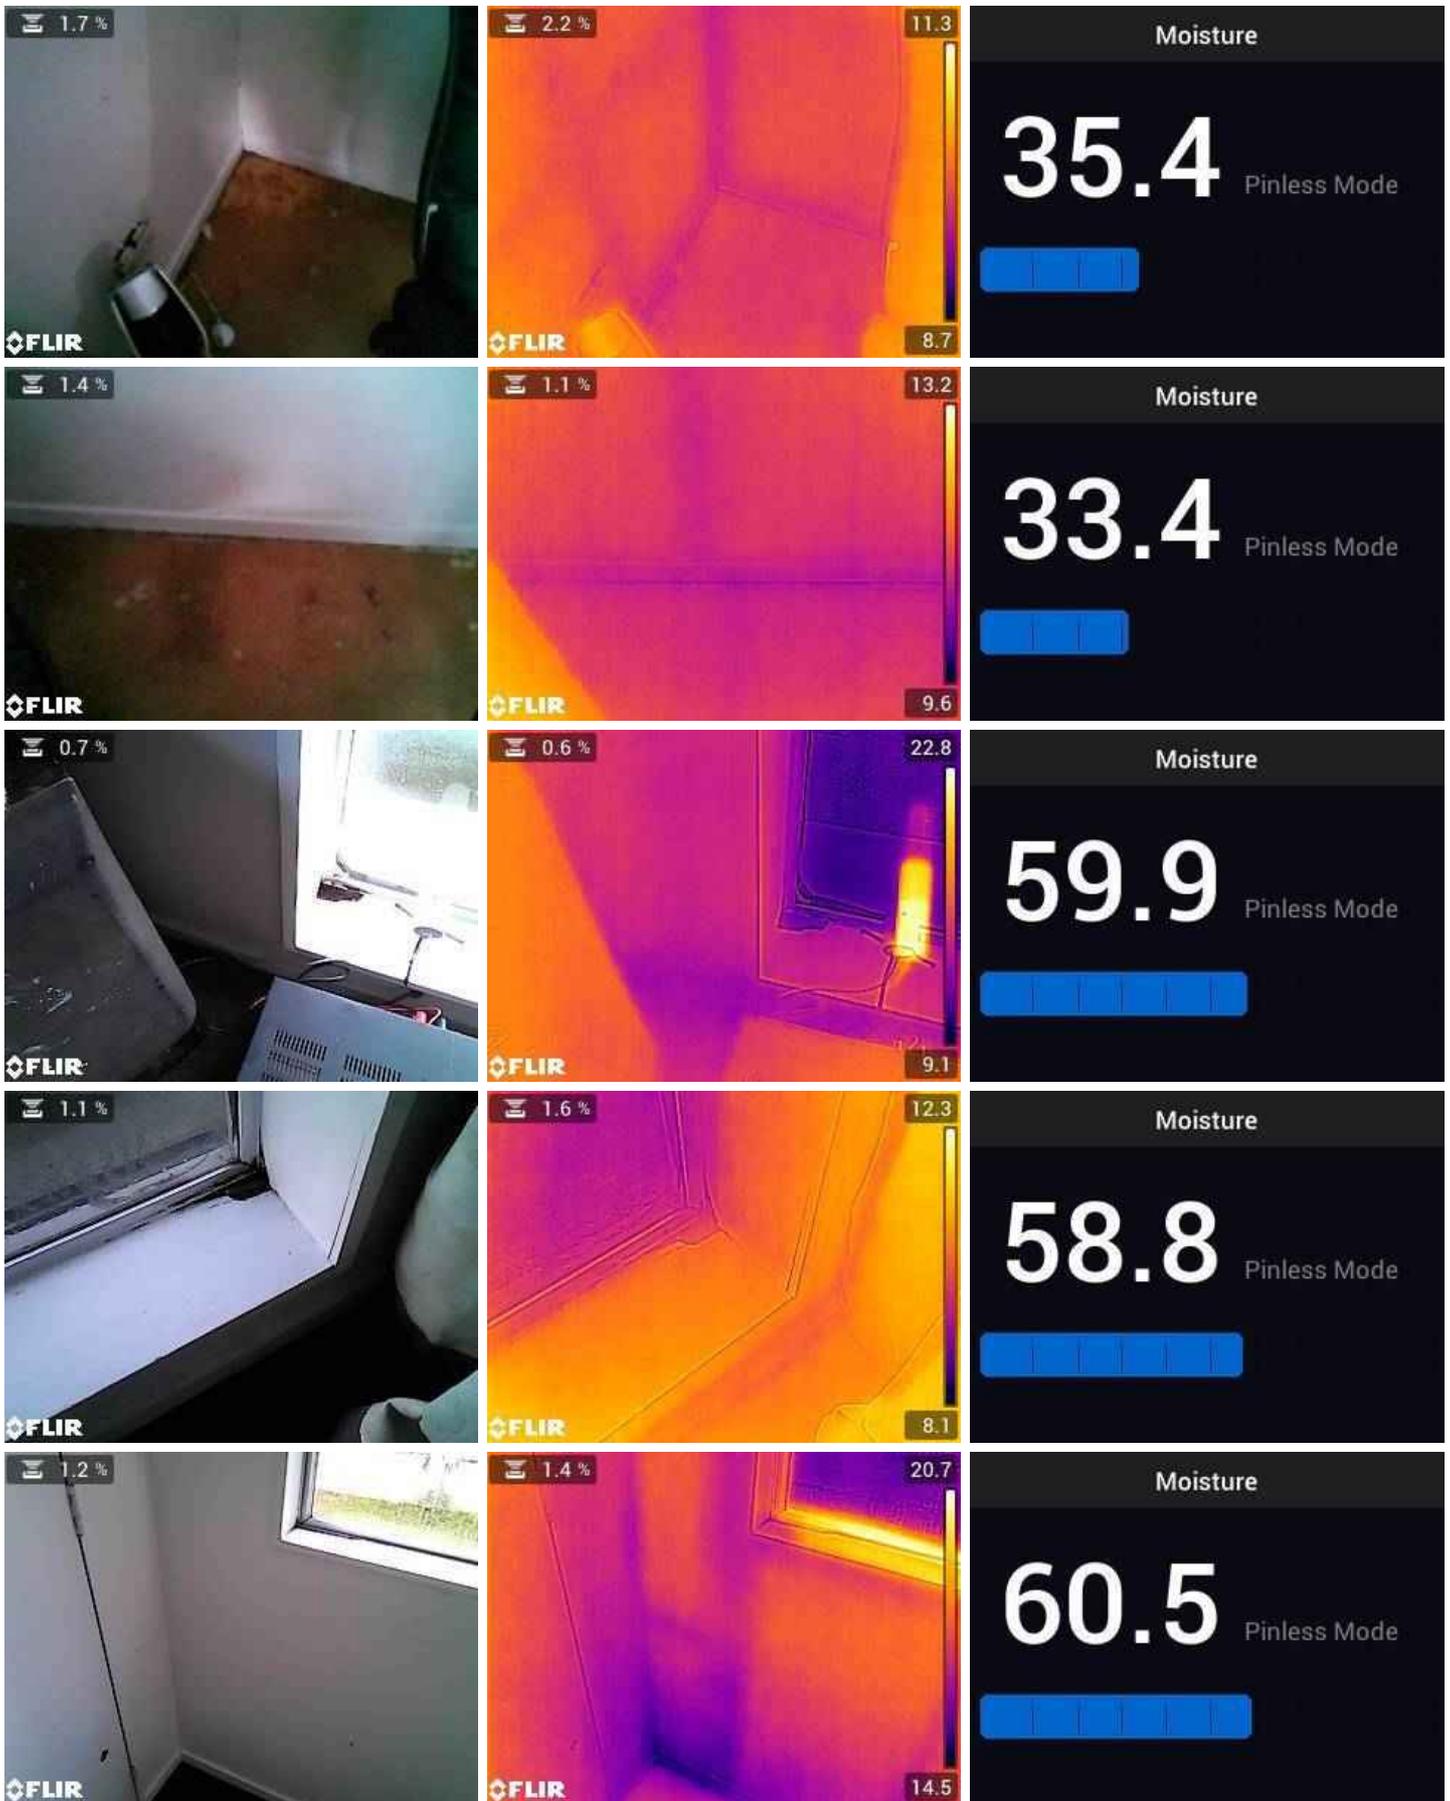
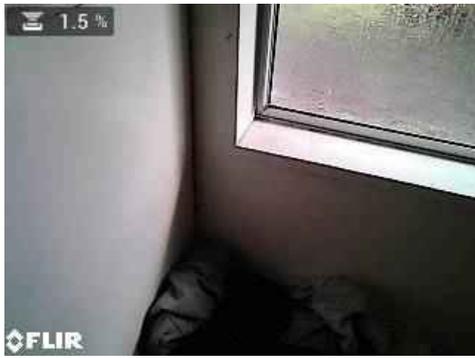
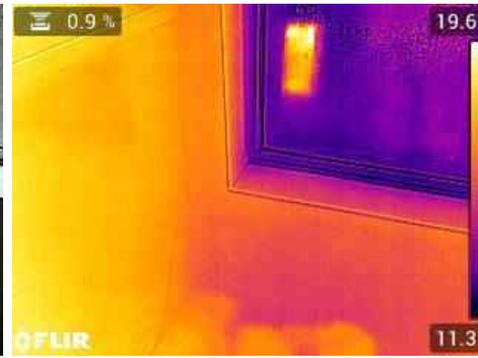
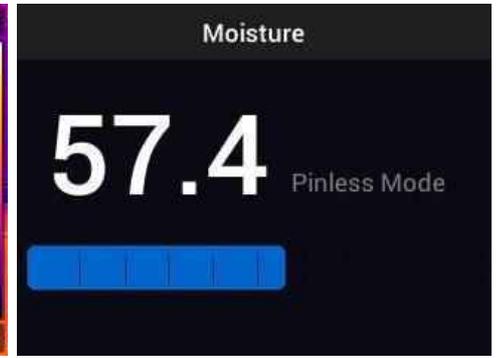
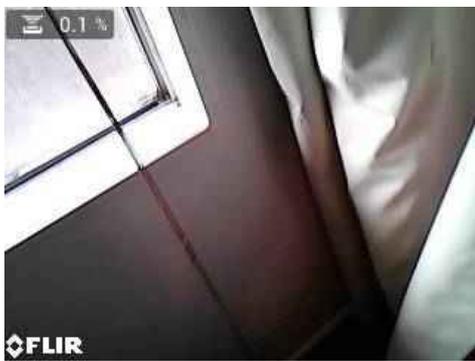
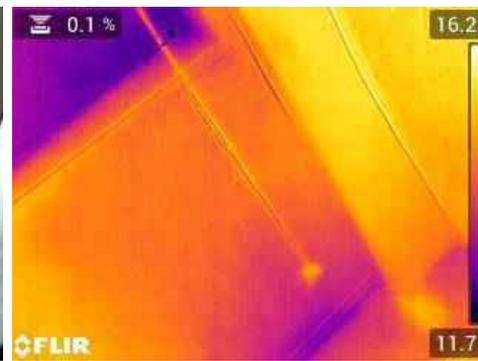
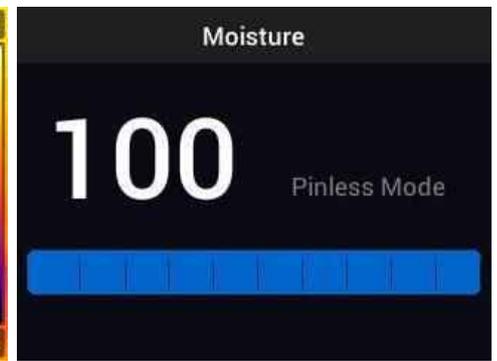
23.1.1 THERMAL & MOISTURE TESTING OBSERVATIONS

ELEVATED MOISTURE LEVELS

Areas indicating an elevated moisture level with the FLIR MR277 and/or visual signs of moisture ingress.
