# COMPREHENSIVE PROPERTY REPORTS

## RESIDENTIAL PROPERTY REPORT COPY

1234 Main St. Paraparaumu Wellington 5032

09/08/2021 9:00AM

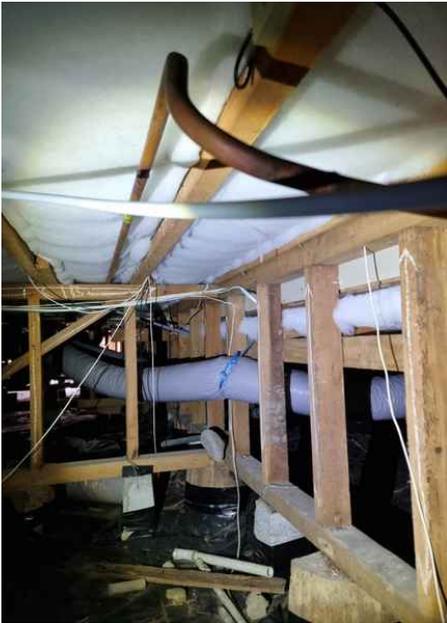
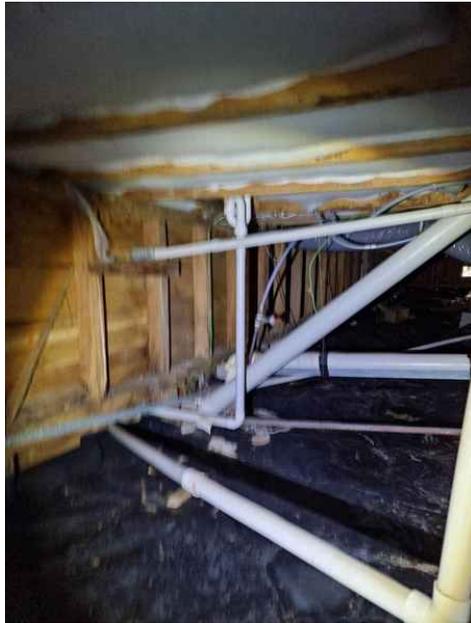
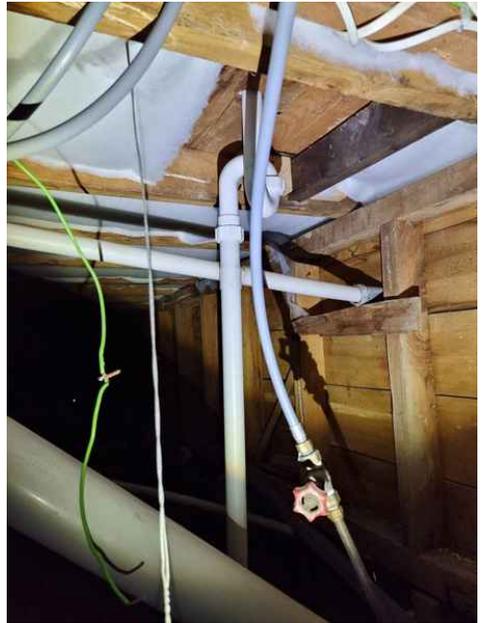
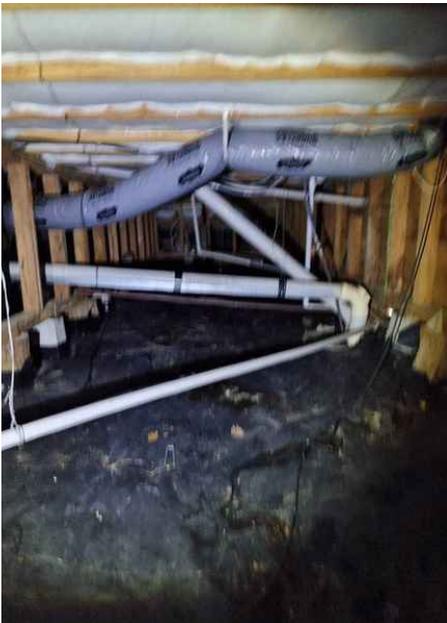
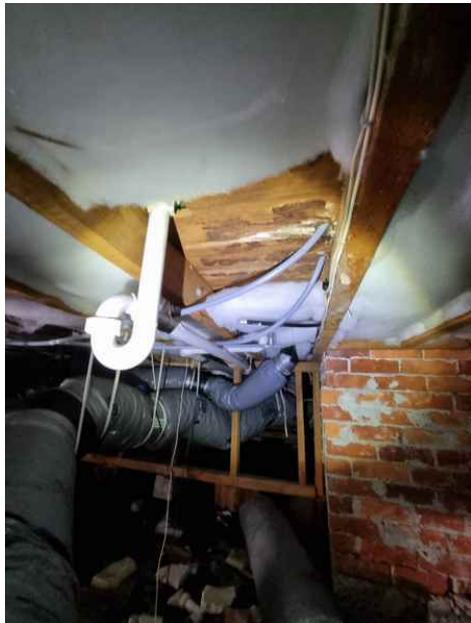
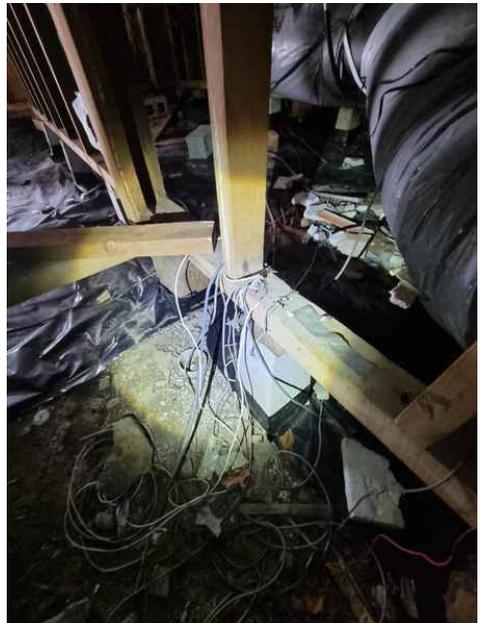
**UNDERFLOOR DRAINAGE SYSTEMS**

**The underfloor area was inspected for:** Correct ground gradients, Areas of standing water, Areas for water to potentially pool and/or How rain water could enter the underfloor area, What erosion paths it may be making and is there sufficient drainage outlets for it to exit the areas.

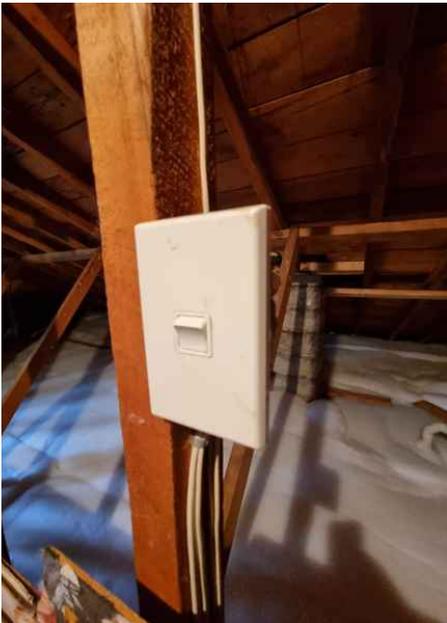
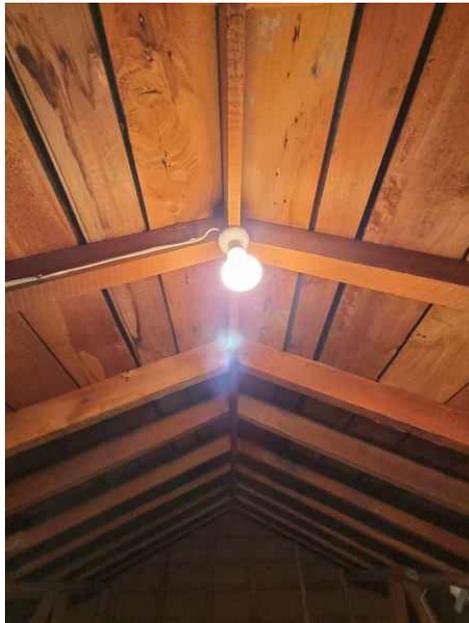
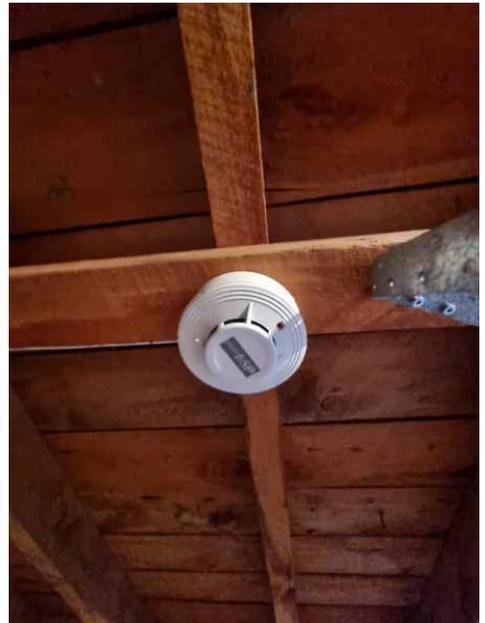
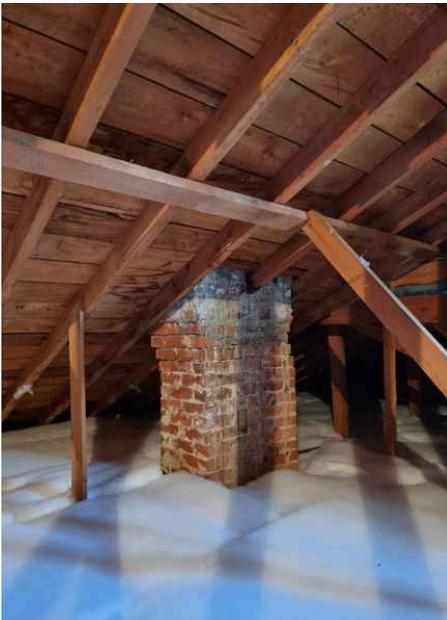
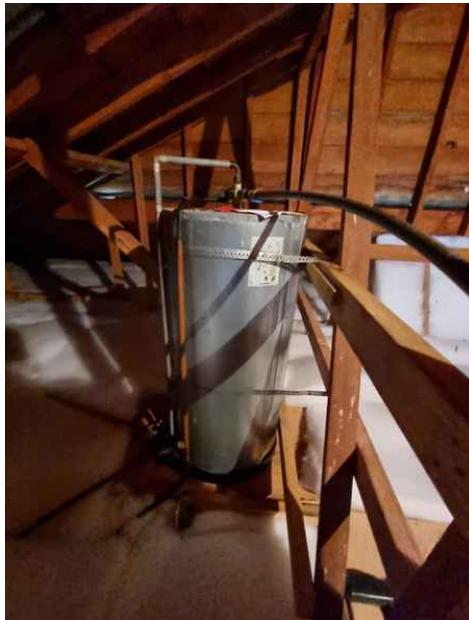
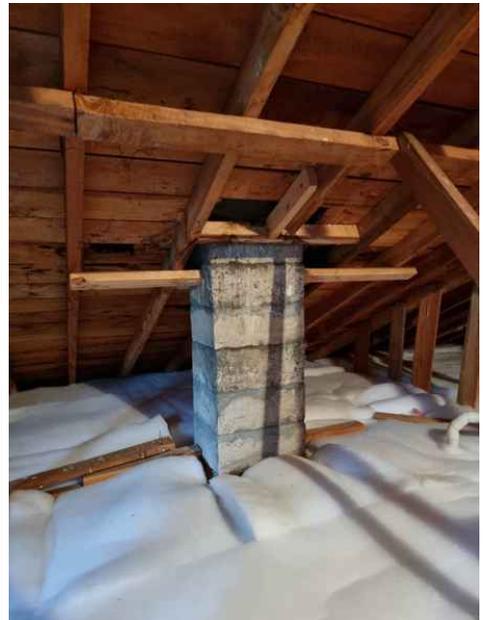
**UTILITY ROOF PENETRATIONS**

**ROOF PENETRATIONS:** All accessible roofing penetrations were inspected from within the ceiling cavity, plus all penetration flashings, boots and/or general weather sealing around penetrations was inspected from the exterior.

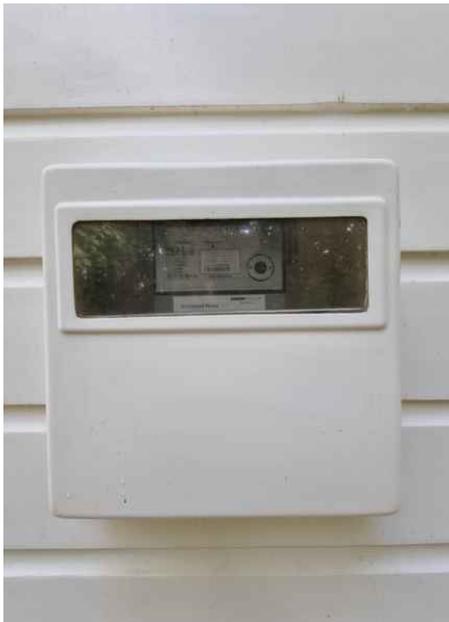
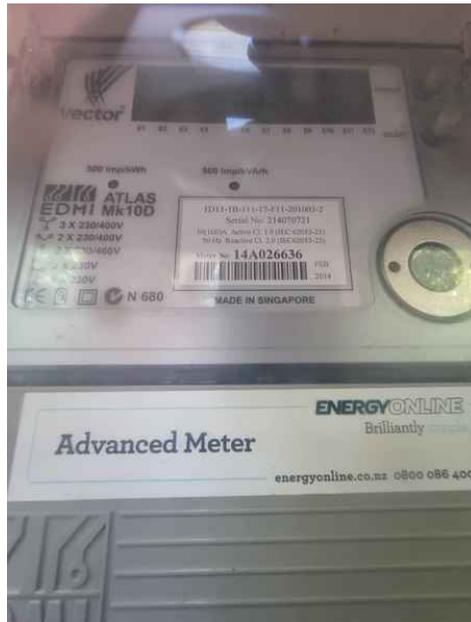
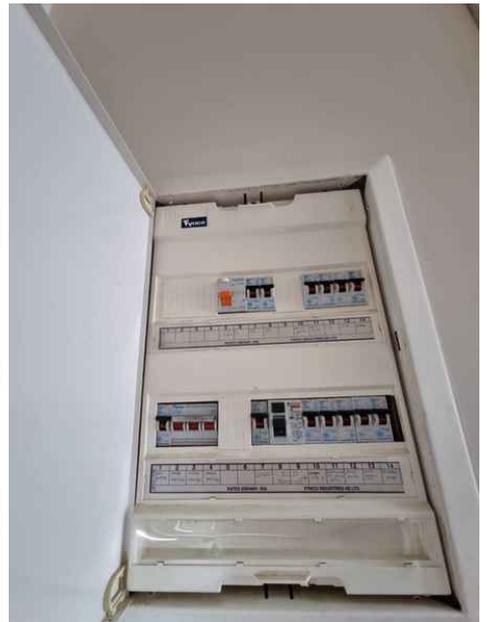
EXTERIOR | UTILITIES & SWITCHBOARD: METER | CIRCUIT BREAKERS | FUSES

When we visually inspect your power meter, we look for any potential problems with your property's electrical facilities. We don't complete a full electrical inspection of the electrical systems, but we'll let you know if we see a problem and if repairs are needed. Inspections may identify damage or exposure of electrical service wires, meter base, meter socket, or electric service grounds. We might also find electrical service tampering.

\*Any homes containing the old wiring should be rewired with TPS (Tough Plastic Sheath) as soon as possible and have their fuses replaced with circuit breakers and residual current devices.

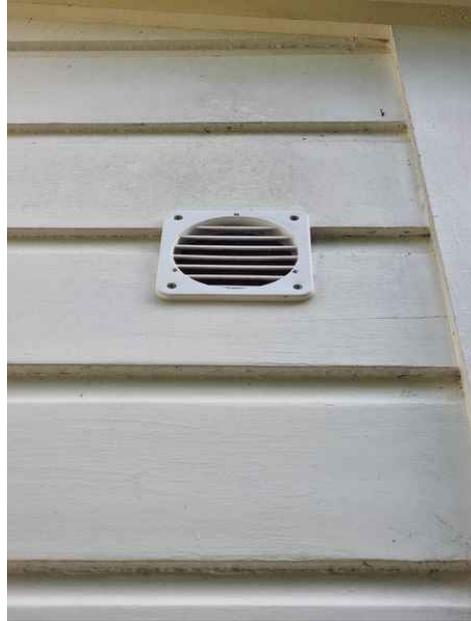
**EXTERIOR | UTILITIES & SWITCHBOARD: VENTS****EXTRACTION VENTS**

NZ Healthy Homes Standards require extractor and exhaust fans to be vented to the outside of the building with an vent cap. If not installed and/or installed incorrectly, the excessive moisture will cause condensation and moisture damage on ceilings and walls. This can cause mould and moisture damage inside the walls and/or ceiling cavity.

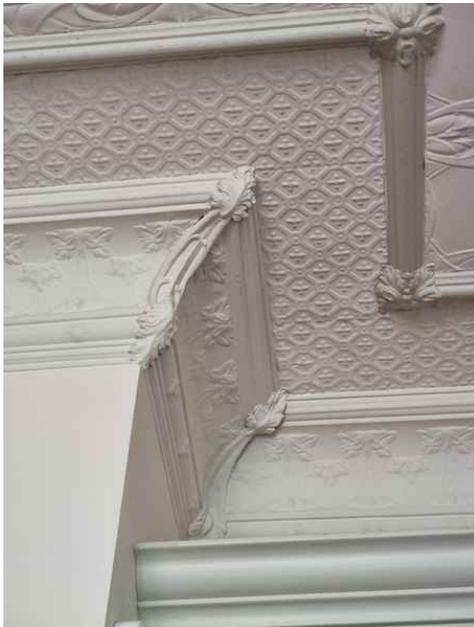
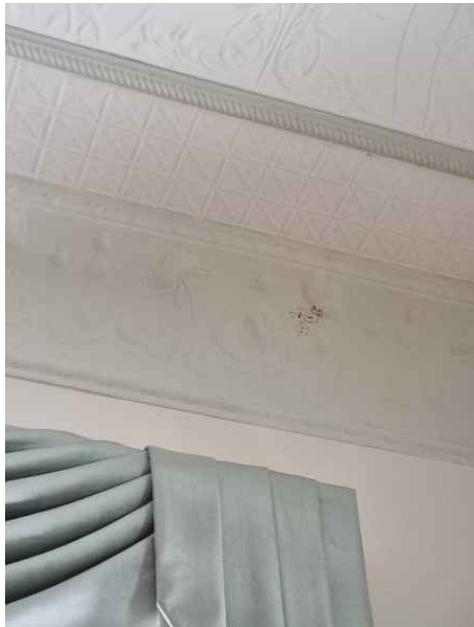
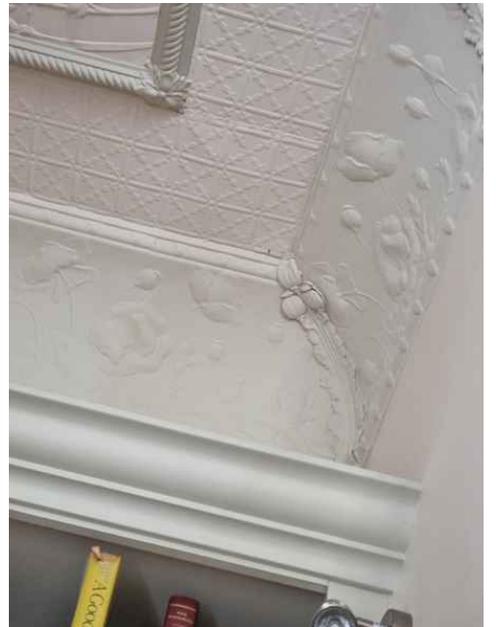
### FINISHINGS

Isolated areas of sub-standard finishing and/or age related wear to interior linings. These should all be a relatively simple fix if you wish to get the area/s finished to a higher standard. We have provided the contact number for a well reputable company who specialize in this area. [PROSTOP FINISHINGS](#) - 022 356 9527

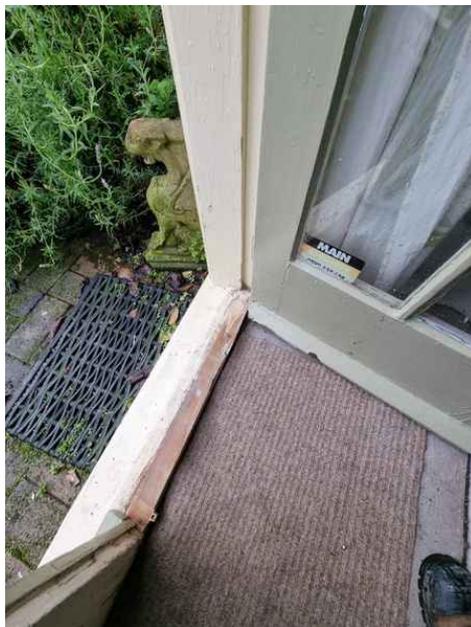
14.1.2 INTERIOR OBSERVATIONS  
**DAMAGE AT OR IN JOINERY**

## DAMAGE AT OR IN JOINERY

**Hardware operation, joinery damage and/or draught seal** observations noted.

**Water damage:** around windows can be caused by condensation or leaks. Try to reduce the amount of condensation in your home.

### CONDENSATION DAMAGE AT JOINERY

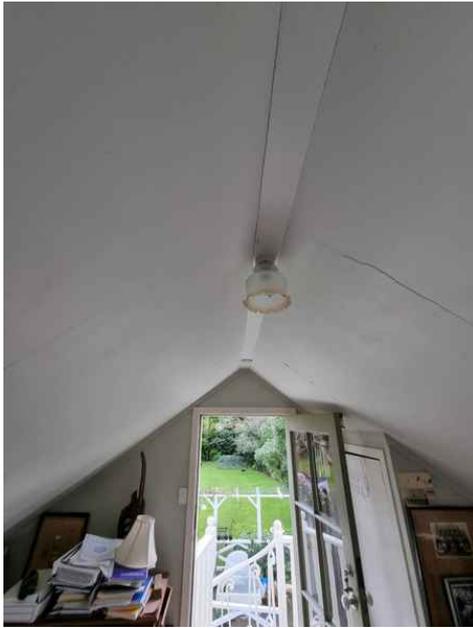
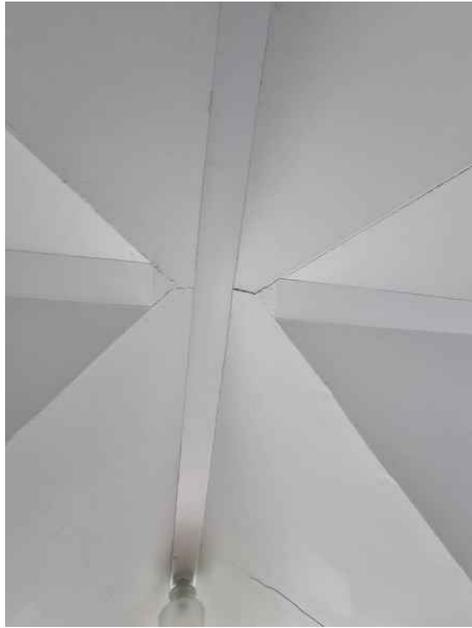
#### 14.1.3 INTERIOR OBSERVATIONS

### DEVELOPING AND/OR PRE-EXISTING MOISTURE INGRESS

**NOTABLE TEMPERATURE DIFFERENTIALS  
AND/OR  
INDICATIONS OF ELEVATED MOISTURE LEVELS**

Images/areas documented in this observation may be showing moderate to high temperature differentials with the FLIR MR277 Thermal Imaging camera and/or elevated moisture levels with the FLIR MR60 Moisture meter. These areas may not be at the through-wall stage yet, they may be considered areas with a "developing" issue that, if remedied sooner rather than later should not develop into a major concern. Regardless of what stage they are currently at, they must still be monitored closely even after repair work has been done.

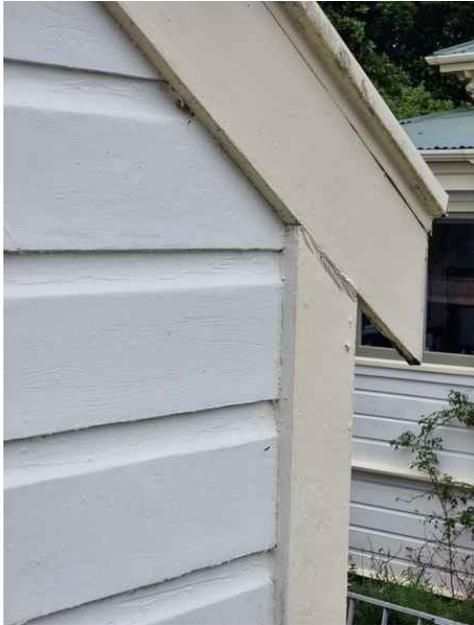
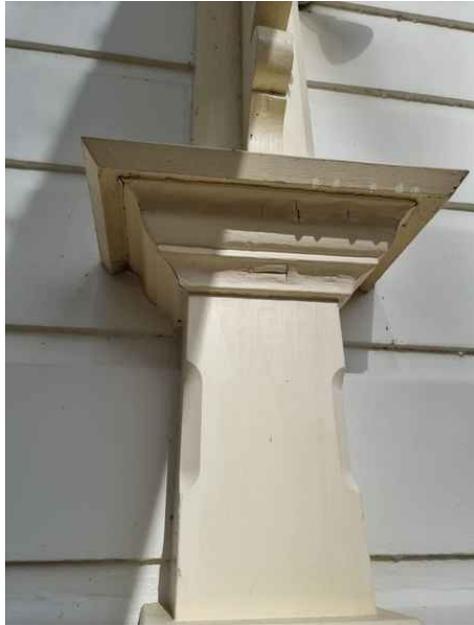
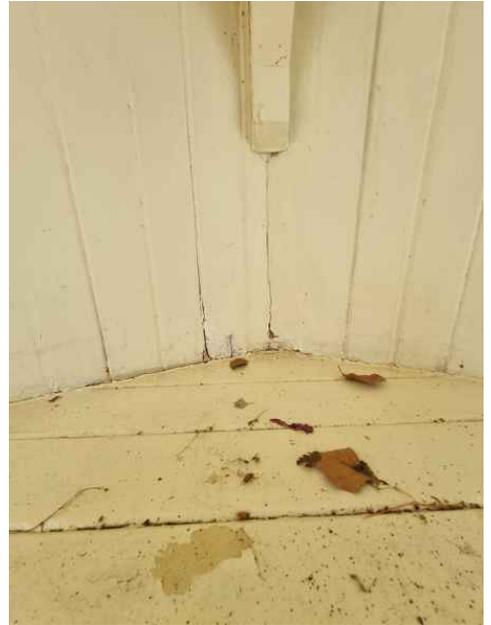
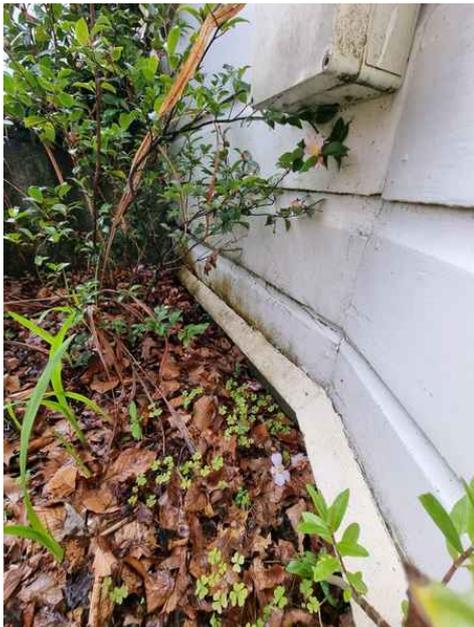
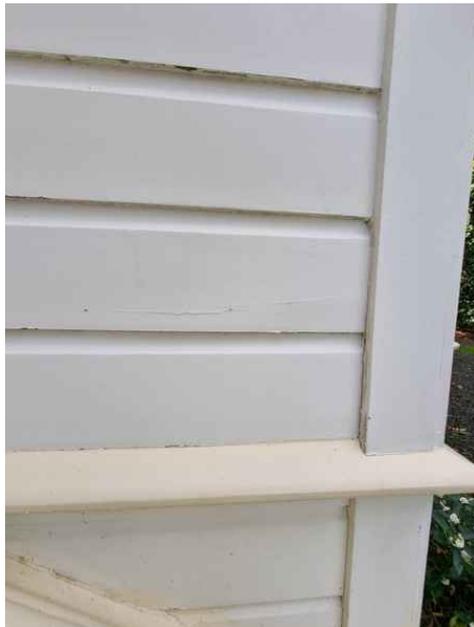
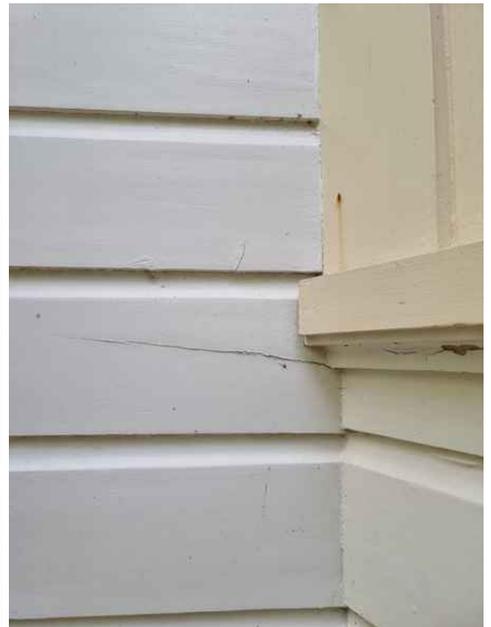
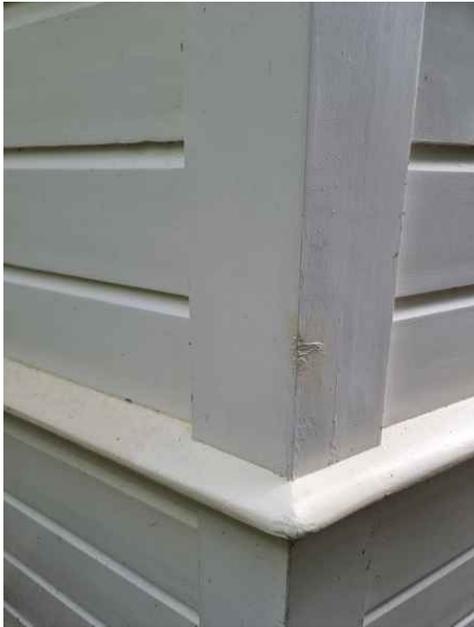
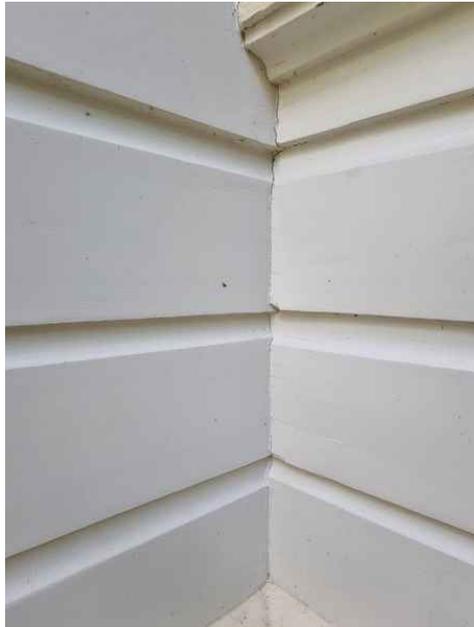
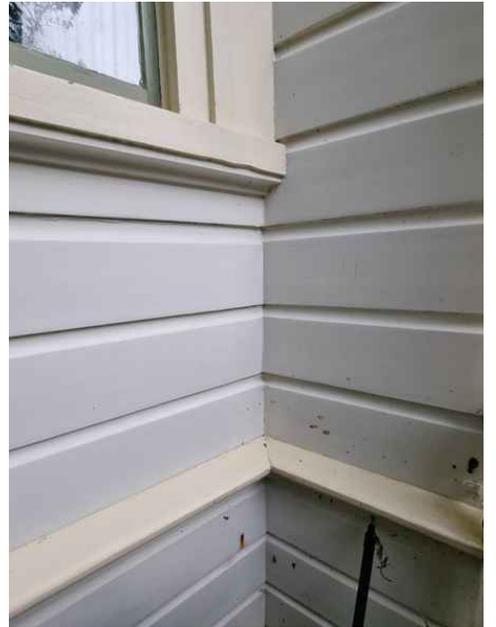
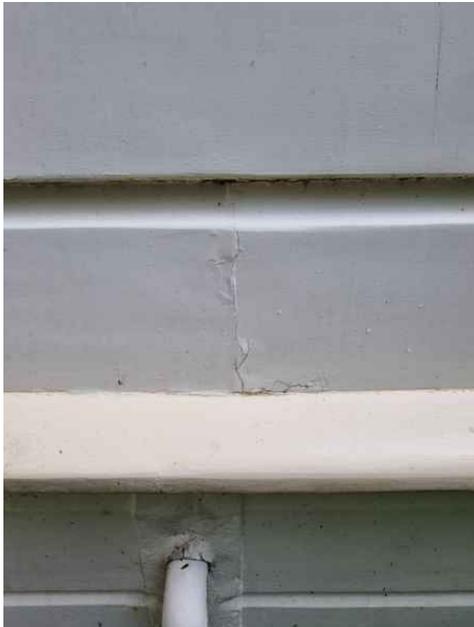
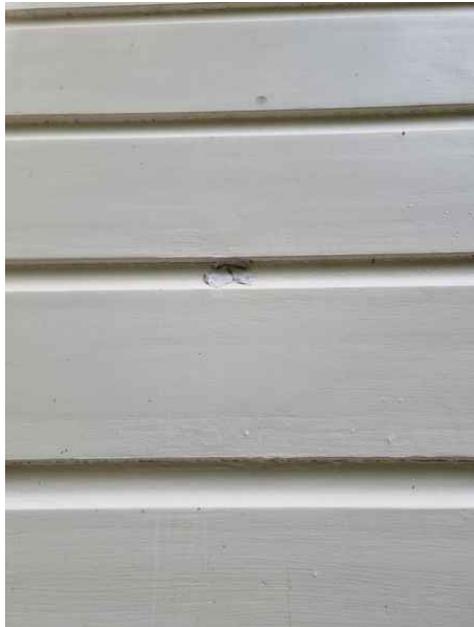
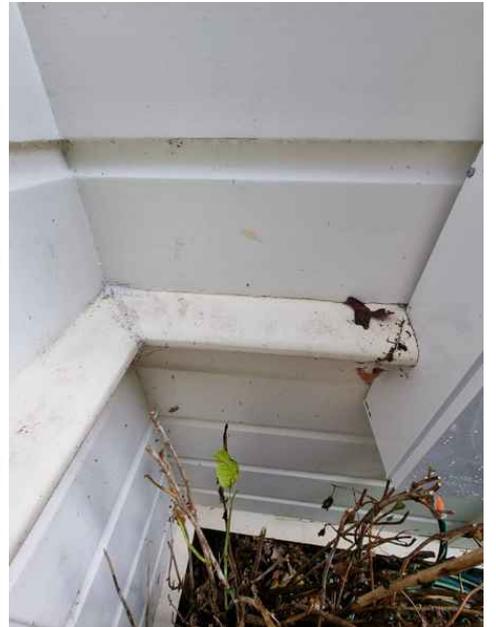
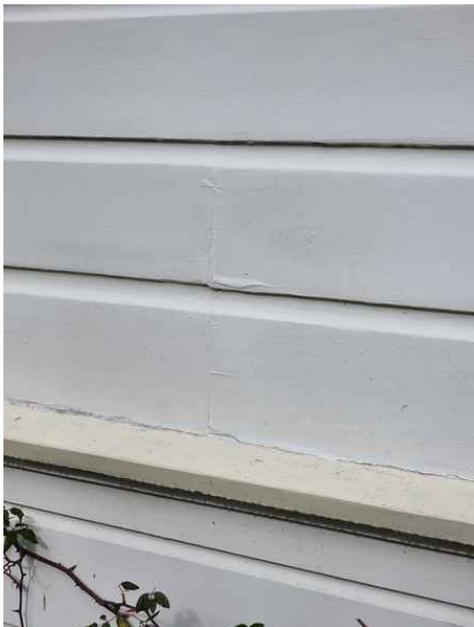
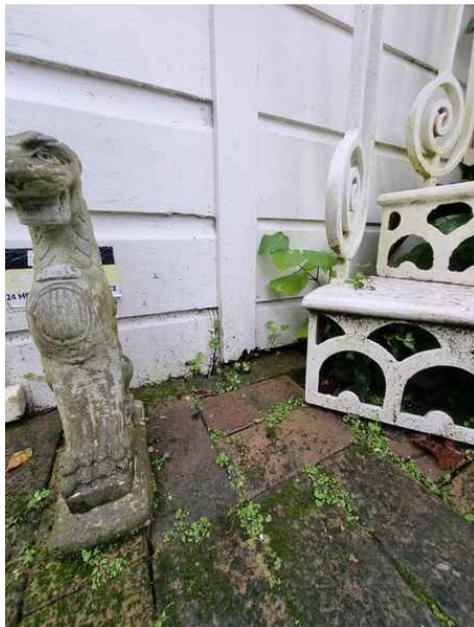
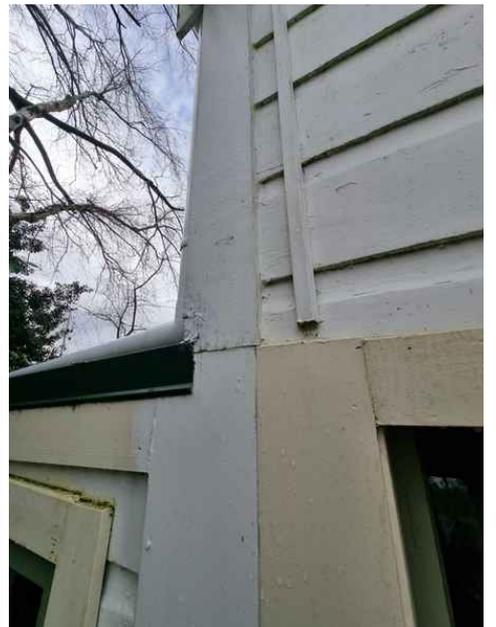
- Siding too close to and/or in contact with the ground. (Rot noted in some of the lower timber weatherboards but very little considering the age and overall size of this building)
- Some isolated open cladding joins.
- Some isolated cracks and/or splits in cladding.

This can be caused by:

- Unboxed corners.
- Moisture ingress damage.
- Ground clearance issues.
- Double nailing.
- Timber can dried out, or is subject to large amounts of heat, typically on a north or north-west facing wall.

When replacing badly damaged timber, replace them with a single line of nails – generally weatherboard and battens should only have one nail per stud or dwang. Pre drilling nail holes at the end of any weatherboards with a smaller drill bit. You shouldn't need to pre-drill the other holes unless you are hanging Linea, and in the situation you will require a masonry drill bit, not an HSS drill bit. Ensure all back surfaces and/or connections are primed/stained before painting/staining the in-situ boards.

**CLADDING WEATHER SEALING ESTIMATE:** \$4,000.00 (Replacement of any rotten timber and resealing requirements over 24-36 months on the main house)

**We recommend** getting exact quotes from the correct specialist contractors. We have provided rough estimates for the work required. These costings range from the DIY lower pricing to the cost to have a professional tradesperson complete the work involved over the next 24-36 months. Not all observations are documented. But are clearly visible from the exterior of the dwelling.

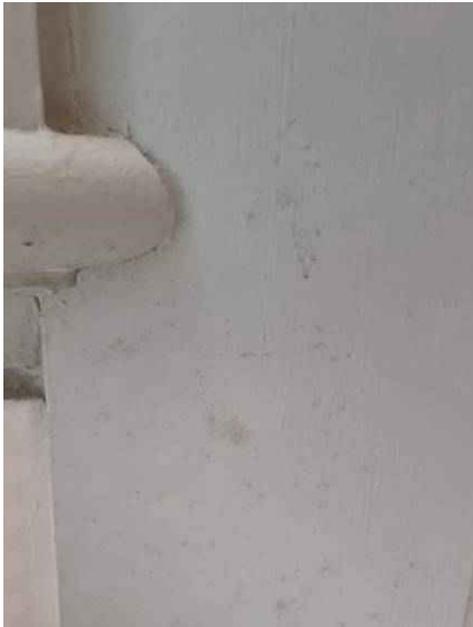
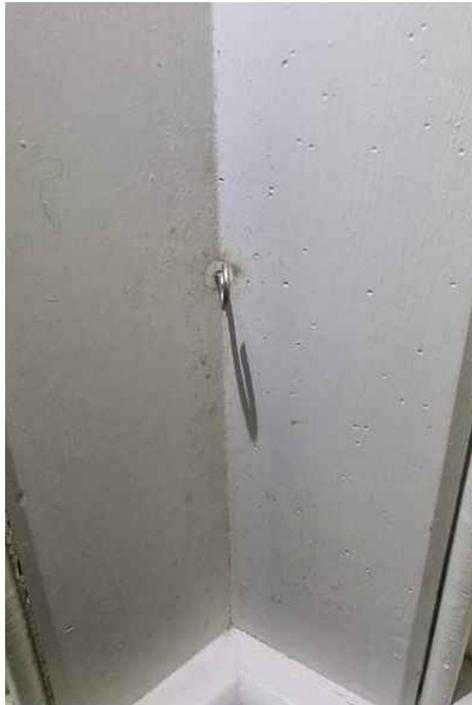
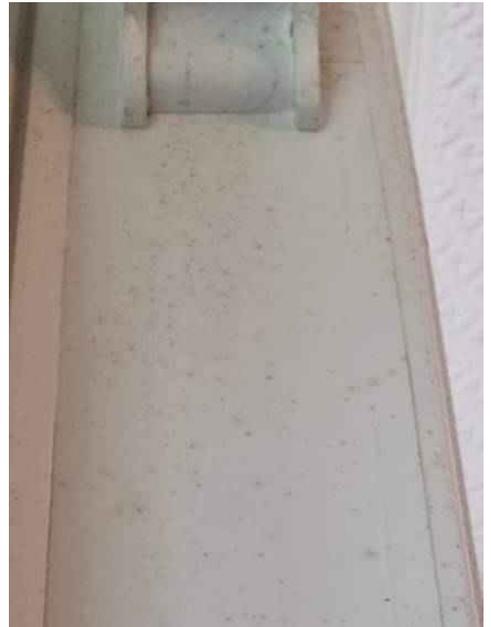
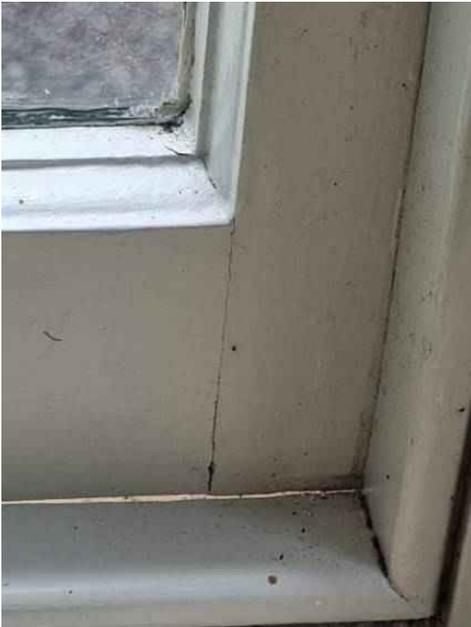
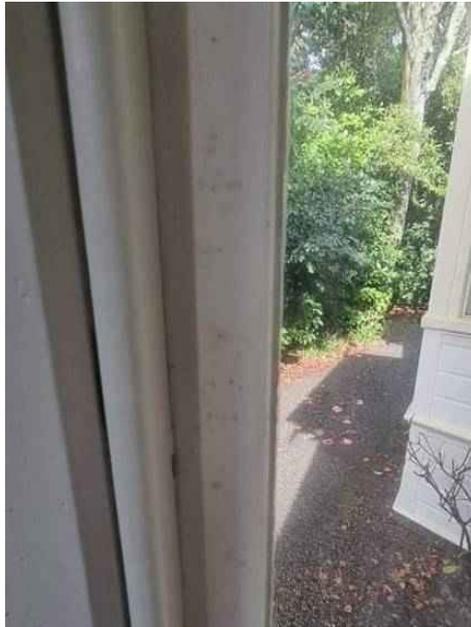
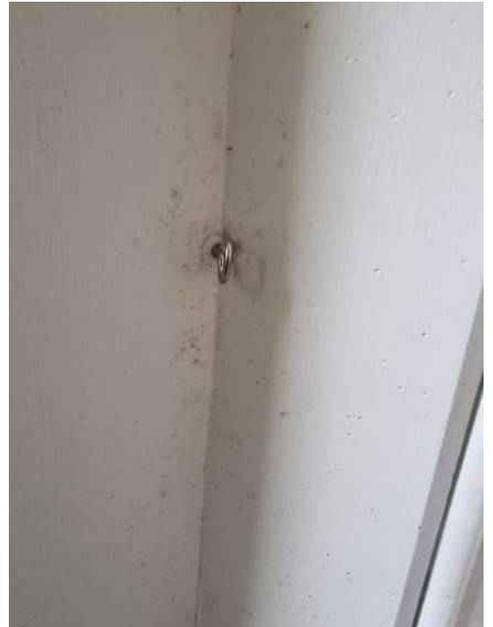
- Weather sealing, Hardware issues, Signs of mould in some sills. Some operation of timber joinery needs easing.

For timber joinery and/or surrounding cladding materials, buff/key the surface before applying any weather sealing paint and/or paintable silicone products.

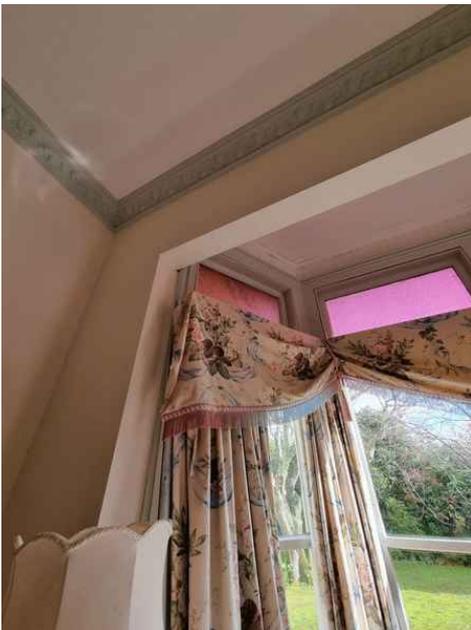
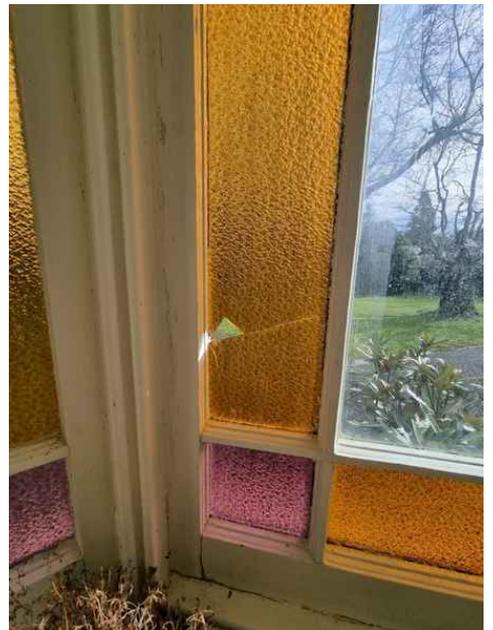
16.1.2 JOINERY OBSERVATIONS

**GLASS PANE NEEDS REPLACING**

Trade Work Required

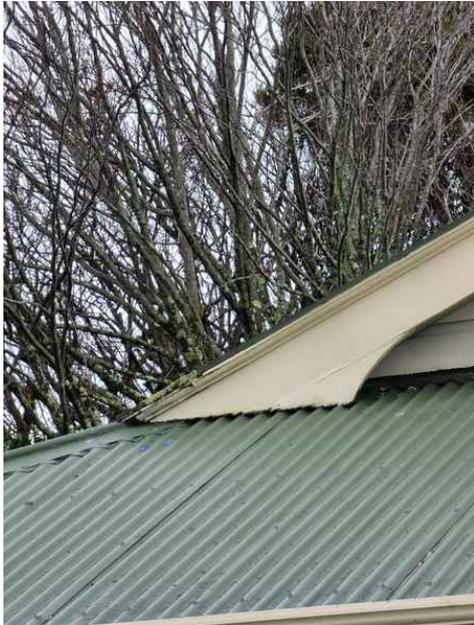
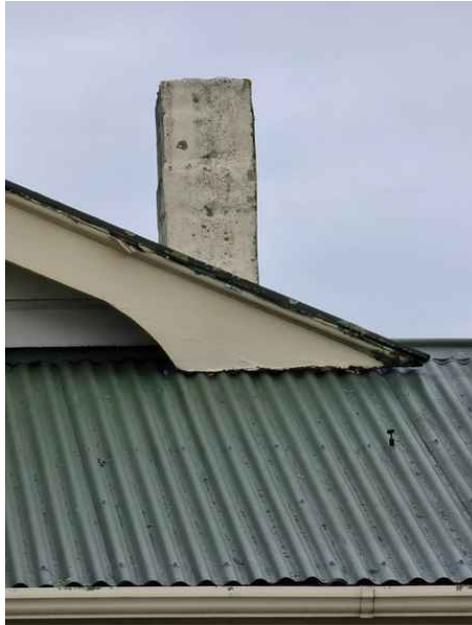
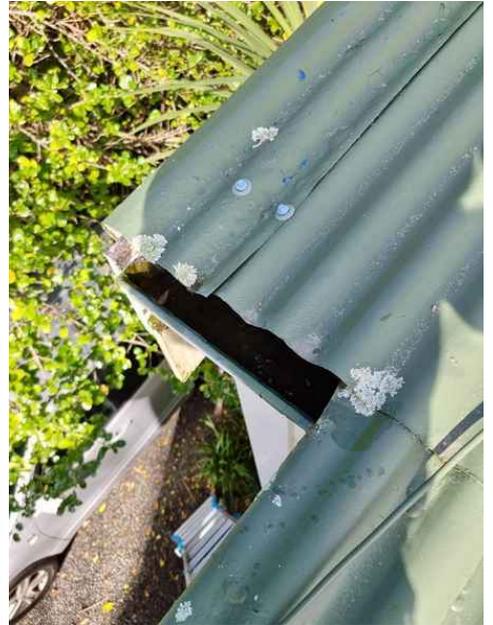
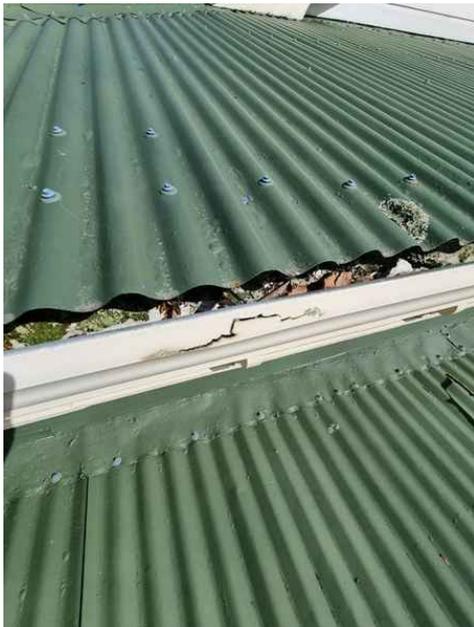
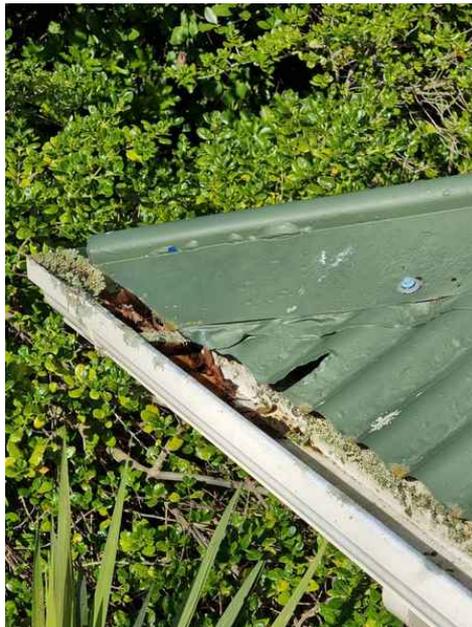
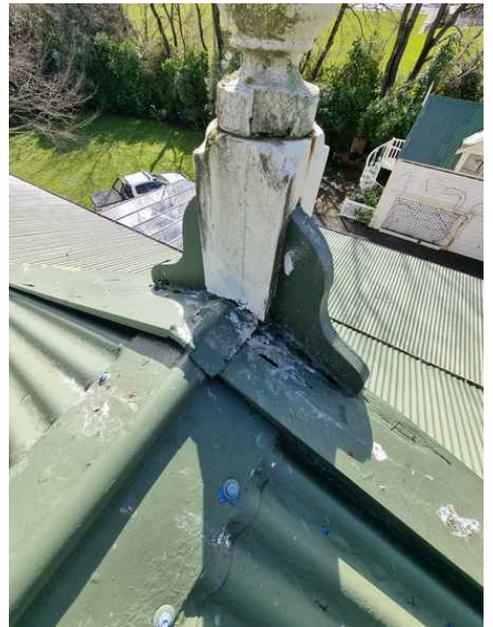
- Lichen, Algae and/or Moss sighted in one or more areas.
- Edges of iron roof lifting.
- Rust sighted in iron roofing.
- Failing/fading weatherproof paint seal.
- Soffits, Fascias and/or Eaves show weathering and/or damage.
- Roof drainage shows debris and/or damage.

The roofing system isn't too bad overall. It does however need attention in specific areas. We recommend having a roofing contractor assess and quote for these areas.

Lichen causes damage and is extremely difficult to remove with pressure cleaning or scrubbing alone. The lichen will begin to regrow immediately after pressure cleaning from the residue left behind.

The roofing iron is mostly still original and in pretty impressive shape for its age. We would recommend having it weather sealed in the next 5-10 years. Sooner rather than later is recommended. Full weather

**PROFESSIONAL ROOFING WEATHER SEALING ESTIMATE:** \$20,000.00 - \$28,000.00

We recommend getting exact quotes from the specialist contractor you choose to hire as quotes can be very different from one roofing company to another. We have provided rough estimates for the work required. These costings range from just replacing the deteriorated timber fascia boards to the cost of having a professional tradesperson complete all the work involved.

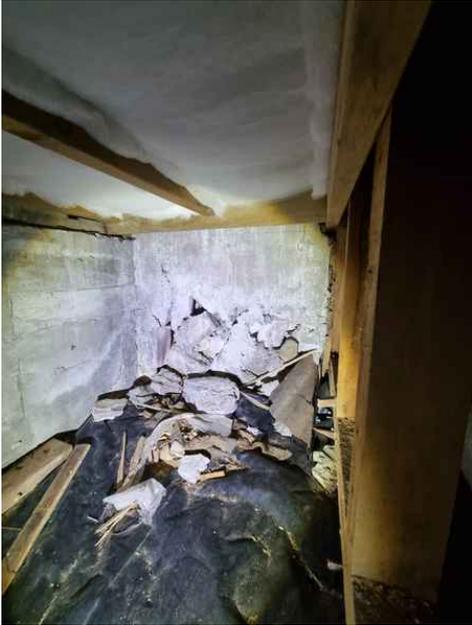
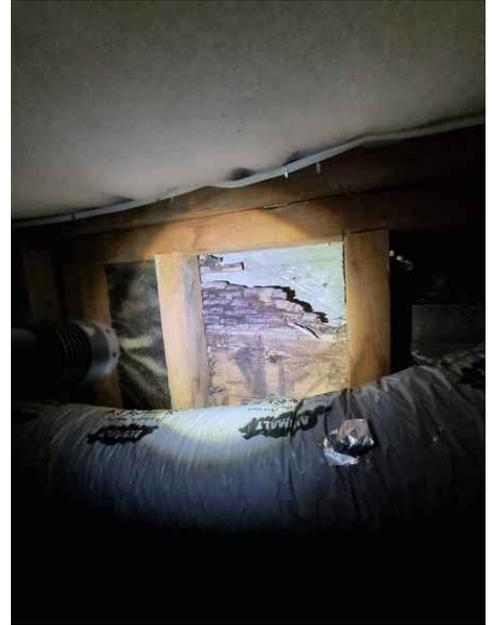
18.1.1 FOUNDATION OBSERVATIONS

## DEFECTS NOTED IN STRUCTURAL AND/OR NON-STRUCTURAL ELEMENTS

Cracking, settlement and/or defects sighted in one or more of the concrete foundational elements. This is a relatively common observation, however any defects in any foundational elements should be monitored for further deterioration every 6 weeks or so.

**Poor construction practices:** Subfloor may have in-line bearer joints at one or more rows of piles. This is a common observation for this era of construction, however common it is a poor construction practice. The bearers will need to be reinforced by adding strong backs. (Strong backs are a second full length bearer or similar strength material that spans across the joints and allows any load to be evenly dispersed)

These areas require monitoring. (Refer to images provided) If the settlement cracking worsens we recommend you seek the advise of a qualified builder and/or structural engineer that can provide a quote to remedy the observation.

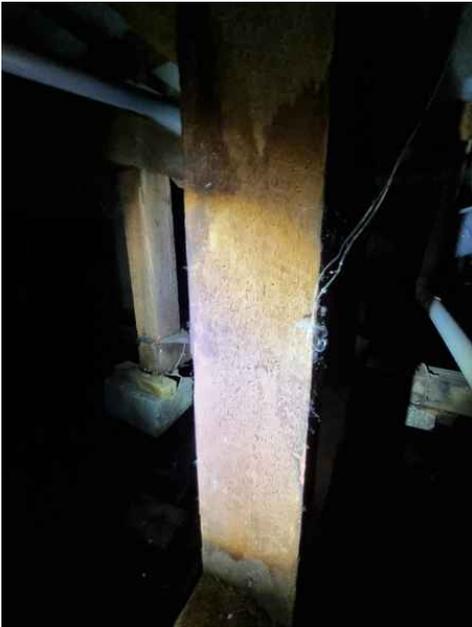
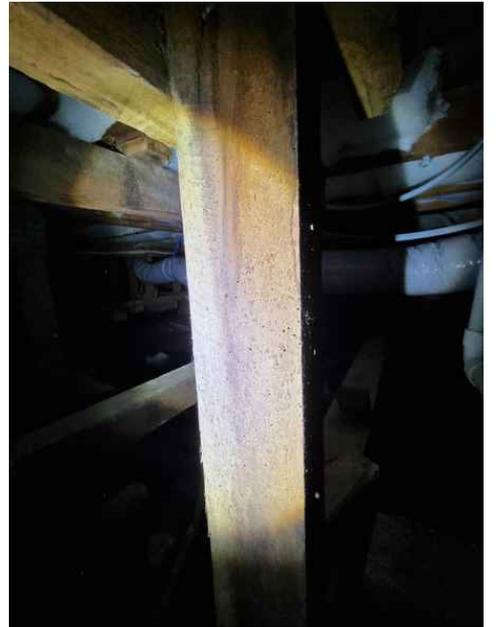
18.1.3 FOUNDATION OBSERVATIONS  
**BORER HOLES SIGHTED**

## SIGNS OF BORER NOTED

**Borer attacks untreated and damp timber.** For minor, or early infestation, treat the infested areas. Replace badly affected timber. This can some times be easier said than done.

Professional Borer treatment cost between \$150.00 & \$300.00 The treatment soaks into the timber and borer larvae and pupae are killed as they consume it. The treatment will provide borer stopping power for at least 5 years.

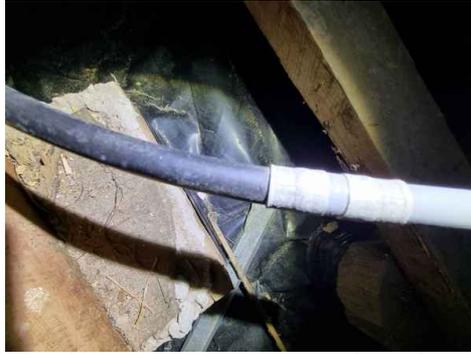
Plumbing systems appear to have been upgraded. We only identified disused Dux Quest during the inspection.

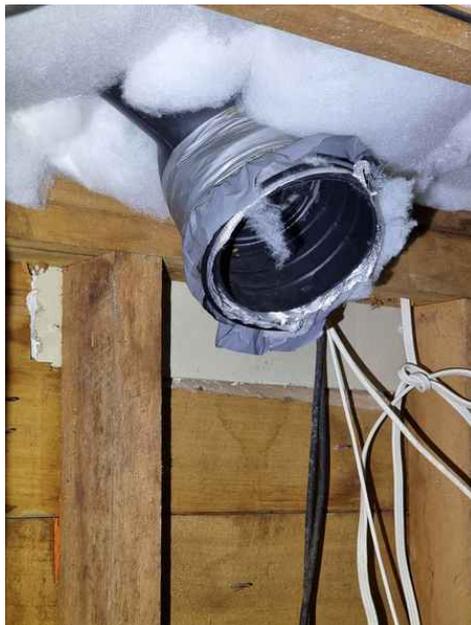
**VENTILATION | EXTRACTION REPAIR AND/OR REPLACE**

NZ Healthy Homes Standards require extractor and exhaust fans to be vented to the outside of the building with an vent cap. If not installed and/or installed incorrectly, the excessive moisture will cause condensation and moisture damage on ceilings and walls. This can cause mould and moisture damage inside the walls and/or ceiling cavity.

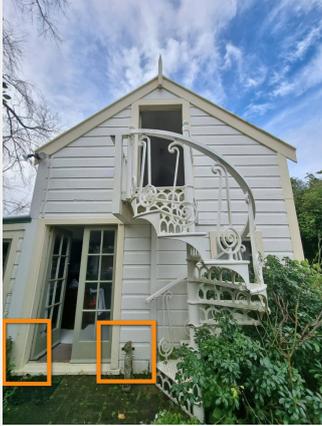
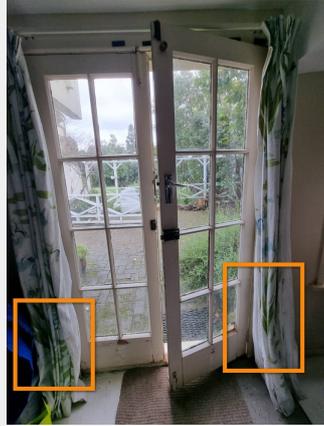
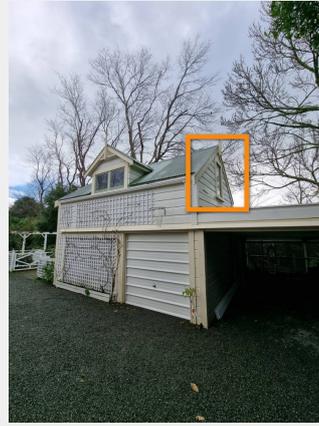
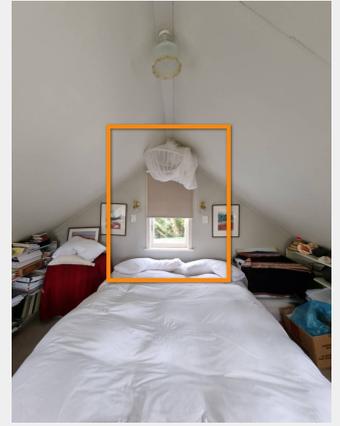
## AREA INSPECTED CEILINGS | WALL LININGS | JOINERY

<b>MOISTURE LEVELS:</b>	<b>EXTERIOR:</b> R52.0%   M48.2%
<b>MODERATE INDICATORS:</b>	<b>INTERIOR:</b> R16.0%   M84.2%
<b>RECOMMENDATION:</b>	<p><b>EXTERIOR:</b> Moisture Damaged Timber.</p> <p><b>INTERIOR:</b> Moisture Damaged Gib.</p> <p><b>EXTERIOR:</b> Replace, Repair, Weather seal.</p> <p><b>INTERIOR:</b> Replace Gib Linings.</p>
