COMPREHENSIVE PROPERTY REPORTS

RESIDENTIAL PROPERTY REPORT COPY

1234 Main St. Paraparaumu Wellington 5032

29/09/2021 9:00AM

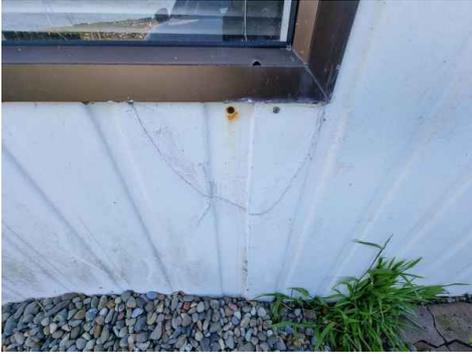
DAMAGED SHADOWLINE

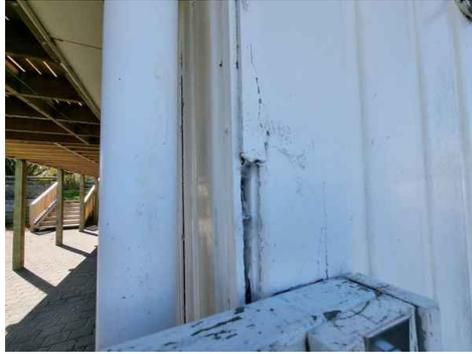
DAMAGED SHADOWLINE

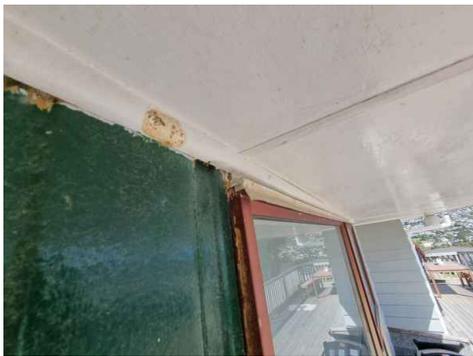
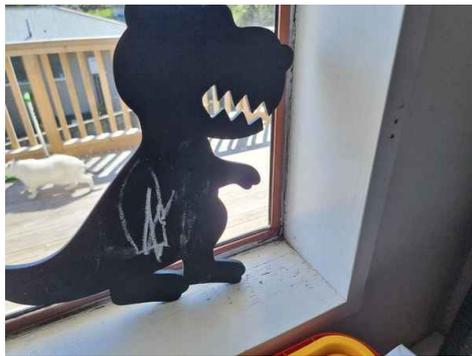
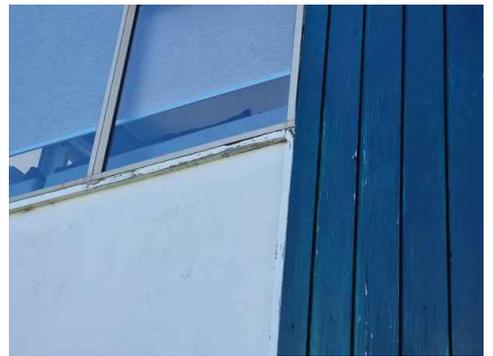
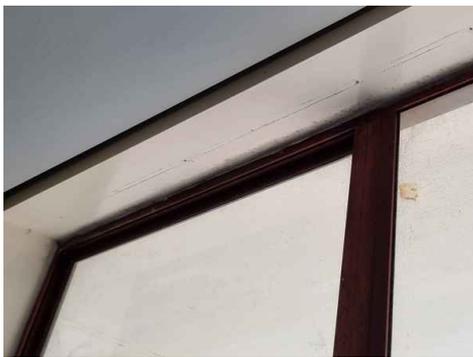
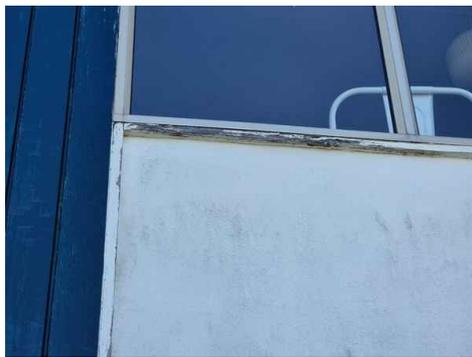
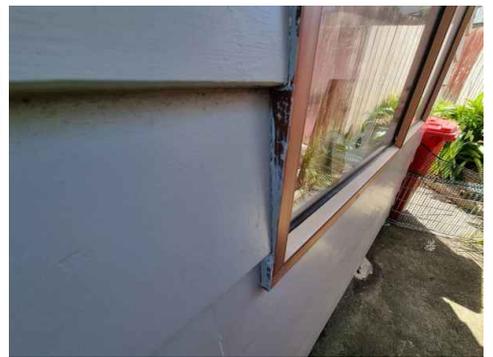
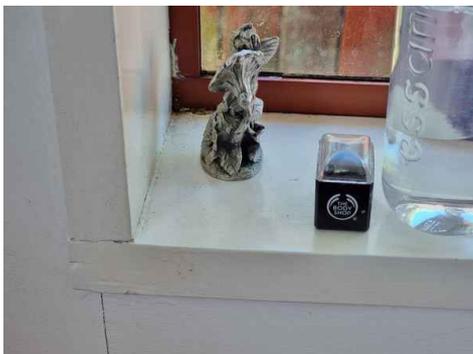
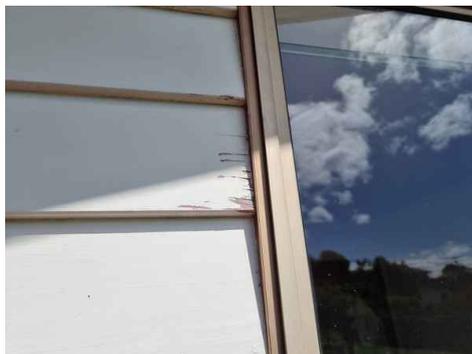
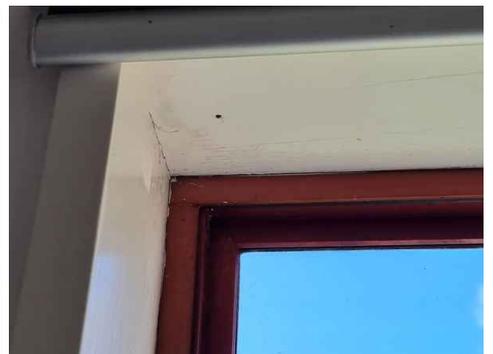
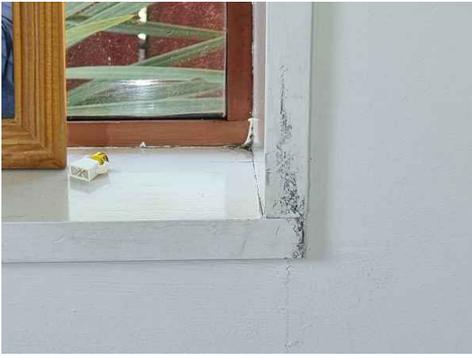
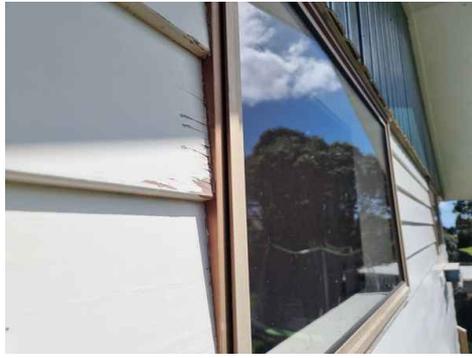
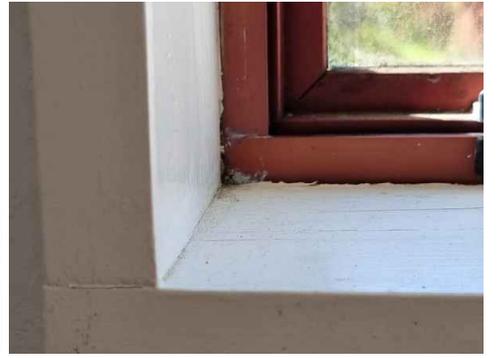
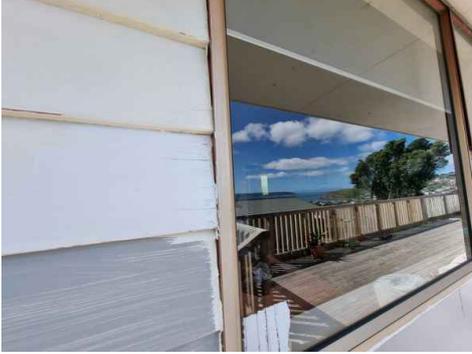
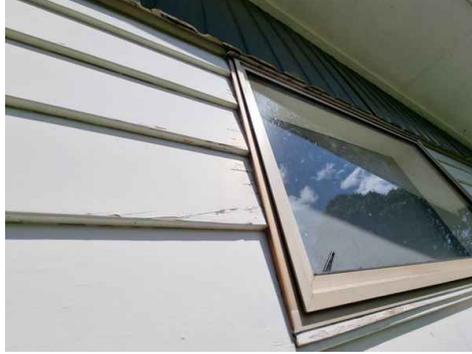
5.1.1 JOINERY OBSERVATIONS

- Substandard weatherproof paint seal at joinery.
- Gaps at joinery to cladding junctions .
- Cracks and/or splits in joinery timber.
- Moisture damage.
- Rot in timber joinery and/or surrounding timber material.
- Missing scribes and/or failing head flashings.

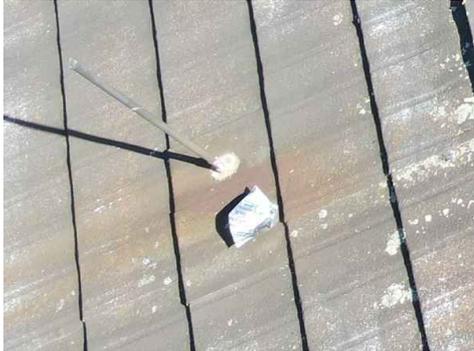
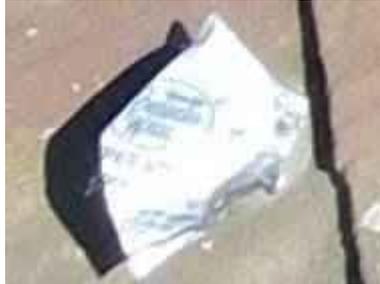
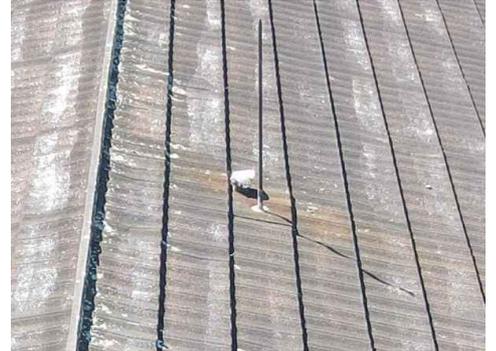
ULO

- Unidentified landed object.

Bro what the hell is this?

Is it supposed to be a vent cowling? **BAHAHAHA**

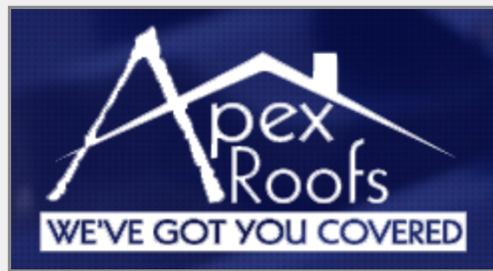
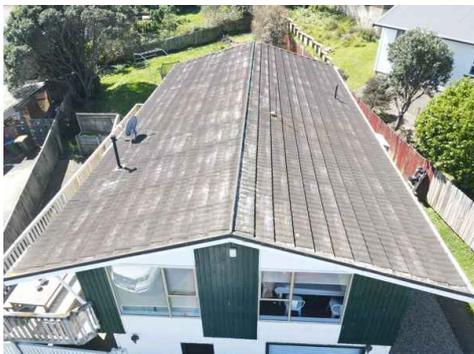
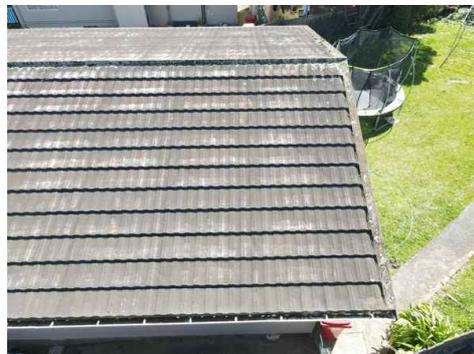
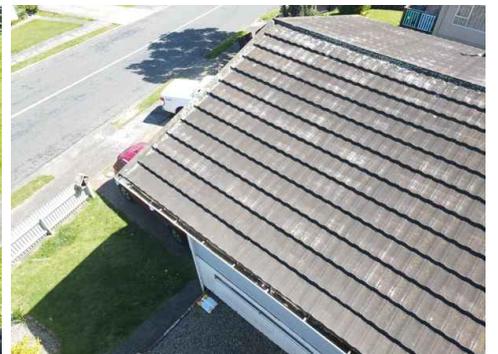
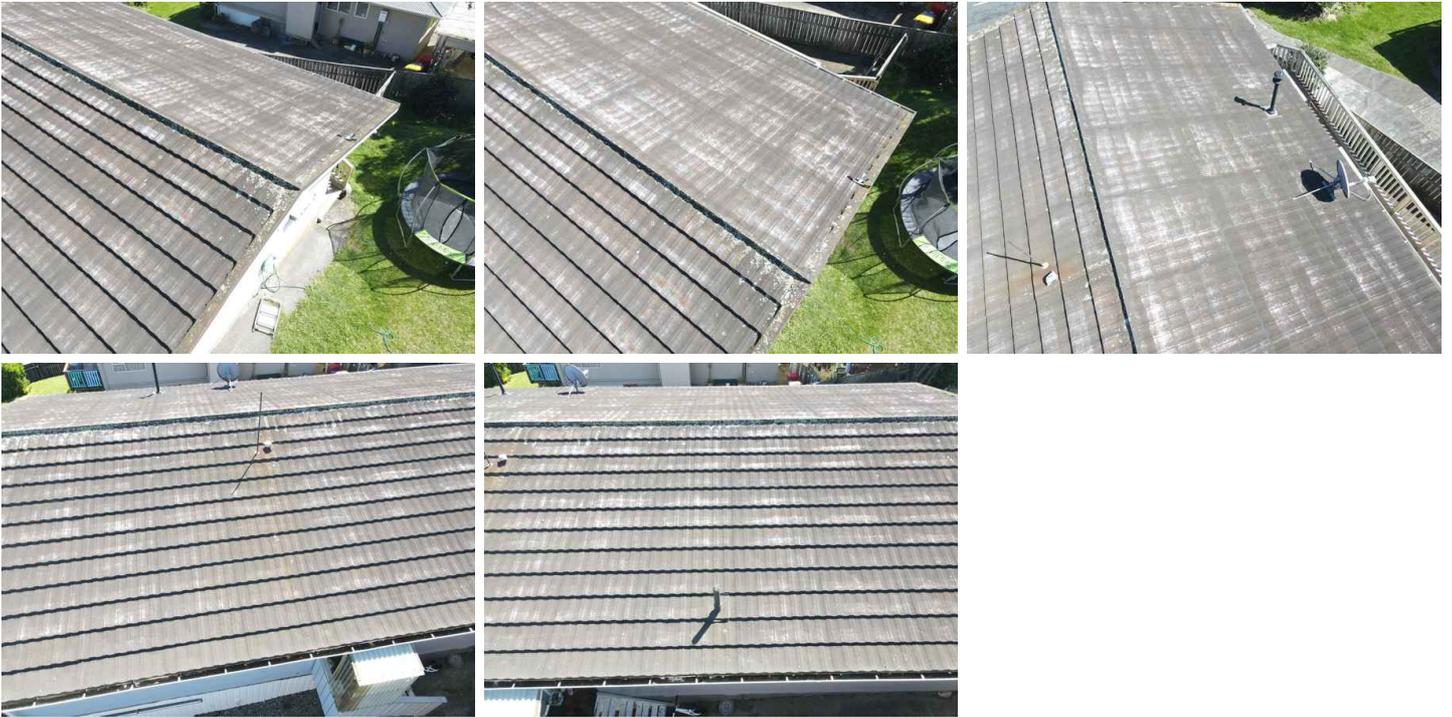
6.1.3 EXTERIOR ROOFING OBSERVATIONS

- Roof coverings show signs of discolouring / fading of the coverings protective coating. Any breakdown of roofing materials can cause the repair cost to quickly escalate into a replacement cost if not corrected early.

- We recommend having the roofing system repaired and resealed by a qualified roof painter, it might cost a little more now, but it can save you thousands in the long term.

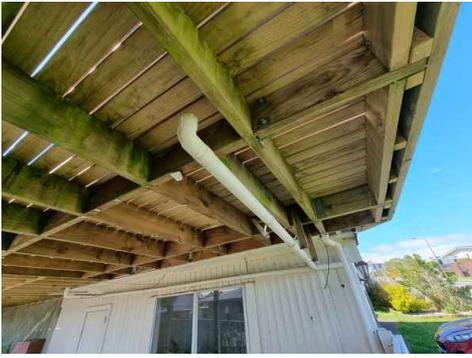
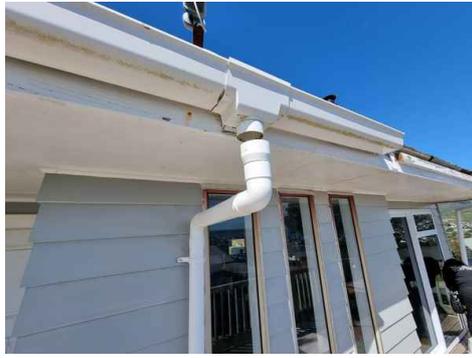
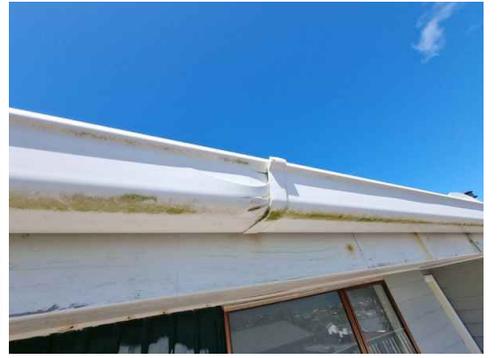
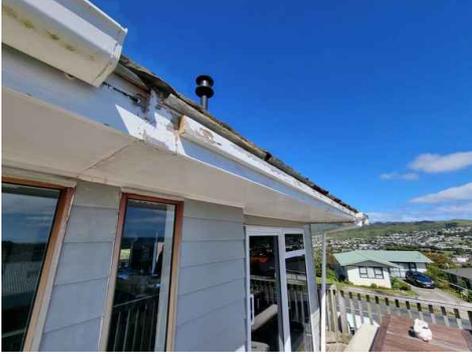
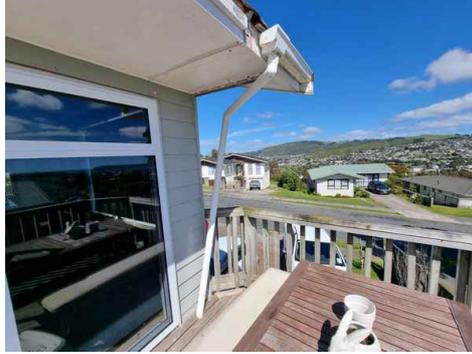
6.1.4 EXTERIOR ROOFING OBSERVATIONS

Guttering section is missing and/or has not been installed.

- One or more downpipe attachments require re-attaching or replacement.
- Roofing drainage system showed damage in one or more areas.
- Recommend a qualified professional evaluate and repair.

Recommend keeping all gutters clear to facilitate water flow.

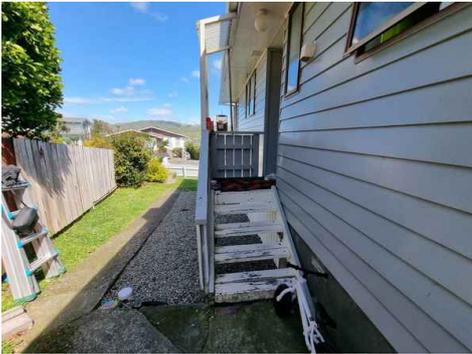
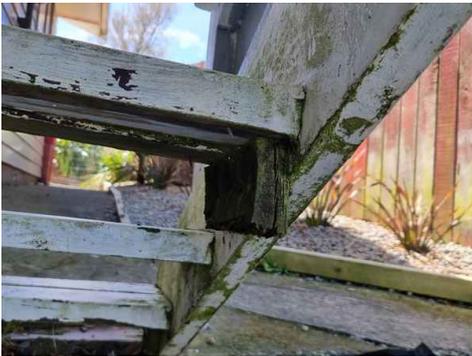
PORCH | VERANDA NEEDS REMOVING AND REBUILDING

- Material deterioration, under foot movement/sag noted.
- Recommend a qualified builder assess and quote for repair and/or replace.

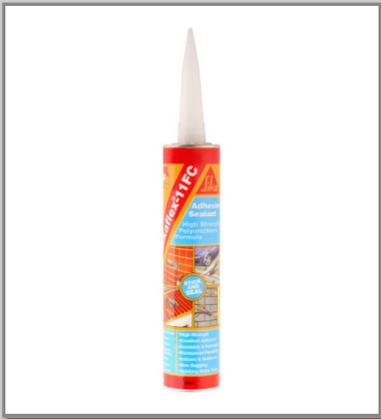
Sikaflex 11FC Concrete Joint Sealant and Adhesive.
 Approximately \$32.68 From Placemakers.

- Monitor the width of cracks for a period of time (approximately every six months):
- If they do not change, seal with a flexible exterior grade sealant. *(You must still monitor these areas after sealing them)*

- If they continue to get wider, obtain a chartered engineer’s advice on repair options.

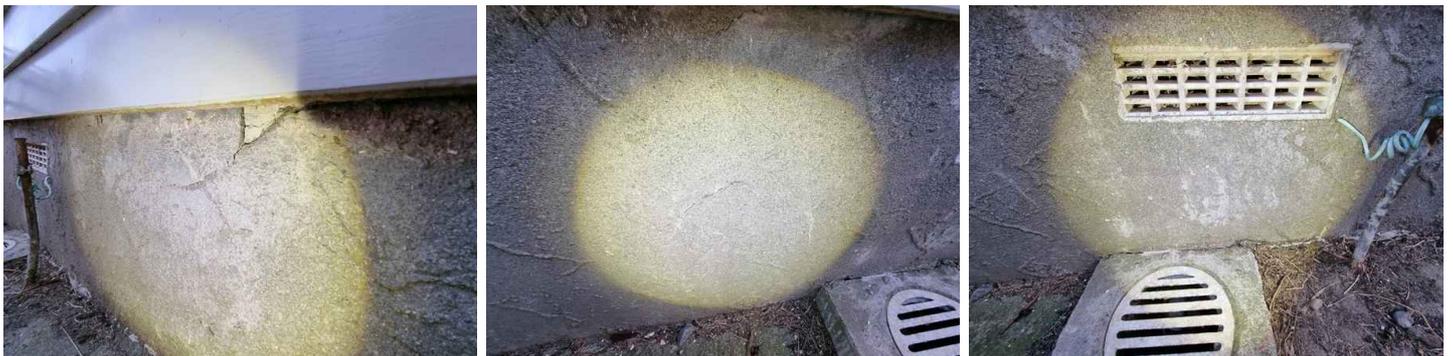
CRACKS NOTED IN CONCRETE WORK

- Cracking due to ground shift/settlement or displacement was noted in the foundation work, masonry walls and/or connecting concrete areas.
- Surface cracking and/or edges cracking of slab corners is relatively normal in concrete construction of this type.
- Cracking in concrete plaster rendering is also a common observation.

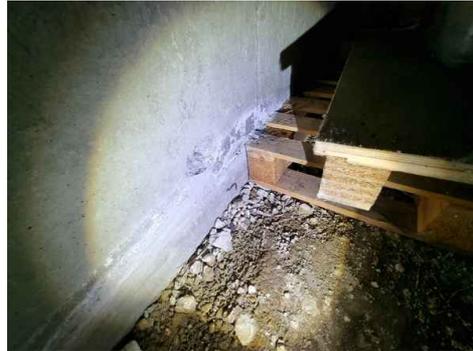
EFFLORESCENCE | STANDING WATER

Efflorescence is usually caused by a combination of the following factors:

- One or more of the constituents of concrete may contain salts
- A high water-cement ratio resulting in a more porous concrete that allows movement of water and salt solutions
- Inadequate curing which may leave un-hydrated products near the surface of the concrete
- Exposure to rain or other water sources (moisture allows salts to be transported to the surface where they accumulate as the water evaporates)
- Slow rate of evaporation of water allowing time for salts to permeate to the surface (this is why efflorescence tends to be more of a problem during the winter months; in summer, high temperatures may cause evaporation and hence depositing of salts within the concrete rather than on the surface)
- Variability of concrete (e.g. from compaction or curing) can result in localised problems where water can permeate more easily through the concrete.
- Poor exterior drainage.

Please contact CPRNZ if you wish to discuss all the possible options for your particular situation.

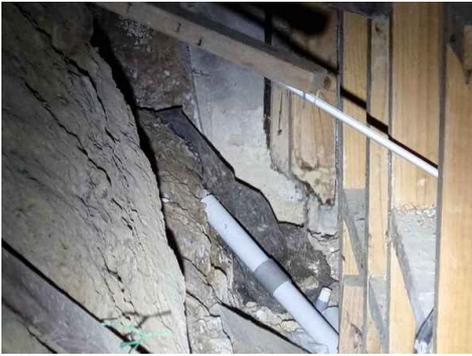
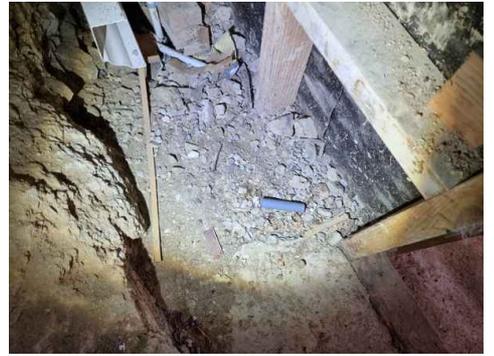
ROT NOTED

The subfloor timber shows rot in one or more isolated areas. This is somewhat common and expected for a building of this age and type of foundation, however it's not ideal, the cause should be addressed and the repair work done sooner rather than later.

Any affected timbers should be removed where possible and replaced with pre-treated timber. Any remaining timbers at risk of being affected by the dry rot should be treated with an effective fungicide. Where the dry rot has passed through the masonry, it should be isolated using physical containment and / or masonry sterilization.

- check that the source of the moisture has been identified and remedied
- remove all visible rot
- remove at least one meter of timber past the last visible sign of rot damage as the root system of the rot may be present in apparently sound timber – in some cases, it may prove easier to replace the entire piece of affected timber rather than trying to replace and strengthen a portion
- treat cut timber with a proprietary paint-on preservative.

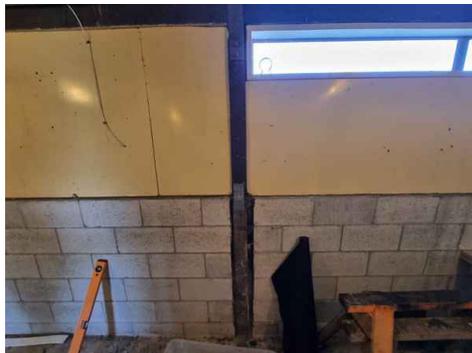
IMPROPER CONSTRUCTION PRACTICES

Trade Work Required**SUB-STANDARD CONSTRUCTION PRACTICES NOTED**

- We recommend further investigation by a qualified construction contractor.

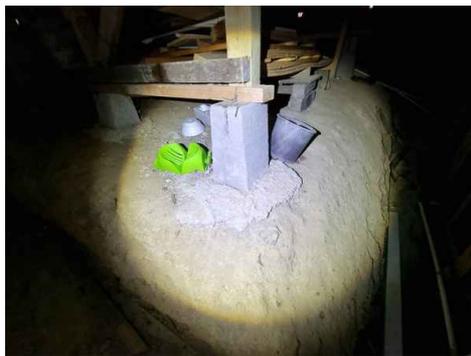
UNDERMINING NOTED BENEATH THE STRUCTURE

- Undermined piles/foundations
- Piles close to the edge of an unsupported bank
- The pile footings may have been exposed

Shovelling soil back around the footings or base of the piles is not a solution. It will not provide the strength needed in the foundations

In some cases, repiling or the installation of new members to support the floor may be required. This falls into the category of 'restricted building work'. When done by a contractor, it must be carried out or supervised by a licensed building practitioner with a Foundations license

If undermining/excavation affects one or two piles, replacing these in the same location will not require a building consent (but still needs to comply with the Building Act). Repiling all of a house or a substantial area will require building consent.

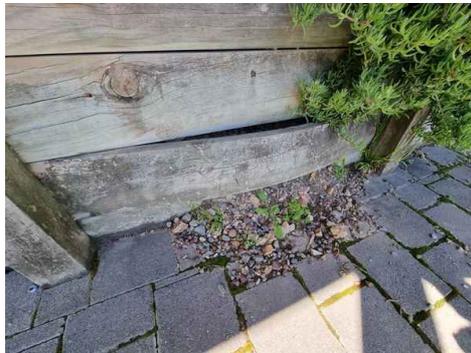
RETAINING DEFECTS SIGHTED

- Defect/s sighted in retaining and/or non retained section.
- This is a relatively common observation for this particular area.
- Further investigation is advised.
- Further deterioration could result.

- Check whether work requires a building consent. Building or repair work on a wall retaining less than 1.5 metres of ground and not supporting a surcharge does not require a building consent. (A surcharge is an additional load on the land above the wall, such as a car park or driveway.)

- Where there is a suspicion of ground movement, getting advice from a geotechnical engineer is recommended
- Even where consent is not required the wall must still comply with the Building Code, including clauses B1 Structure, B2 Durability and F4 Safety from falling

- In almost all circumstances, good piped drainage behind the wall is essential to dispose of water – a build-up of water behind the wall is the principal cause of retaining wall failure.

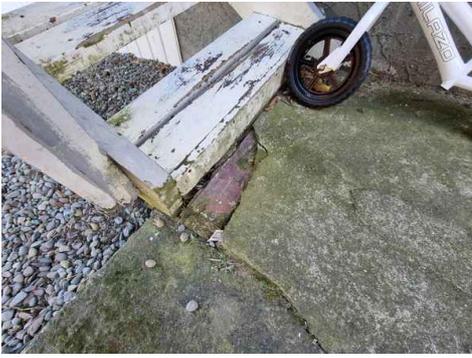
GROUND SETTLEMENT AND/OR FLAT CONCRETE CRACKS

Minor to moderate cracking observed in driveway and/or pathway concrete and/or masonry areas. These are a common observation and generally expected at most properties.

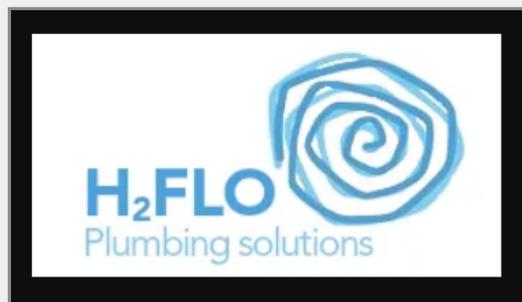
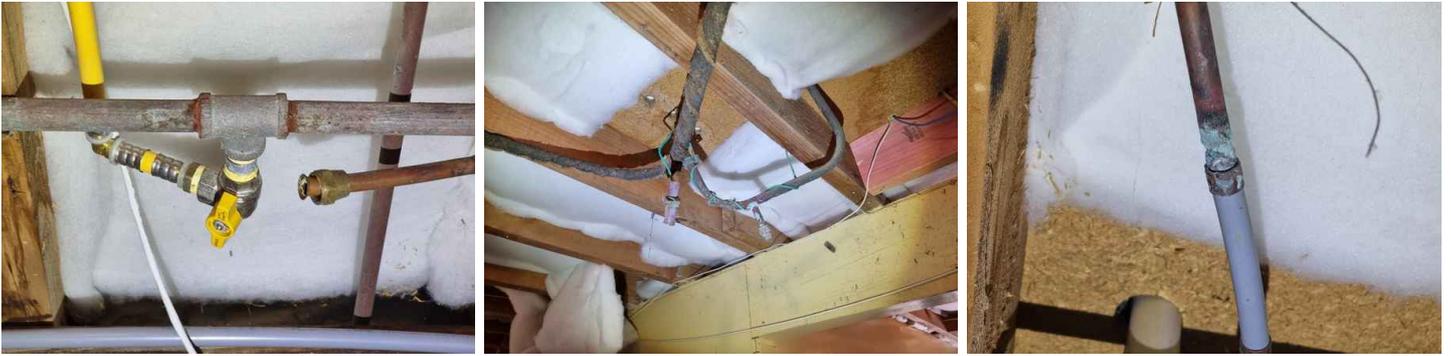
The item/s in this section require repair/replacement.

- The item/s in this section require tidying up.
- The less questions you give buyers to ask the less things they will have to knock you back on.

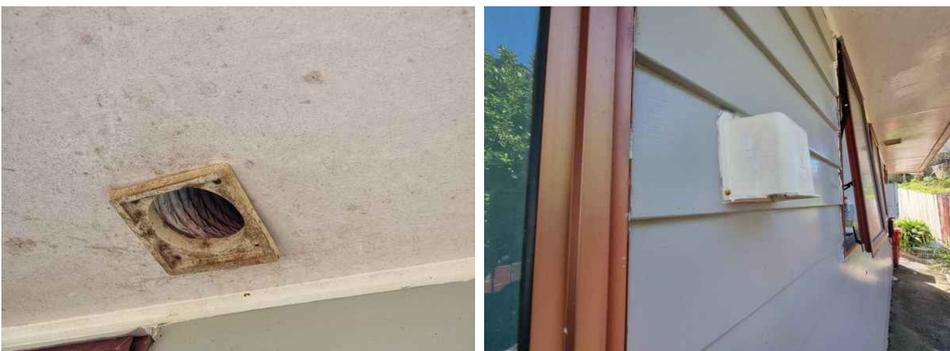
- The item/s in this section requires cleaning/repair/replacement.
- The ventilation system has been poorly installed.
- Bathroom fan vents into the attic, this can cause moisture and mold to form in the ceiling cavity. Both scenarios can be harmful to your health over time.
- Ventilation system need to be upgraded and/or installed throughout the property.
- Kitchen rangehood not ducted to the exterior.
- Kitchen extractor fan does not meet the requirements of the healthy homes standards
- Bathroom fan vents into the attic, which can cause moisture and mould. Ducting not connected to the soffit vent.
- Bathroom extractor fan does not meet the requirements of the healthy homes standards.

NZ Healthy Homes Standards require extractor and exhaust fans to be vented to the outside of the building with an vent cap. If not installed and/or installed incorrectly, the excessive moisture will cause condensation and moisture damage on ceilings and walls. This can cause mould and moisture damage inside the walls and/or ceiling cavity.

Recommend a qualified contractor property install the correct exhaust fan unit/s to terminate to the exterior of the dwelling.

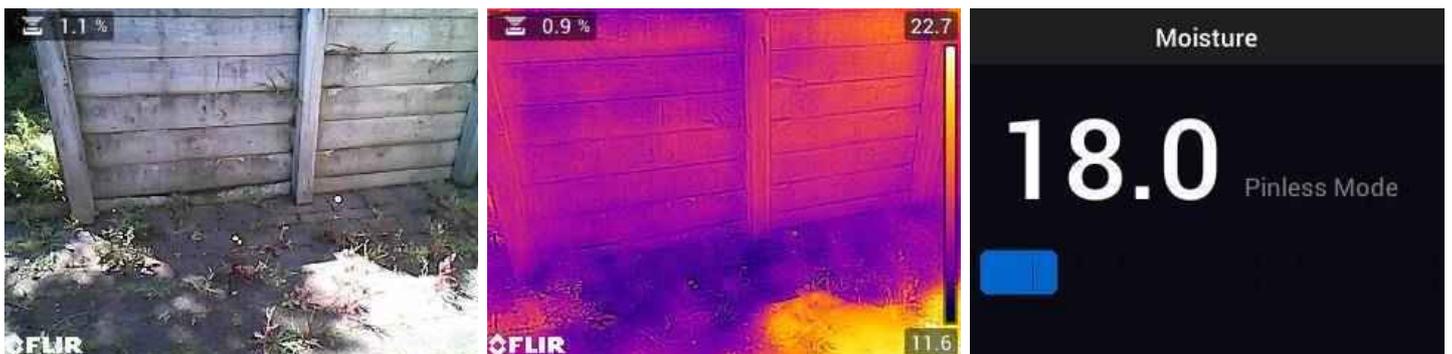
ELEVATED MOISTURE LEVELS

Indication of moisture documented with the FLIR MR60, FLIR MR277, FLIR PIN PROBES and/or Visual Signs of Moisture Ingress were noted.
