REPAIR REQUEST LIST

1234 Main St.
16/10/2021 4:24 am

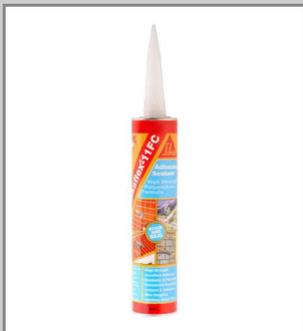
Sikaflex 11FC Concrete Joint Sealant and Adhesive.
Approximately \$32.68 From Placemakers.

Monitor the width of cracks for a period of time (approximately every six months):
If they do not change, seal with a flexible exterior grade sealant. *(You must still monitor these areas after sealing them)*

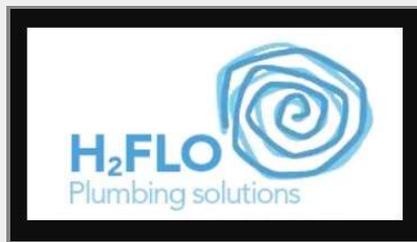
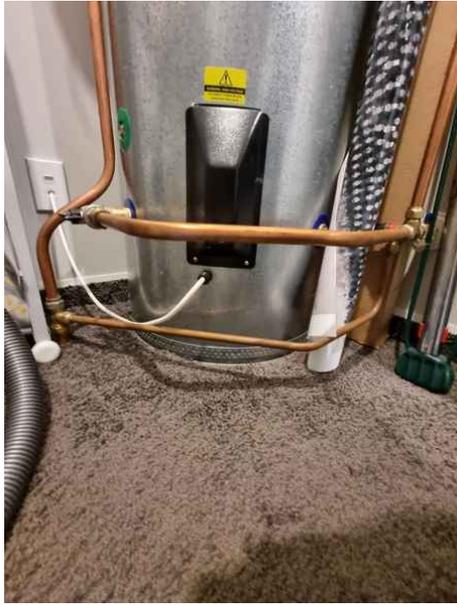
UNSATISFACTORY PLUMBING ITEM

The item/s in this section require repair/replacement.
We recommend having a qualified plumber assess and address the issue.

PLUMBING CONTRACTOR:
H2FLO PLUMBING SOLUTIONS
DAN KENDELL | 0273216211
