WEATHERTIGHTNESS REPORT COPY

1234 Main St. Paraparaumu Wellington 5032

13/02/2022 9:00AM

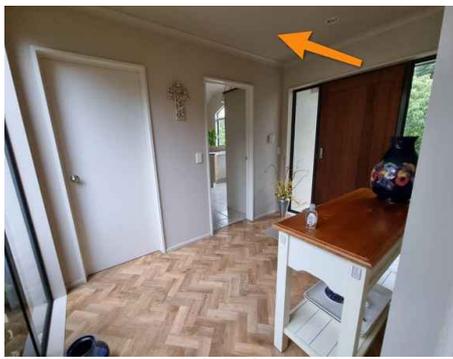
ENTRANCE - CEILING

ELEVATED MOISTURE NOTED IN THE CEILING INSIDE THE FRONT DOOR

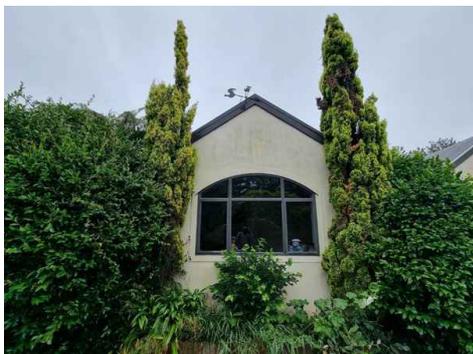
PLANTS IN CONTACT WITH CLADDING

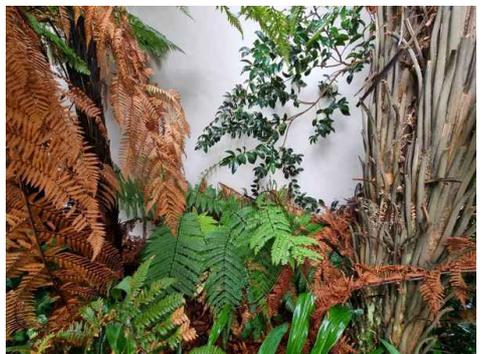
PLANTS IN CONTACT WITH CLADDING

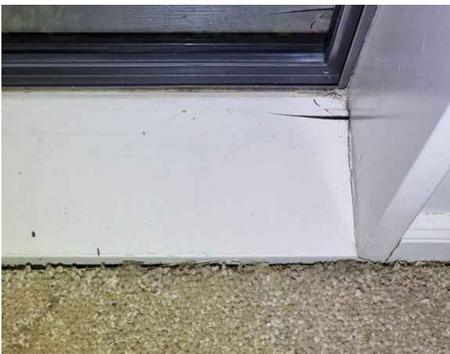
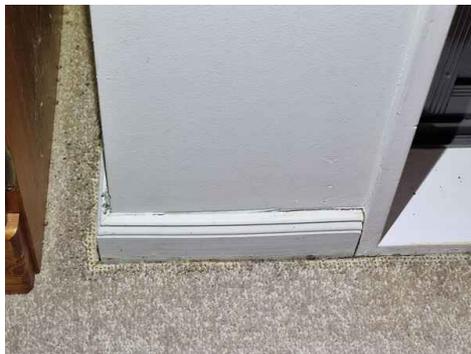
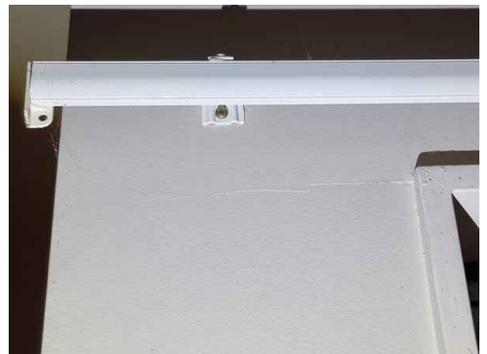
MOULD SIGHTED

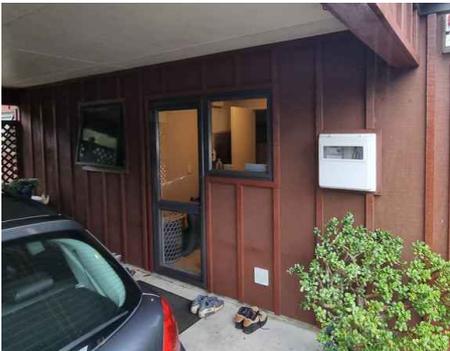
GROUND CLEARANCE

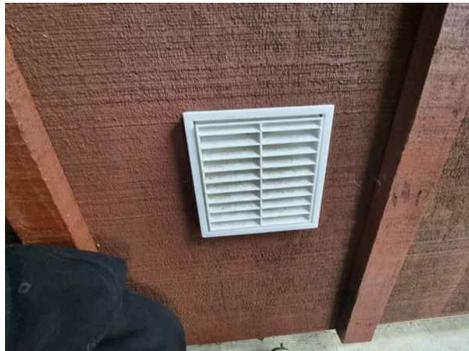
CORRECT WEATHER SEAL

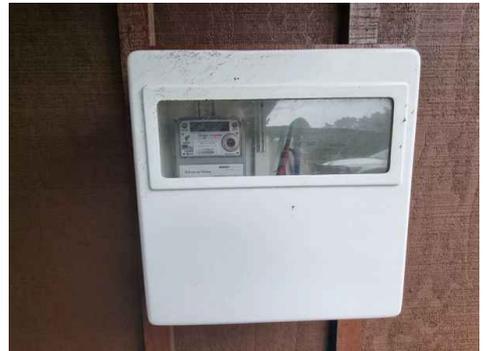
CORRECT WEATHER SEAL

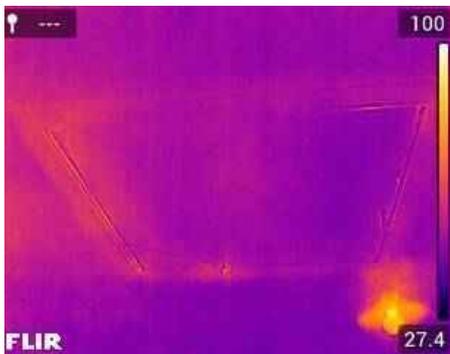
Moisture

16.7

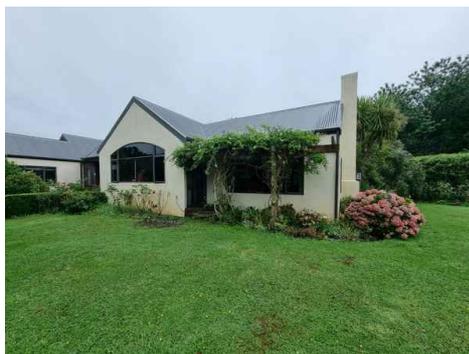
TOO MANY OBSERVATIONS TO LIST

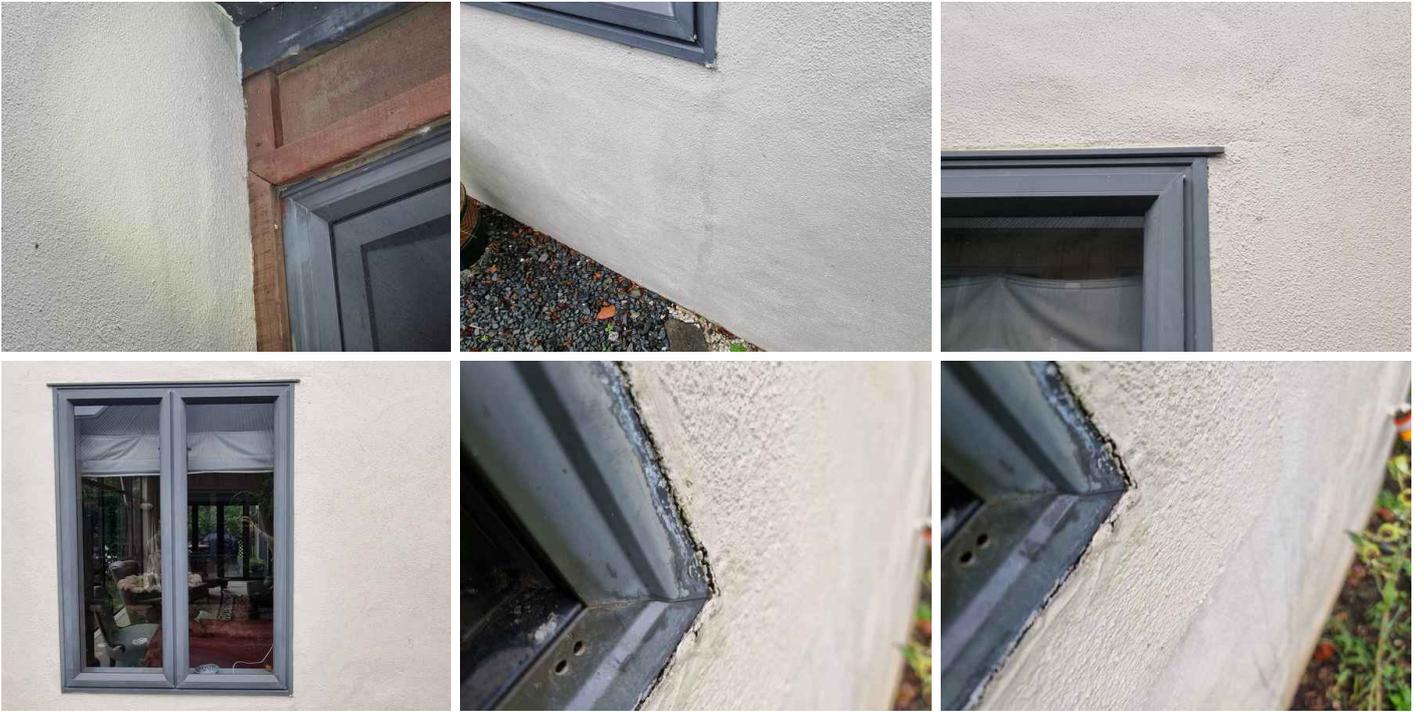
CLADDING: VISUAL OBSERVATION GALLERY

There may be defects identified both internally and externally of the room, indicating a higher chance of through wall moisture ingress. However, not all defects identified within an observation will be directly related to a current moisture ingress issue. We may have noted an area of "potential" risk to the cladding systems weatherproof envelope. The defect may require maintenance ,repair and/or re-sealing. We recommend any areas of moderate and/or major exposure be weather sealed by a cladding expert sooner rather than later.
